Report on the investigation of
a person overboard during a passenger transfer from

HMS Westminster to Princess Rose

on the River Thames

Report 16/2009
July 2009

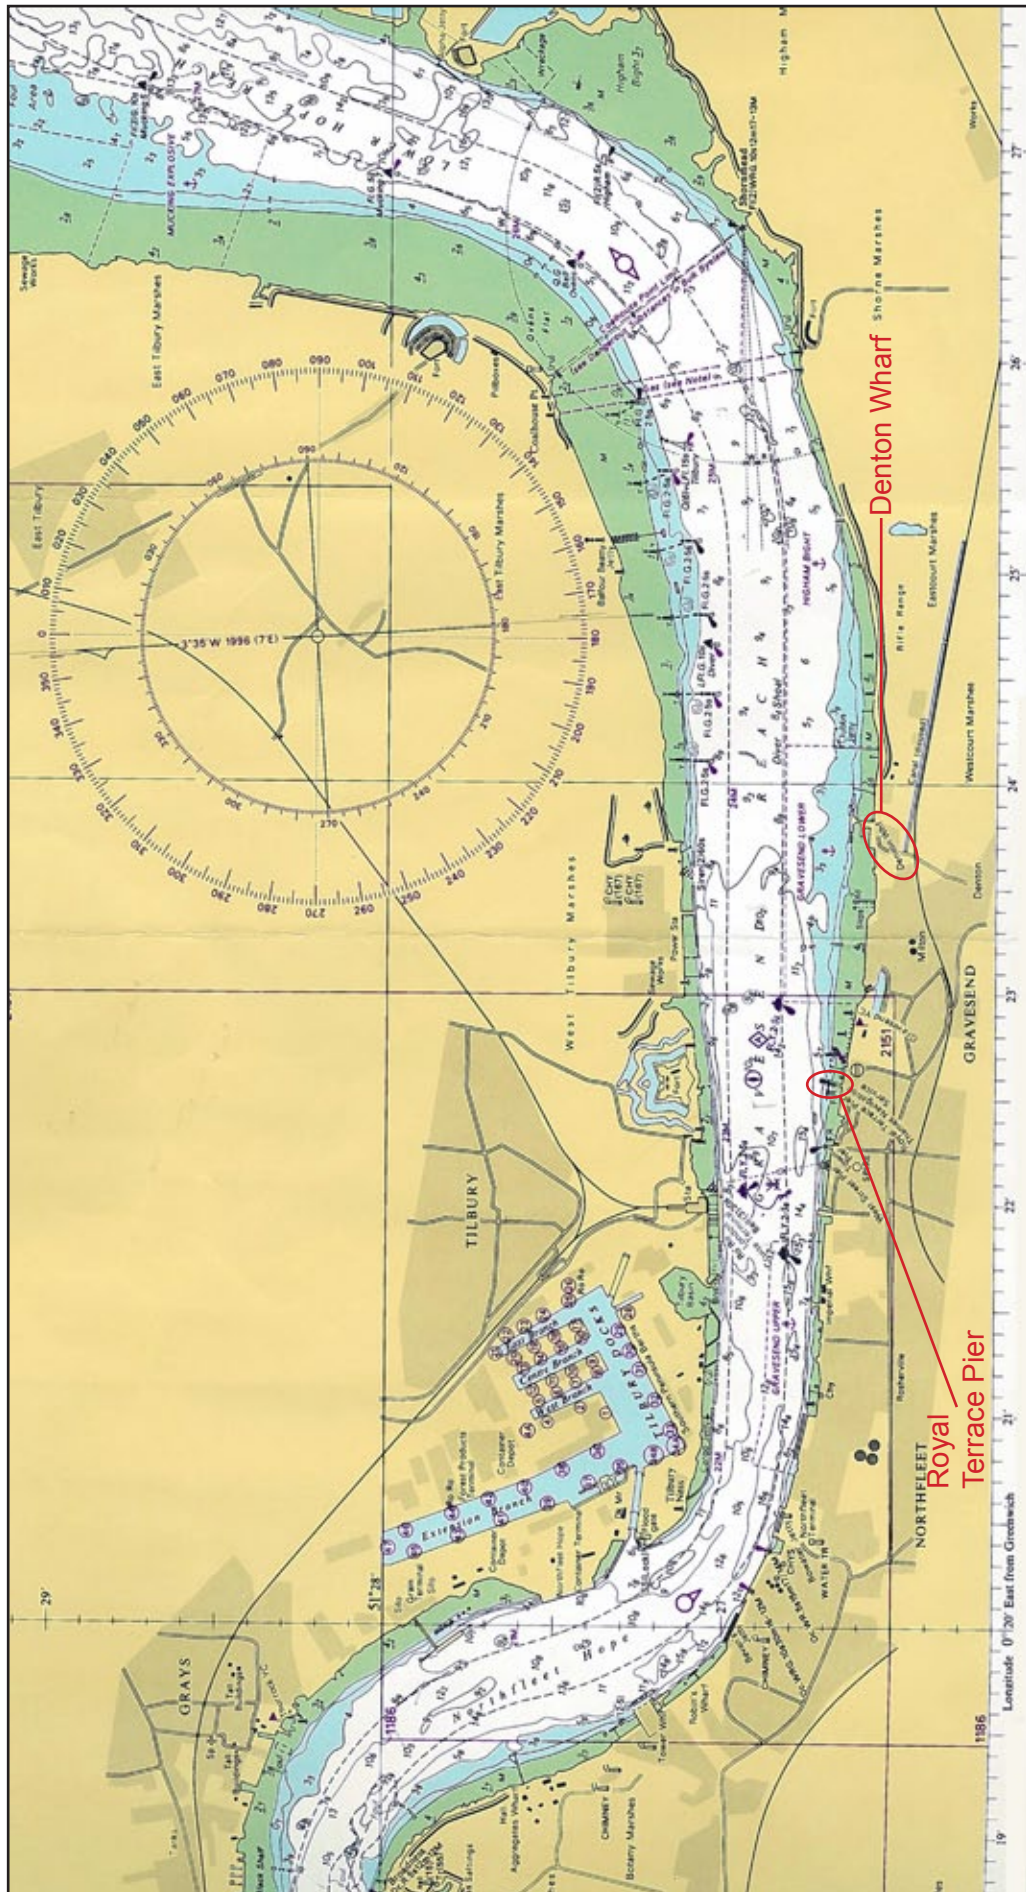
At 1317, while the fenders were prepared, the frigate started to reduce speed from 15 knots to 7 knots over the ground (**Figure 2**). Her heading had also been adjusted to 093°, which provided a lee on her starboard side from the brisk wind blowing over the port bow. During this period, the Gravesend 'E class' inshore lifeboat took up a position about 200m astern of *HMS Westminster* to act as a safety boat during the passenger transfer. The Thames pilot boat was also in close proximity astern, ready to disembark the pilot on completion of the boat transfer.

Gravesend Reach - Location used for passenger transfer

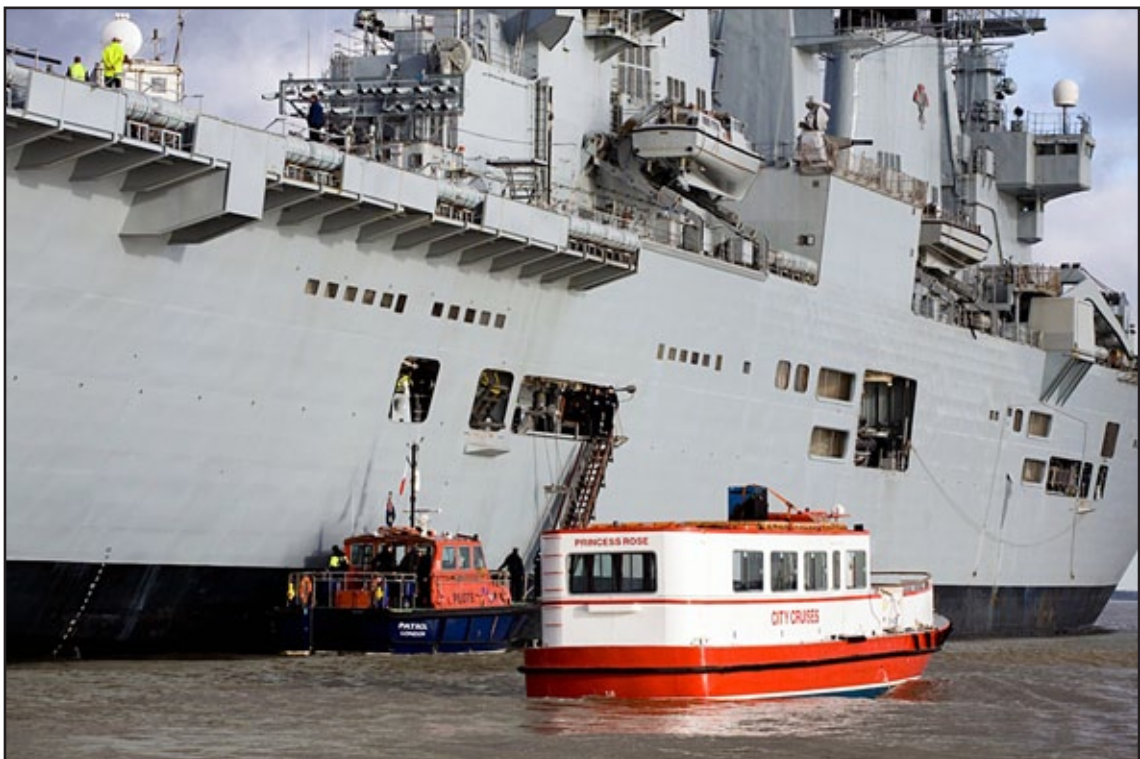
Figure 6

City Cruises used *Princess Rose* to transfer service and civilian passengers to and from warships visiting London on several occasions. These included transfers to vessels underway and making way using a pilot ladder, vessels underway but stopped using an accommodation ladder (**Figure 6**), and vessels moored to a buoy using an accommodation ladder. The company was content for the warship to determine the method used for the transfer, but had not assessed the risks associated with the three transfer methods used.

Example of an underway passenger transfer at slow speed using an accommodation ladder
