Report on the investigation of  
a person overboard during a passenger transfer from

***HMS Westminster to Princess Rose***

on the River Thames

**Report 16/2009**  
**July 2009**

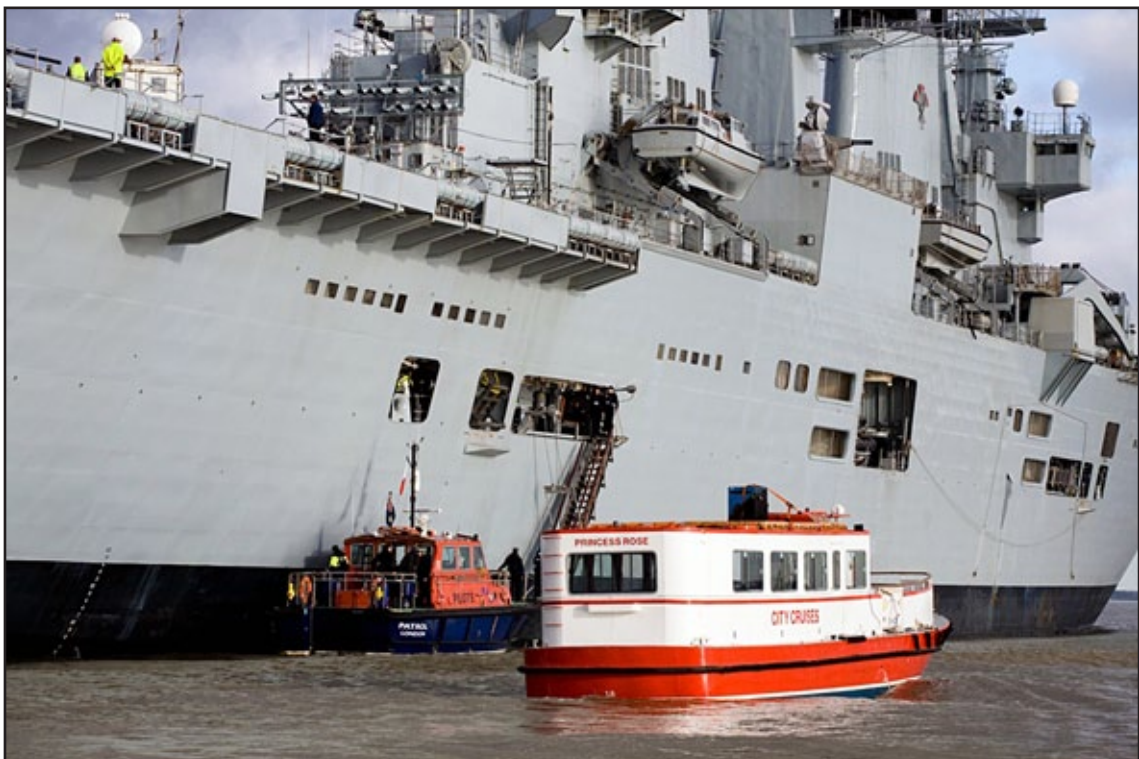
Figure 6

City Cruises used *Princess Rose* to transfer service and civilian passengers to and from warships visiting London on several occasions. These included transfers to vessels underway and making way using a pilot ladder, vessels underway but stopped using an accommodation ladder (**Figure 6**), and vessels moored to a buoy using an accommodation ladder. The company was content for the warship to determine the method used for the transfer, but had not assessed the risks associated with the three transfer methods used.

Example of an underway passenger transfer at slow speed using an accommodation ladder
