Report on the investigation of

the collision between

Scot Isles

Wadi Halfa

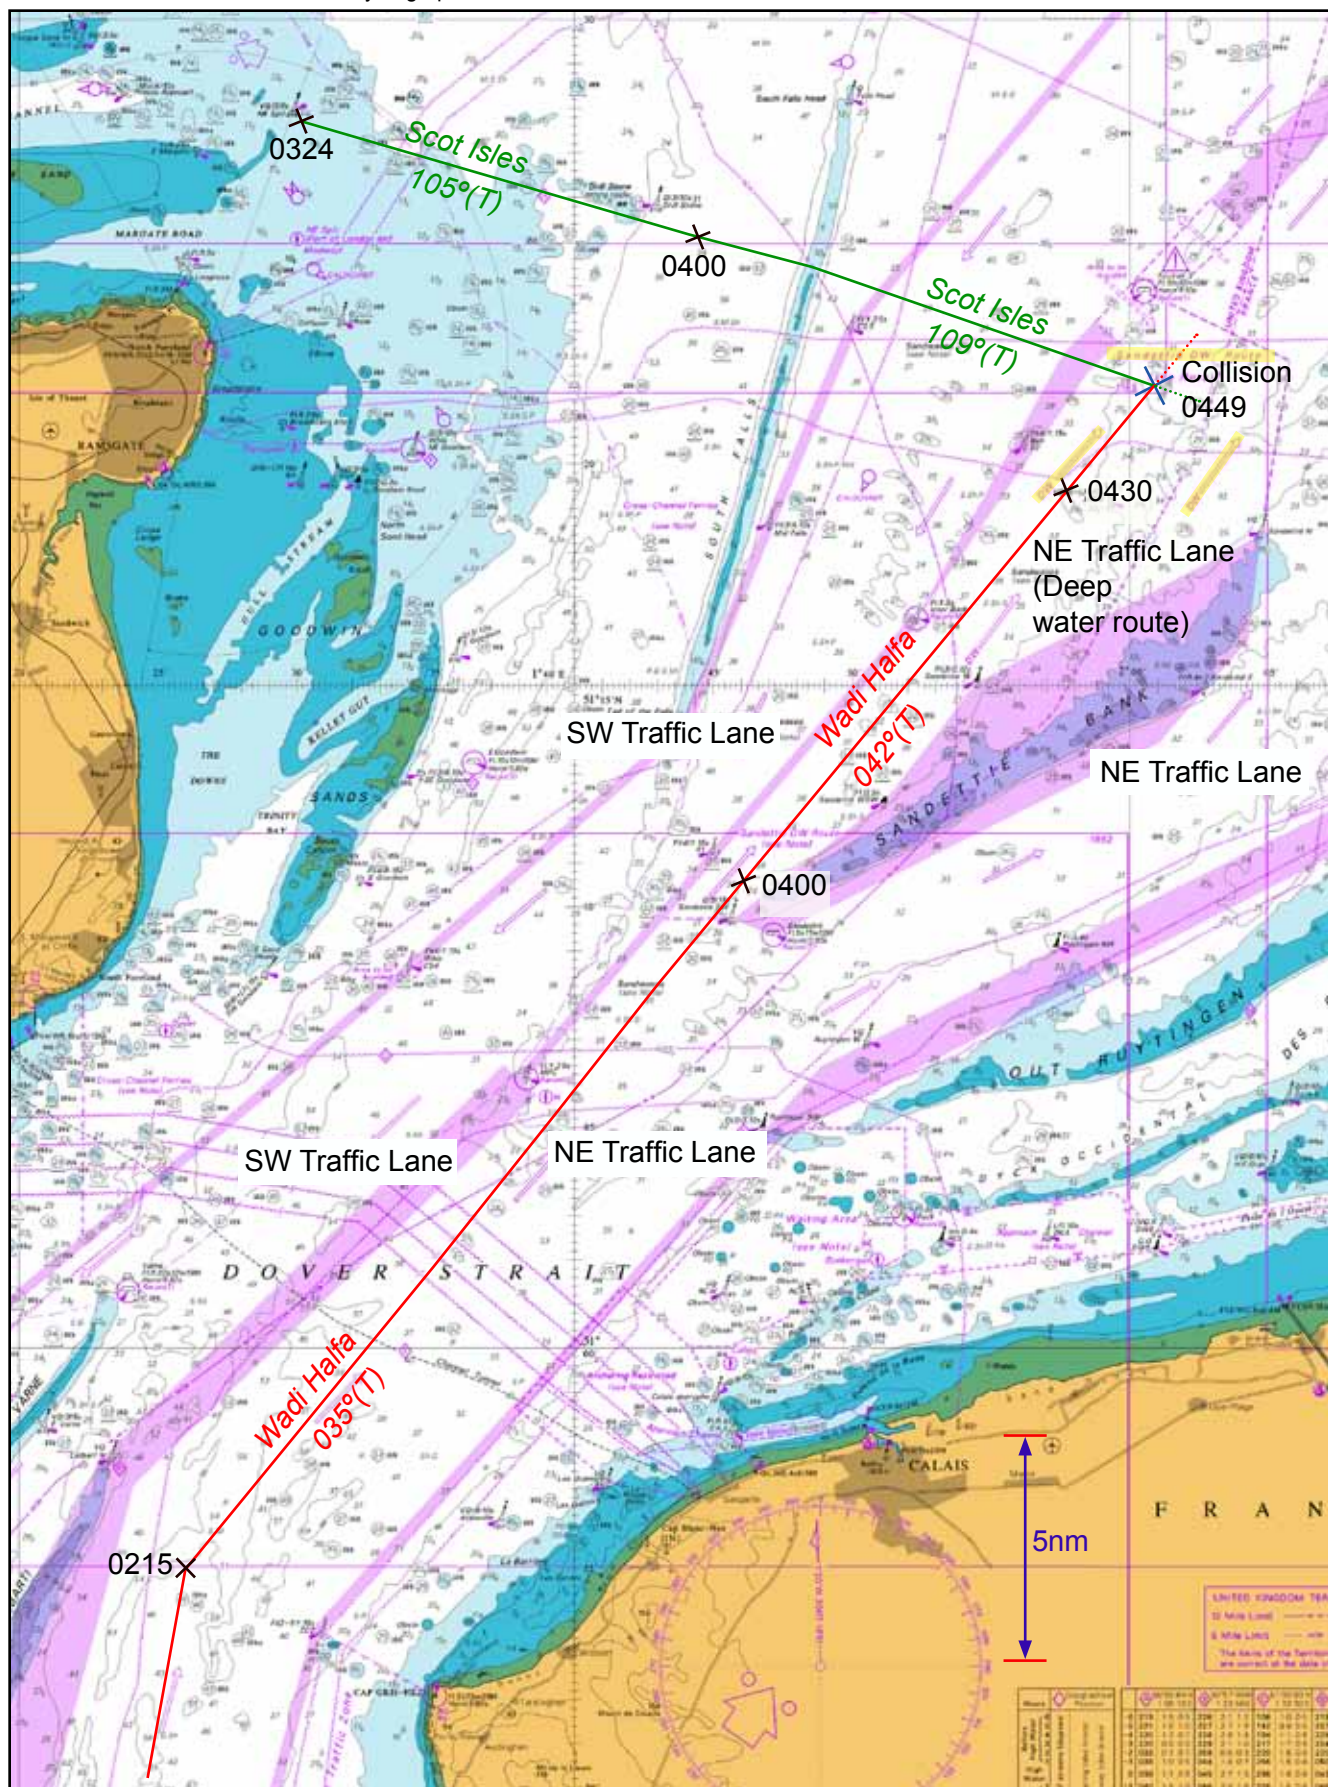
Extract from chart BA 2449, with passages of both vessels

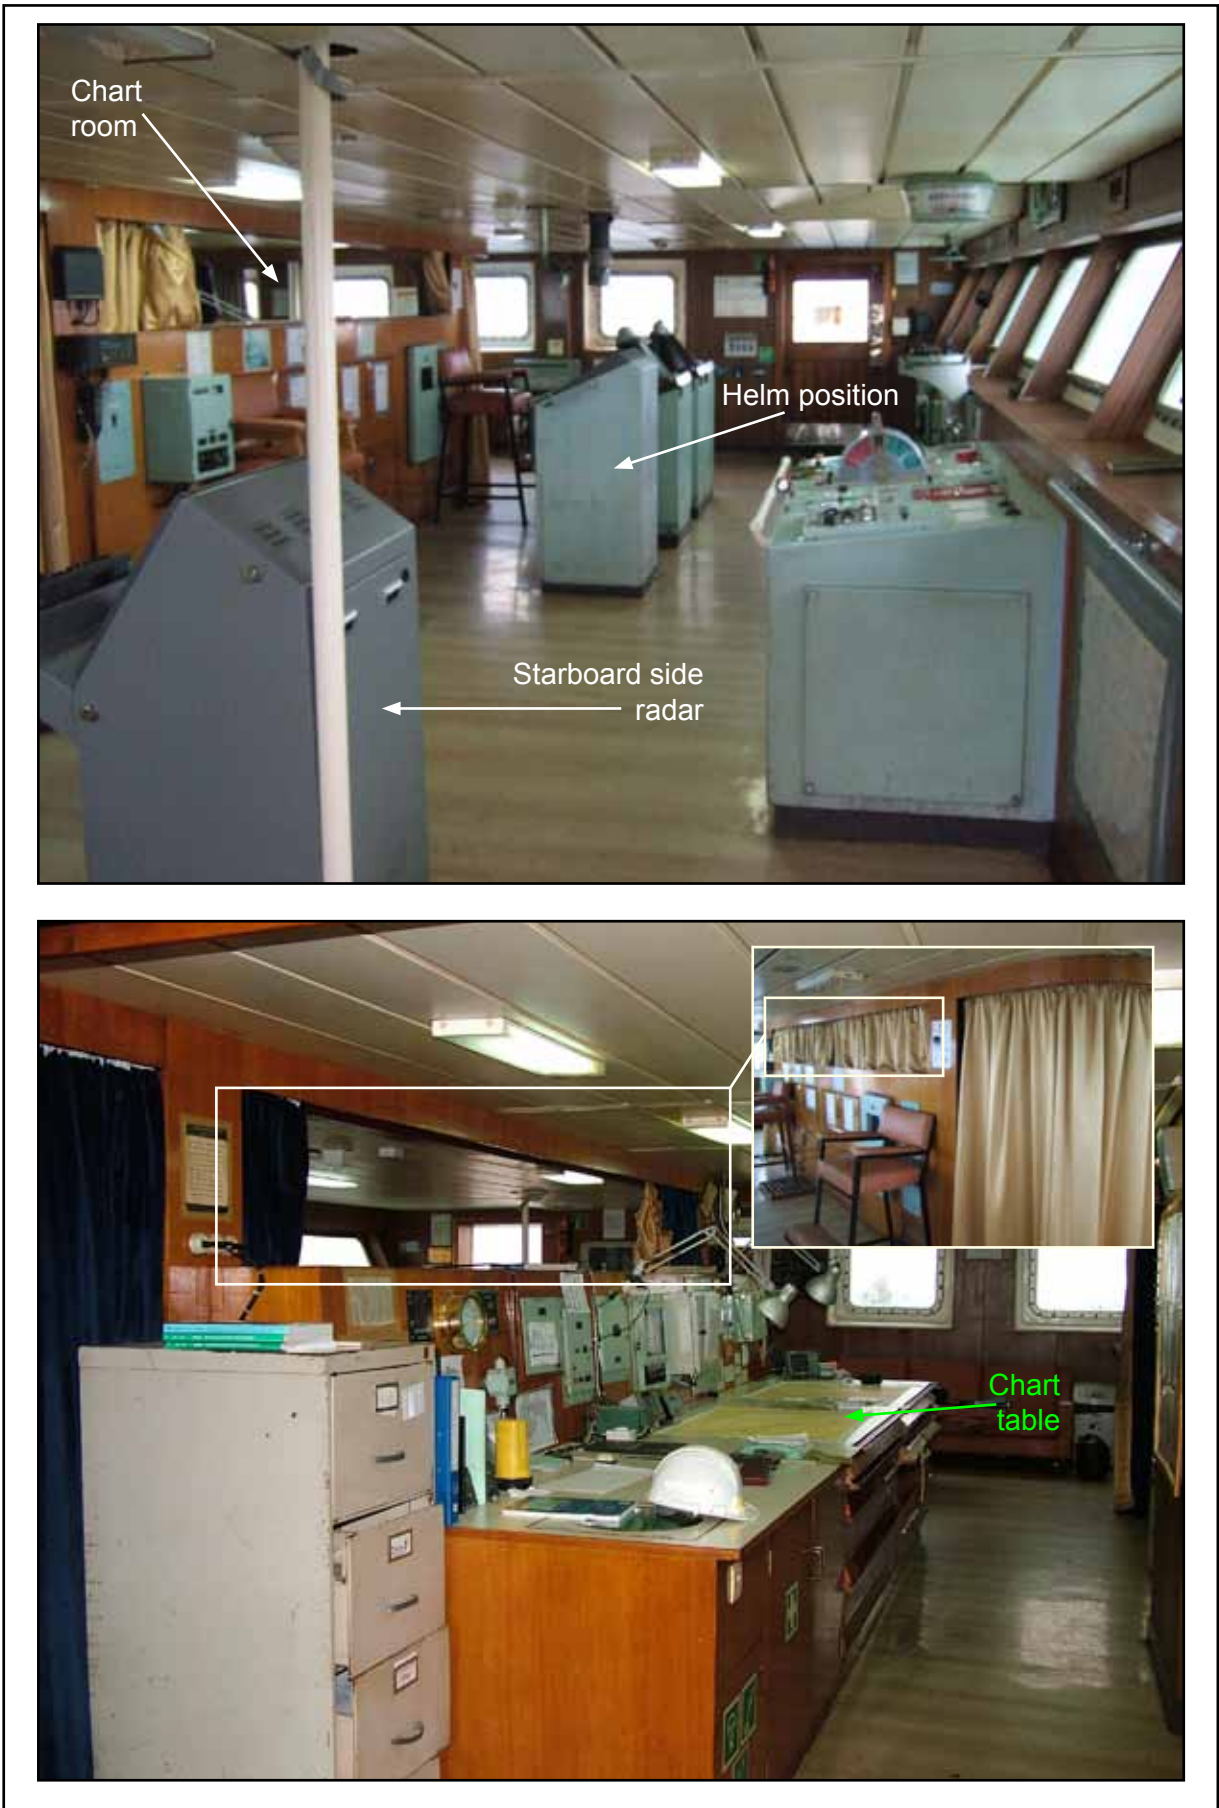
Wadi Hafa - interior of wheelhouse

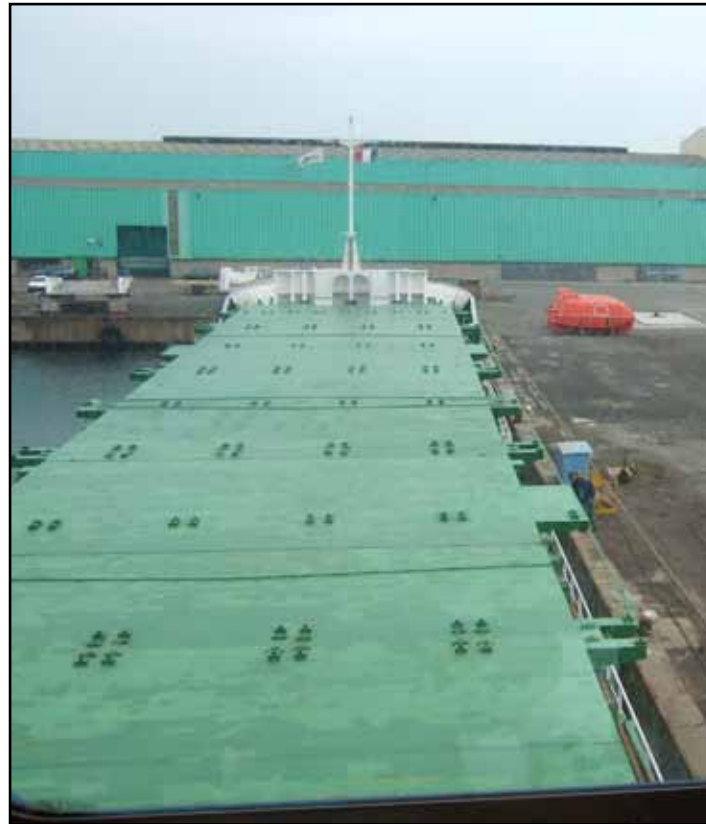
Figure 11

In assuming that only *Scot Isles*' starboard bridgework had been damaged during the collision, the master relied on information provided to him by the chief officer, who was in a state of shock, and on what could be seen from the wheelhouse (**Figure 11**). A thorough inspection of the entire vessel, which should have included sounding all tanks and spaces, should have been undertaken following the collision.

Scot Isles - view looking forward from wheelhouse

A prompt, which required the master to inform the nearest coastal state in the event of a collision, was not included on the relevant SMS checklist. Early notification of all accidents and incidents to the nearest coastal state will ensure appropriate shore resources can be briefed and placed on standby, thereby allowing a more effective response, should the situation worsen. Without such a prompt, it is entirely understandable that masters will, in the heat of the moment, not be focused on the need to inform the coastal authorities of a developing problem. It is therefore essential that the requirement should be formally incorporated into the shipboard contingency plans.
