Report on the investigation of
injury to a passenger on board the RIB

Celtic Pioneer

26 August 2008

Report No 11/2009
May 2009

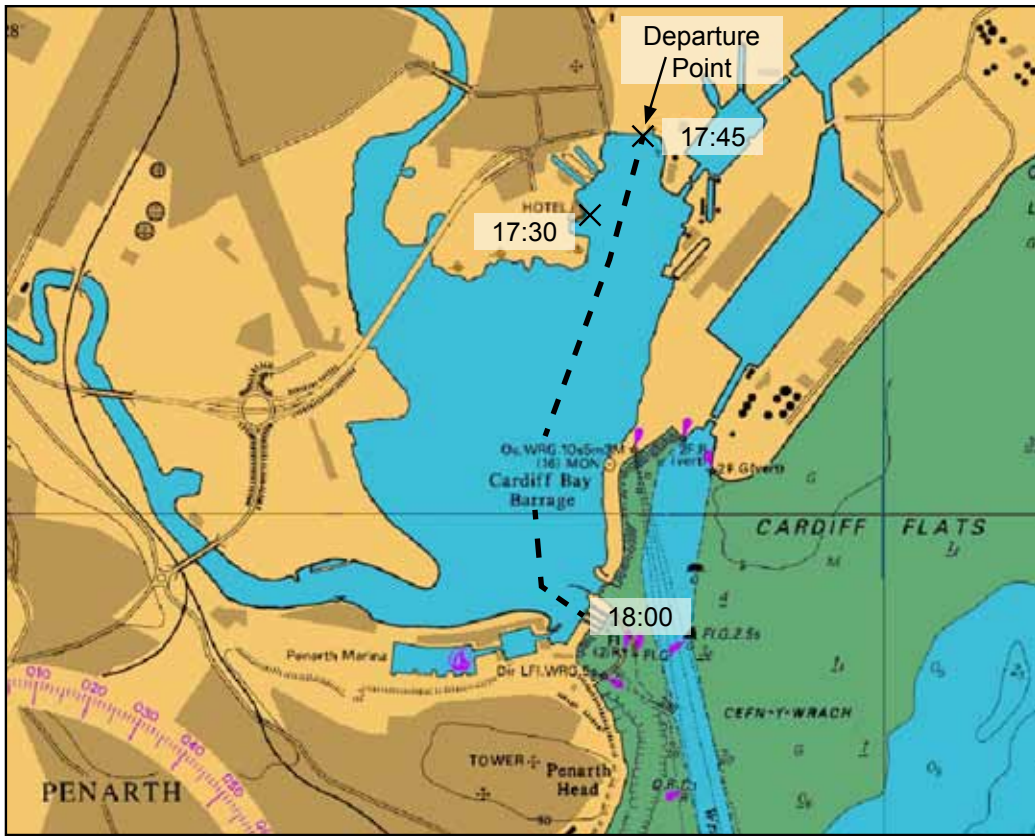
Figure 1

At about 1745 on 26 August 2008, a group of 11 adults arrived at Mermaid Quay in Cardiff Bay (**Figure 1**), for a 1 hour boat ride on board the rigid inflatable boat (RIB), *Celtic Pioneer*, operated by Bay Island Voyages. The group had arrived later than expected and were ushered directly onto the pontoon, where each person was issued a lifejacket and a waterproof coat. They were then helped on board and sat on the seats provided (**Figure 2**); the centre seat on the front row was unoccupied. *Celtic Ranger*, another RIB operated by Bay Island Voyages, which had been booked for a similar 1 hour trip by another group was also moored alongside. Its passengers were already seated and waiting to go.

Extract of chart BA 1182 - Cardiff Bay

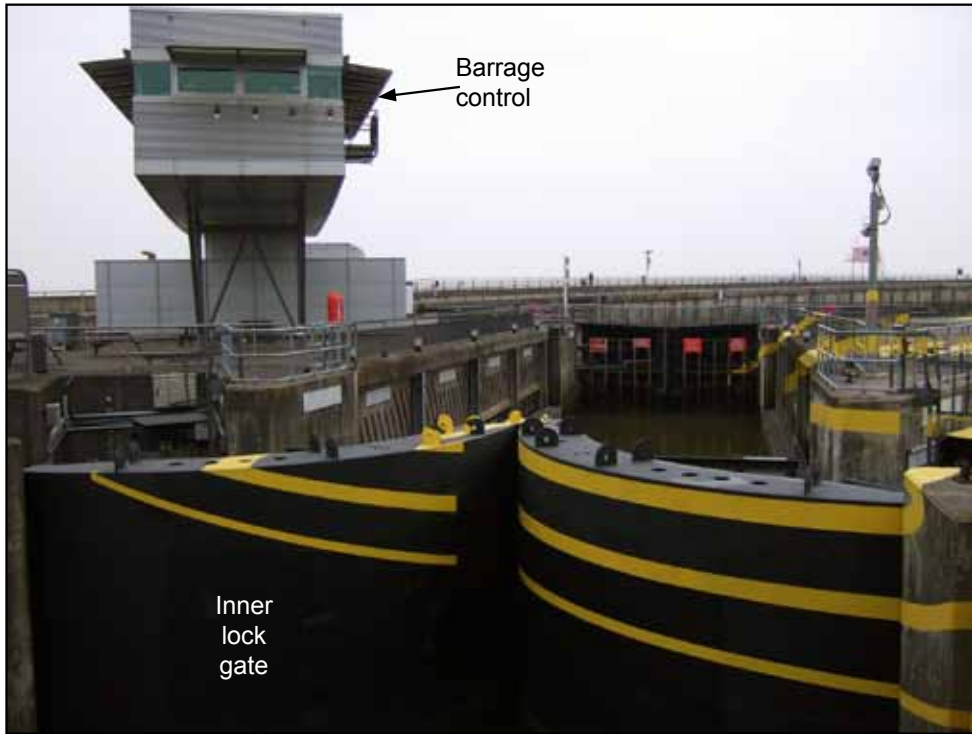
Figure 3

The RIBs set off at a speed of approximately 5 knots towards the Cardiff barrage locks. During the 1 mile transit, the passengers on board *Celtic Pioneer* put on their waterproof coats and lifejackets. The boats entered lock number two (**Figure 3**) at about 1800, where the owner of Bay Island Voyages, who was acting as crewman on board *Celtic Pioneer*, briefed the passengers. He explained how the lifejackets worked, what to expect during the trip and how to sit on the jockey style seats while riding the waves. The passengers were told to hold onto the handrail in front of them, keep their heads up, grip the seat pod between their thighs and use their knees to absorb the shocks in a similar manner to a jockey riding a horse.

Cardiff Bay barrage locks

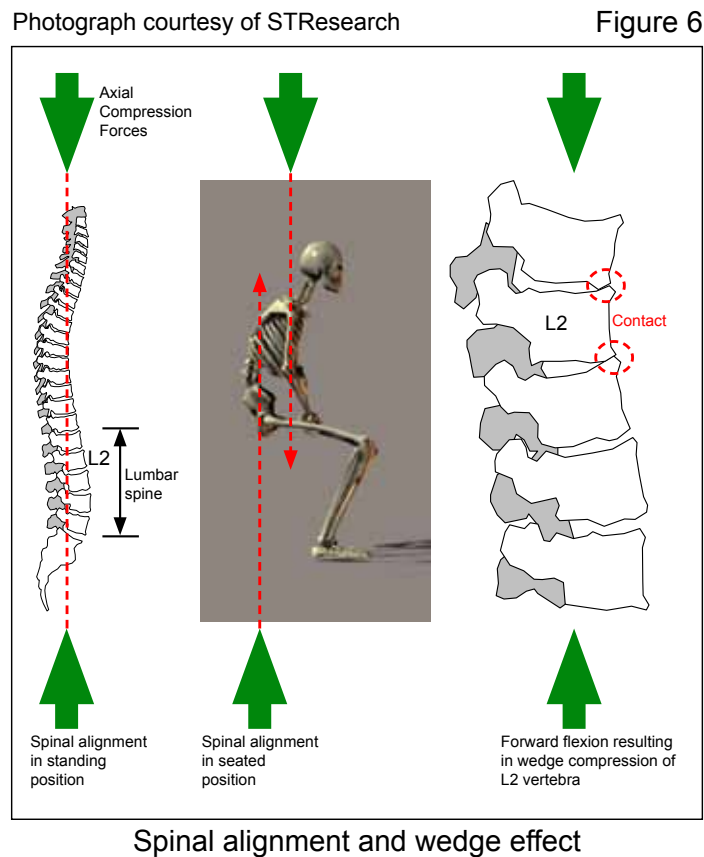
loading. It is the combination of the flexion of the spine and the axial forces applied that causes contact between the vertebrae and results in fractures due to the wedging effect (**Figure 6**). If a twist or bend is introduced to the lower back region the risk of this type of injury is further increased. Research indicates that the introduction of a twist can reduce the mechanical strength of the vertebra/intervertebral disc unit by about one third.

People suffering from osteoporosis, which causes a loss of mineralization and results in a reduction of BMD, are more prone to spinal wedge compression, and other types of fracture. Groups at an increased risk of developing this condition include: the elderly, post menopausal women and women with a strong family history of osteoporosis.

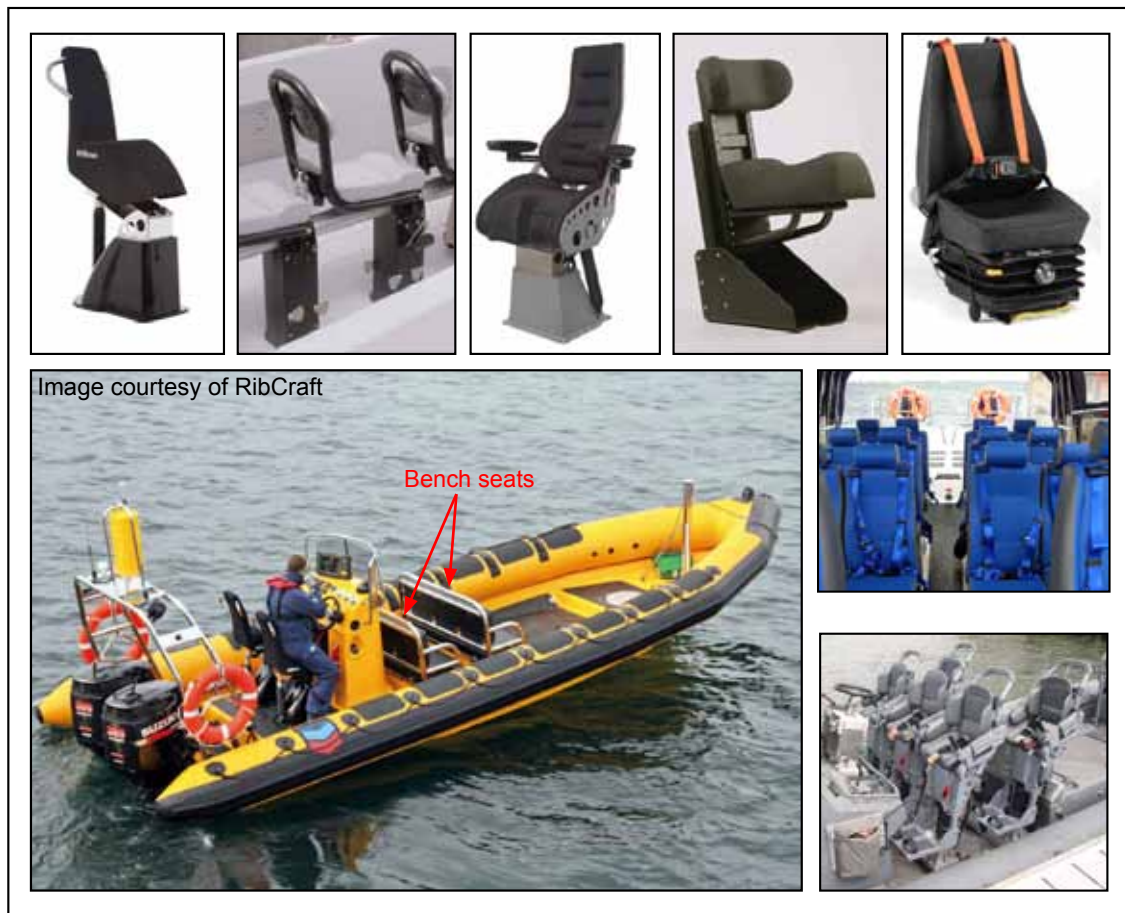
Figure 10

Seats are available for use on high speed craft, which are designed to dampen the transmission of shock and vibration and improve the occupant's posture and spinal alignment. Some of the most commonly adopted designs include shock absorption systems, restraint harnesses, and adjustable features to allow for people of differing sizes (**Figure 10**).

Examples of seats used on board high speed craft

Shock absorption is not simply a case of adding extra padding to a seat. Although this might increase the comfort of its occupant when the boat is at rest, it will not necessarily provide a reduction in the magnitude of vibrations felt while underway. Indeed, the use of certain cushioning materials can lead to an increase in shock and vibration magnitude (**Annex F**). However, there are several suspension seats available which significantly dampen out the magnitude of repeated shocks and reduce exposure to WBV. Restraint harnesses help ensure an occupant stays in contact with the seat while underway, and offer additional support and a sense of security as the boat is manoeuvred at speed or in choppy seas, but they present other hazards that need to be carefully considered. Adjustable seats will help passengers of varying sizes assume the designed optimum posture.
