Report on the investigation of
injury to a passenger on board the RIB

Celtic Pioneer

26 August 2008

Report No 11/2009
May 2009

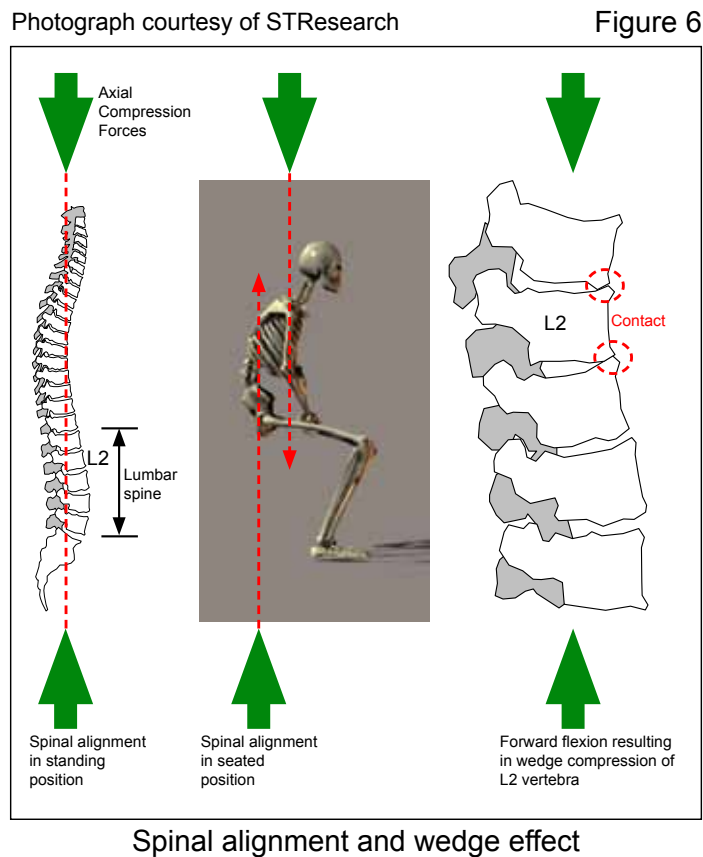
loading. It is the combination of the flexion of the spine and the axial forces applied that causes contact between the vertebrae and results in fractures due to the wedging effect (**Figure 6**). If a twist or bend is introduced to the lower back region the risk of this type of injury is further increased. Research indicates that the introduction of a twist can reduce the mechanical strength of the vertebra/intervertebral disc unit by about one third.

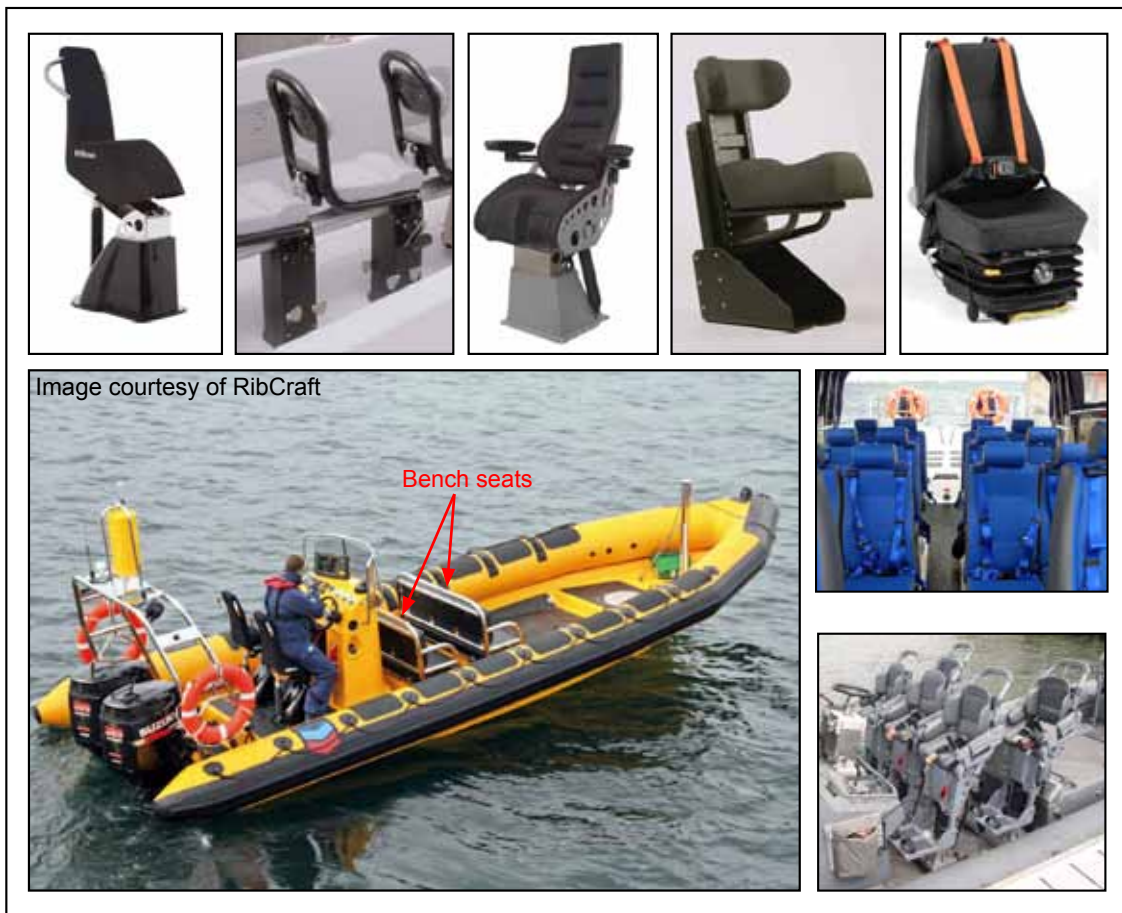
Figure 10

Seats are available for use on high speed craft, which are designed to dampen the transmission of shock and vibration and improve the occupant's posture and spinal alignment. Some of the most commonly adopted designs include shock absorption systems, restraint harnesses, and adjustable features to allow for people of differing sizes (**Figure 10**).

Shock absorption is not simply a case of adding extra padding to a seat. Although this might increase the comfort of its occupant when the boat is at rest, it will not necessarily provide a reduction in the magnitude of vibrations felt while underway. Indeed, the use of certain cushioning materials can lead to an increase in shock and vibration magnitude (**Annex F**). However, there are several suspension seats available which significantly dampen out the magnitude of repeated shocks and reduce exposure to WBV. Restraint harnesses help ensure an occupant stays in contact with the seat while underway, and offer additional support and a sense of security as the boat is manoeuvred at speed or in choppy seas, but they present other hazards that need to be carefully considered. Adjustable seats will help passengers of varying sizes assume the designed optimum posture.
