Report on the investigation of
injury to a passenger on board the RIB

Celtic Pioneer

26 August 2008

Report No 11/2009
May 2009

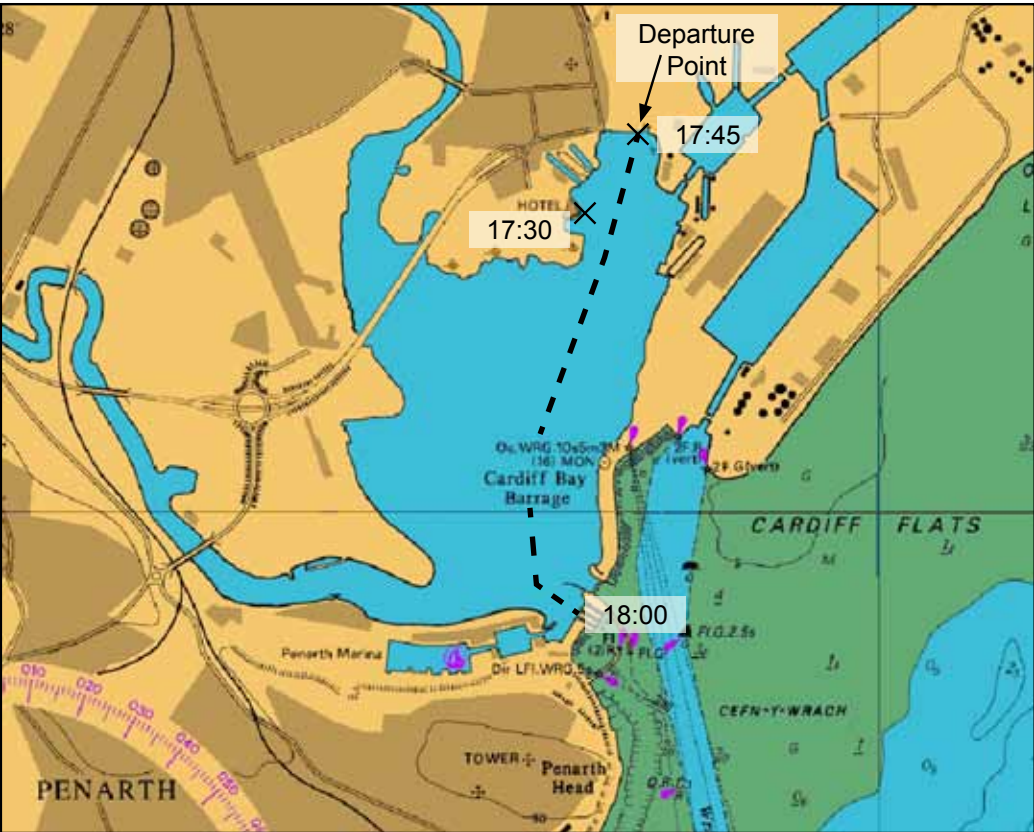
Figure 1

At about 1745 on 26 August 2008, a group of 11 adults arrived at Mermaid Quay in Cardiff Bay (**Figure 1**), for a 1 hour boat ride on board the rigid inflatable boat (RIB), *Celtic Pioneer*, operated by Bay Island Voyages. The group had arrived later than expected and were ushered directly onto the pontoon, where each person was issued a lifejacket and a waterproof coat. They were then helped on board and sat on the seats provided (**Figure 2**); the centre seat on the front row was unoccupied. *Celtic Ranger*, another RIB operated by Bay Island Voyages, which had been booked for a similar 1 hour trip by another group was also moored alongside. Its passengers were already seated and waiting to go.

Extract of chart BA 1182 - Cardiff Bay

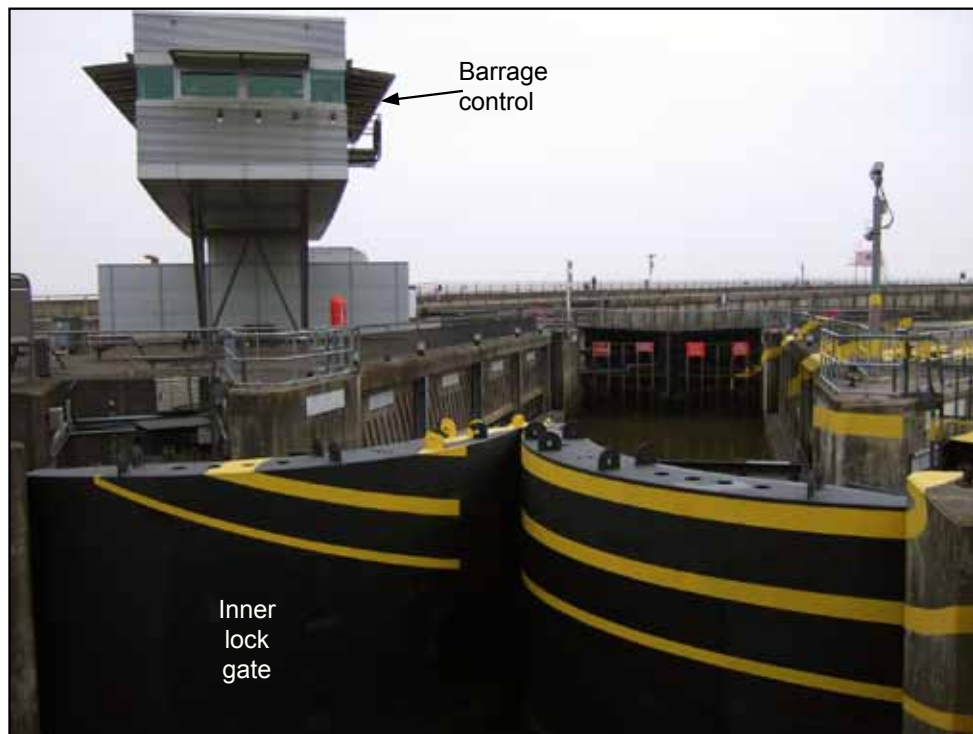
Figure 3

The RIBs set off at a speed of approximately 5 knots towards the Cardiff barrage locks. During the 1 mile transit, the passengers on board *Celtic Pioneer* put on their waterproof coats and lifejackets. The boats entered lock number two (**Figure 3**) at about 1800, where the owner of Bay Island Voyages, who was acting as crewman on board *Celtic Pioneer*, briefed the passengers. He explained how the lifejackets worked, what to expect during the trip and how to sit on the jockey style seats while riding the waves. The passengers were told to hold onto the handrail in front of them, keep their heads up, grip the seat pod between their thighs and use their knees to absorb the shocks in a similar manner to a jockey riding a horse.

Cardiff Bay barrage locks

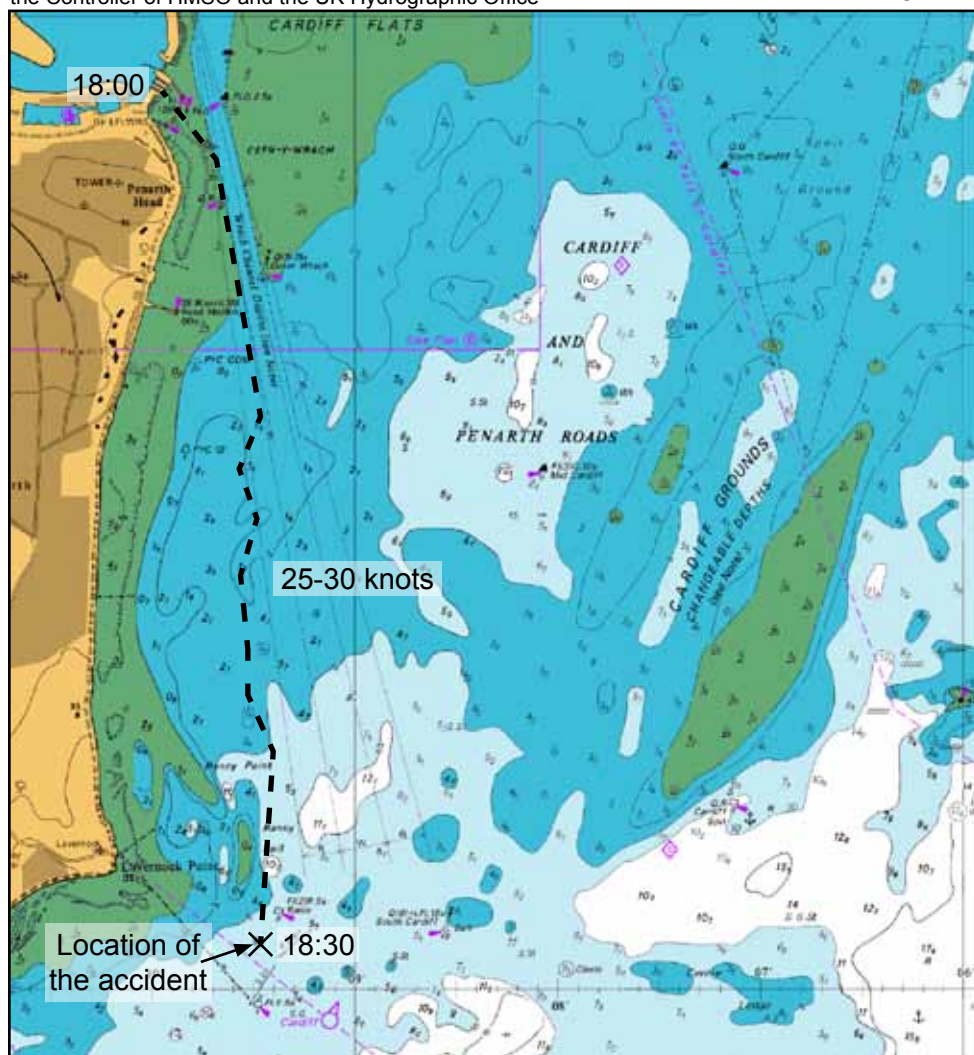
Figure 4

At about 1815 the RIBs left the lock and headed into the Bristol Channel (**Figure 4**). Although both RIBs were working in the same area and were following a similar routine, they were operating independently. The skipper of *Celtic Pioneer* gradually increased speed to between 25 and 30 knots and conducted several helm manoeuvres as the RIB headed south towards the Rannie buoy. However, on several occasions during the transit he slowed down to allow the owner the opportunity to gauge the comfort of the passengers.

Extract of chart BA 1182 - passage and accident location

As *Celtic Pioneer* approached the Rannie buoy the seas became choppy. The skipper slowed to approximately 10 to 12 knots and began to dodge between and over the waves. At approximately 1830, the motion of the boat lifted the female passenger in the front row into the air. She then landed heavily on her seat and screamed due to a sudden intense pain in her lower back. The skipper immediately stopped the boat. The injured passenger moved from her seat towards the bow and lay down. Two passengers, one of whom was a consultant doctor, immediately went to her assistance, quickly followed by the boat's owner. The owner instructed the skipper to turn around and head slowly back towards Cardiff Bay. The casualty was in extreme pain and was wet and cold. She was positioned on her back with her head resting on a fender and her feet elevated onto the RIB's buoyancy tube. The owner used two of the boat's thermal protective aids as blankets to shelter her from the elements.

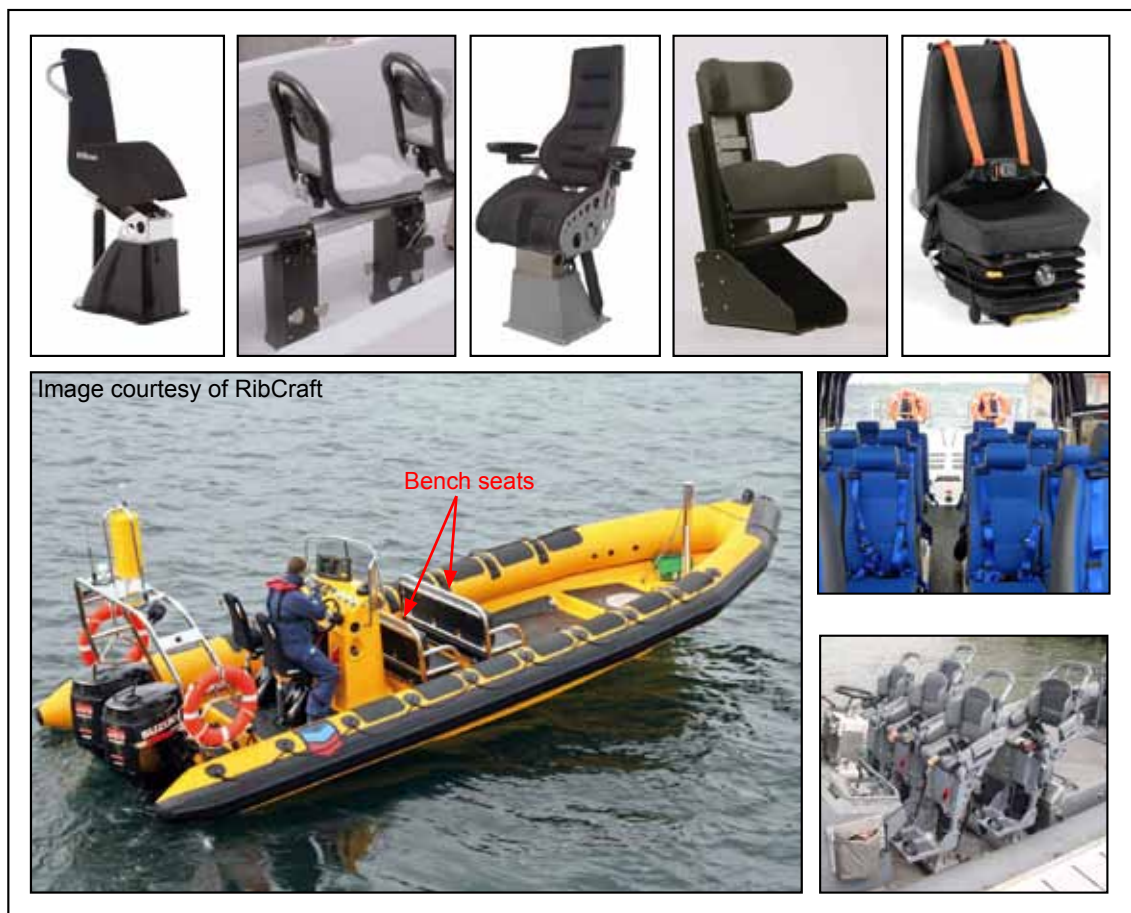
Figure 10

Seats are available for use on high speed craft, which are designed to dampen the transmission of shock and vibration and improve the occupant's posture and spinal alignment. Some of the most commonly adopted designs include shock absorption systems, restraint harnesses, and adjustable features to allow for people of differing sizes (**Figure 10**).

Examples of seats used on board high speed craft

Shock absorption is not simply a case of adding extra padding to a seat. Although this might increase the comfort of its occupant when the boat is at rest, it will not necessarily provide a reduction in the magnitude of vibrations felt while underway. Indeed, the use of certain cushioning materials can lead to an increase in shock and vibration magnitude (**Annex F**). However, there are several suspension seats available which significantly dampen out the magnitude of repeated shocks and reduce exposure to WBV. Restraint harnesses help ensure an occupant stays in contact with the seat while underway, and offer additional support and a sense of security as the boat is manoeuvred at speed or in choppy seas, but they present other hazards that need to be carefully considered. Adjustable seats will help passengers of varying sizes assume the designed optimum posture.
