Report on the investigation of  
the loss of a passenger overboard from

***Hurlingham***

at Westminster Pier, on the River Thames

**Report No 12/2009**  
**June 2009**

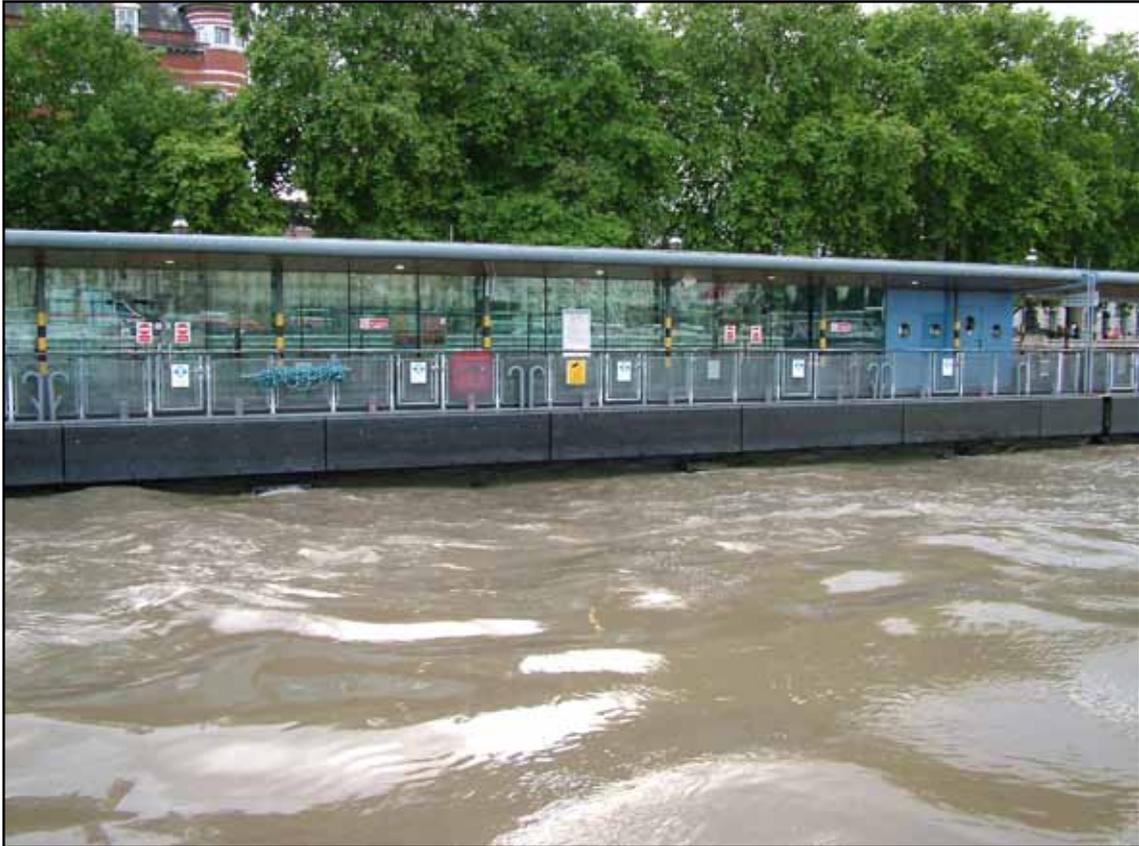
Figure 2a

The skipper brought *Hurlingham* alongside Westminster Pier (**Figures 2a and b**) and, due to the effect of turbulence from Westminster Bridge, he asked the mate to secure it with head and midships lines. The skipper left the propeller engaged in astern gear and the engine running at idle to put some tension on the mooring line and draw the boat into the pier. The layout of the boat and height of the pier made it preferable for passengers to embark using the forward entrances. These were on the turn of the bow, and it was normal practice for the boat to berth at a slight angle against the pier and for passengers to step directly from the pier onto the boat. A gangway was not routinely used, and none was used throughout that night.

Westminster Pier, viewed from the river

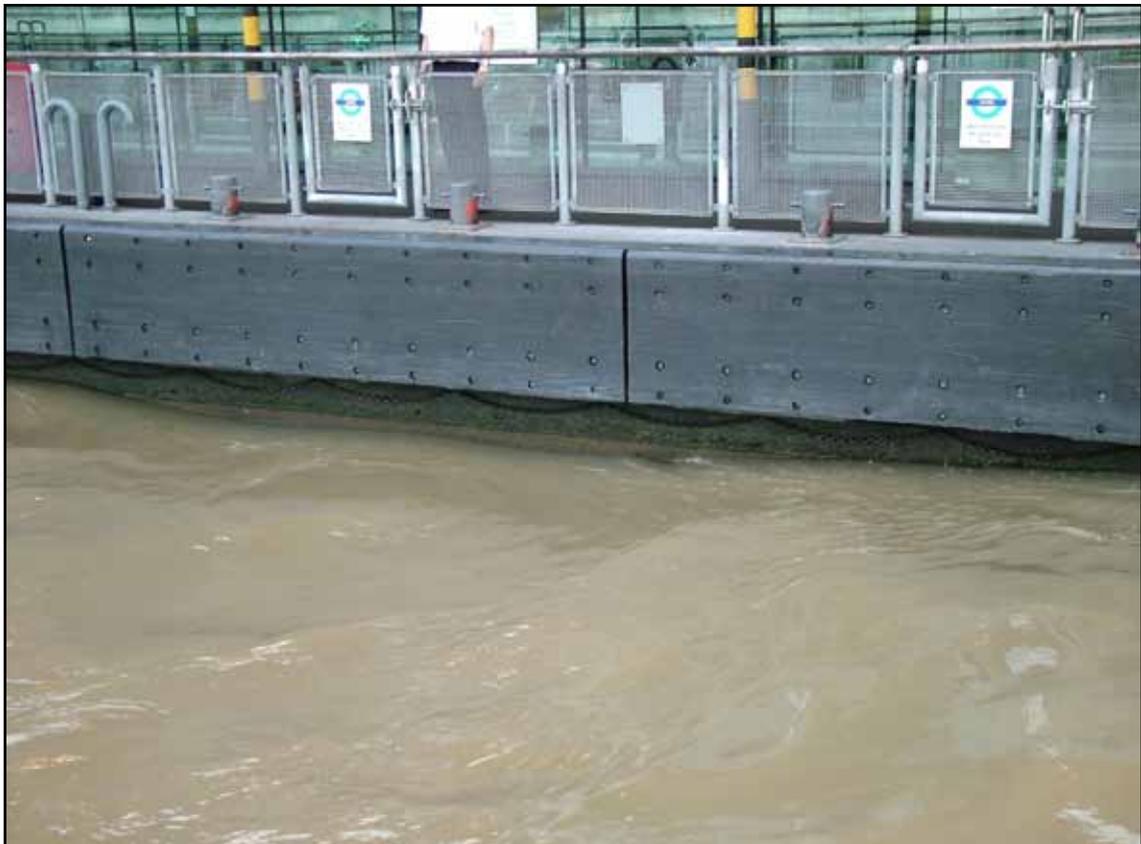
Figure 2b

Details of Westminster Pier

Westminster Pier is fitted with a substantial, black coloured, fender (**Figure 2**). The lights are fitted above the central part of the pier and provide a level of illumination typical of street lighting at a public facility. A substantial guardrail is fitted around the edge of the pontoon and inevitably casts a shadow over the outboard edge of the pontoon. The shadow is reduced when the gate is opened, but increases if passengers congregate at the guardrail.

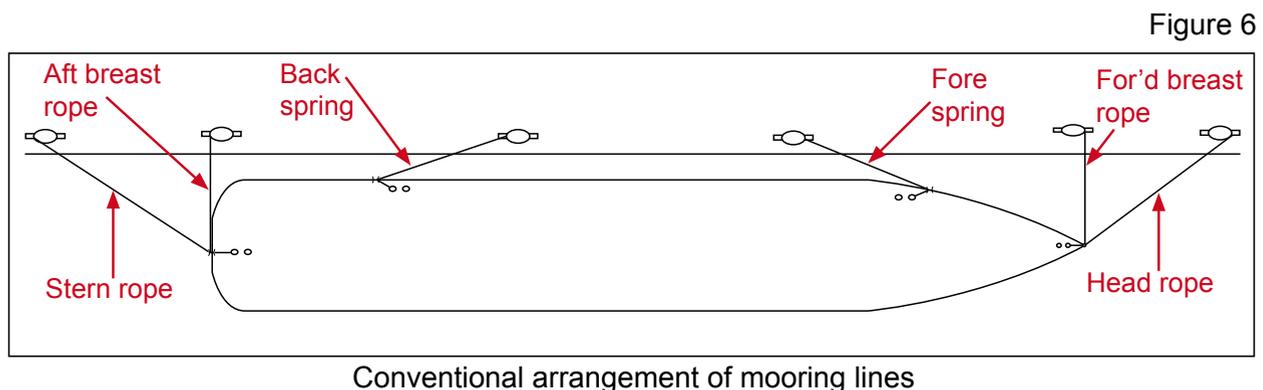
Any vessel alongside a pier will move in a combination of four principal ways: surging forwards and backwards along its longitudinal length, laterally sideways, yawing about a vertical axis and lastly, pitching and rolling with the motion of waves or wash from other vessels. Conventional mooring practice uses several ropes (**Figure 6**) to resist the longitudinal, sideways and yawing movement.
