Report on the investigation of the
grounding of the cargo vessel

Sea Mithril

on the River Trent

Report No 16/2008
September 2008

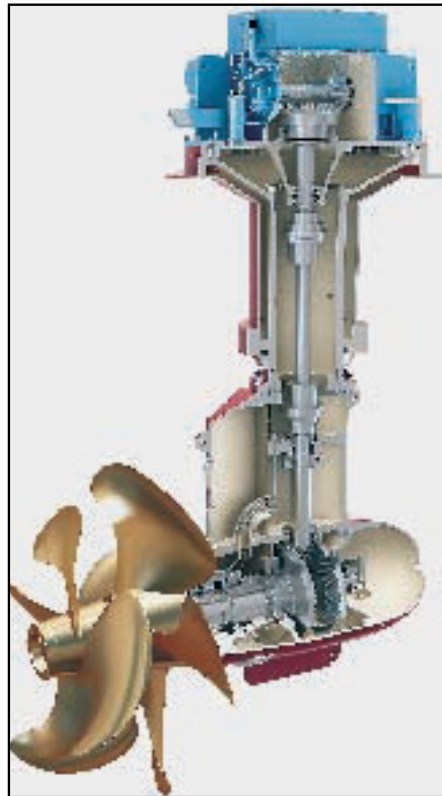
Figure 11

Sea Mithril is powered by two engines driving a series of shafts connected to two azimuth pods (**Figure 11**). The speed of the propellers and the azimuth of the pods are controlled by single levers sited on the bridge (**Figure 12**). The ship is steered by changing the direction of the pods via the levers.

Typical azimuth pod
