Report on the investigation of the
grounding of the cargo vessel

Sea Mithril

on the River Trent

Report No 16/2008
September 2008

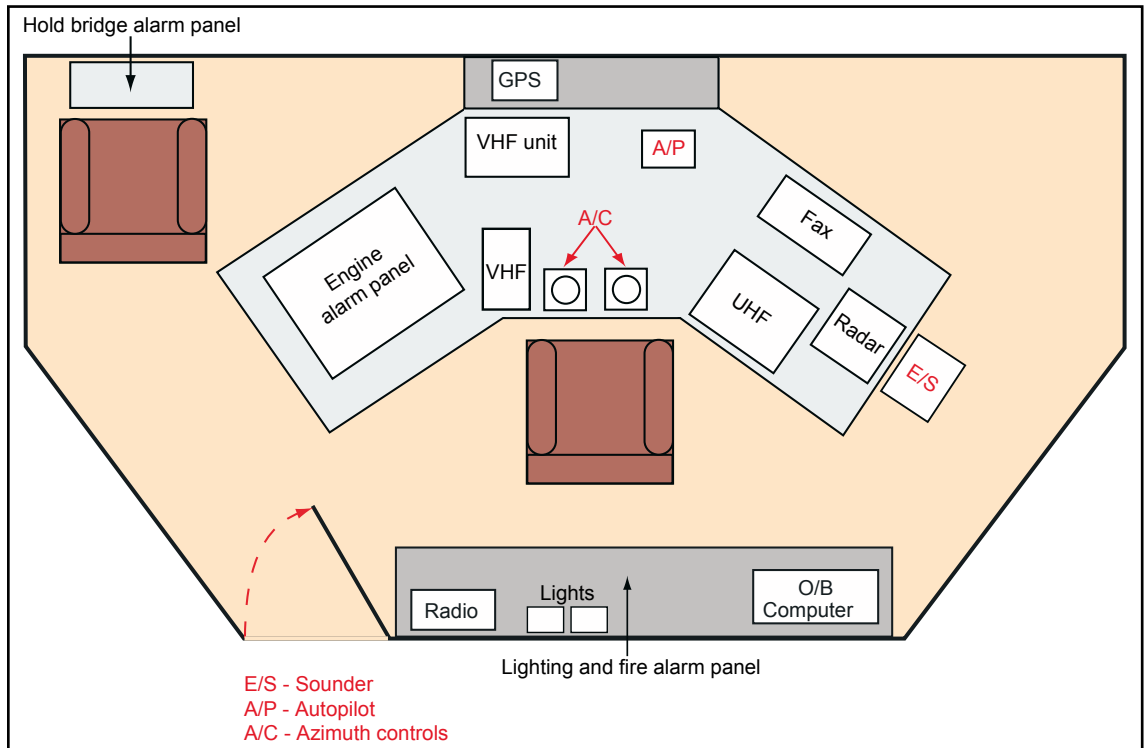
Figure 2

At about 0215, as *Sea Mithril* approached the Humber suspension bridge, the visibility suddenly reduced to about 50 metres. The chief officer immediately called the master; he also called the vessel's engineer and an AB. When the master arrived on the bridge, he sat in the centre chair (**Figures 2 and 3**), from where he started to steer the vessel manually. The pilot stood by the radar display which was sited on the starboard side of the bridge. The chief officer also remained on the bridge, while the engineer went to the engine room and the AB went to the focsle head to act as lookout. The lookout was able to communicate with the master via a hand-held radio.

Diagram of the bridge layout

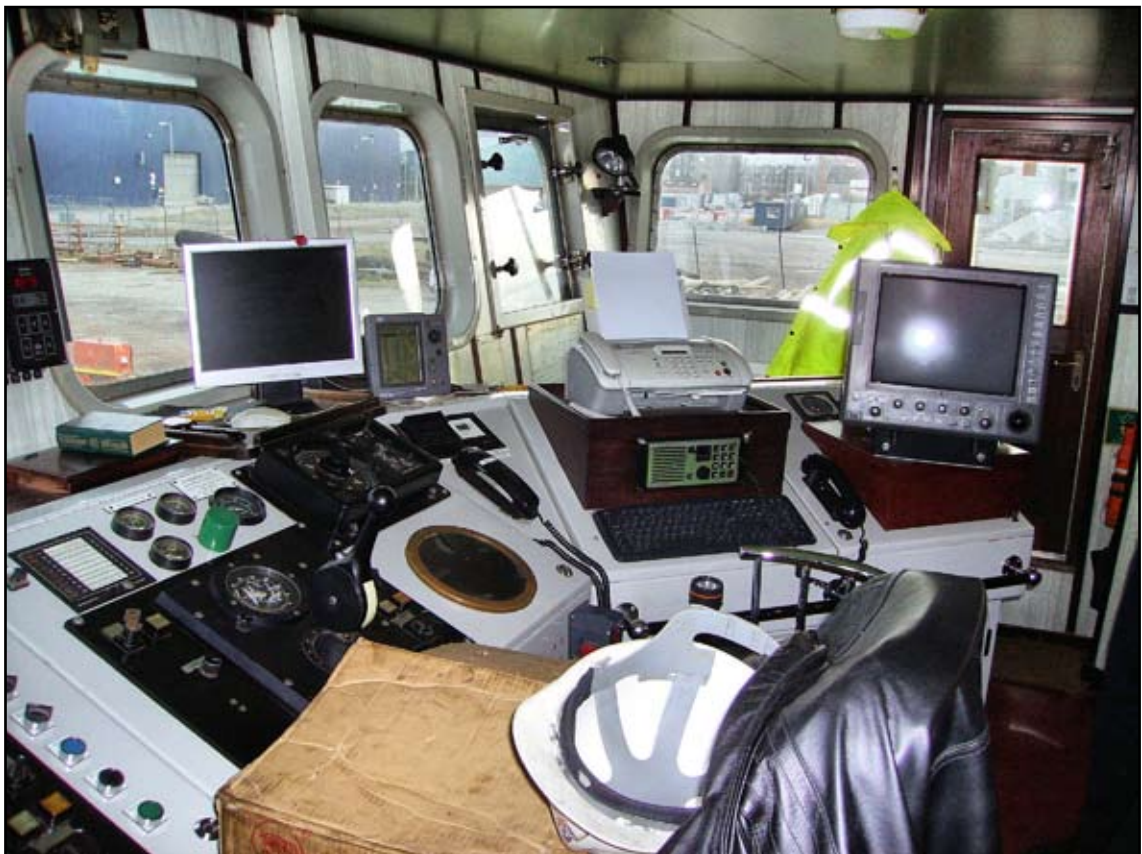
Figure 3

Photograph of the bridge layout

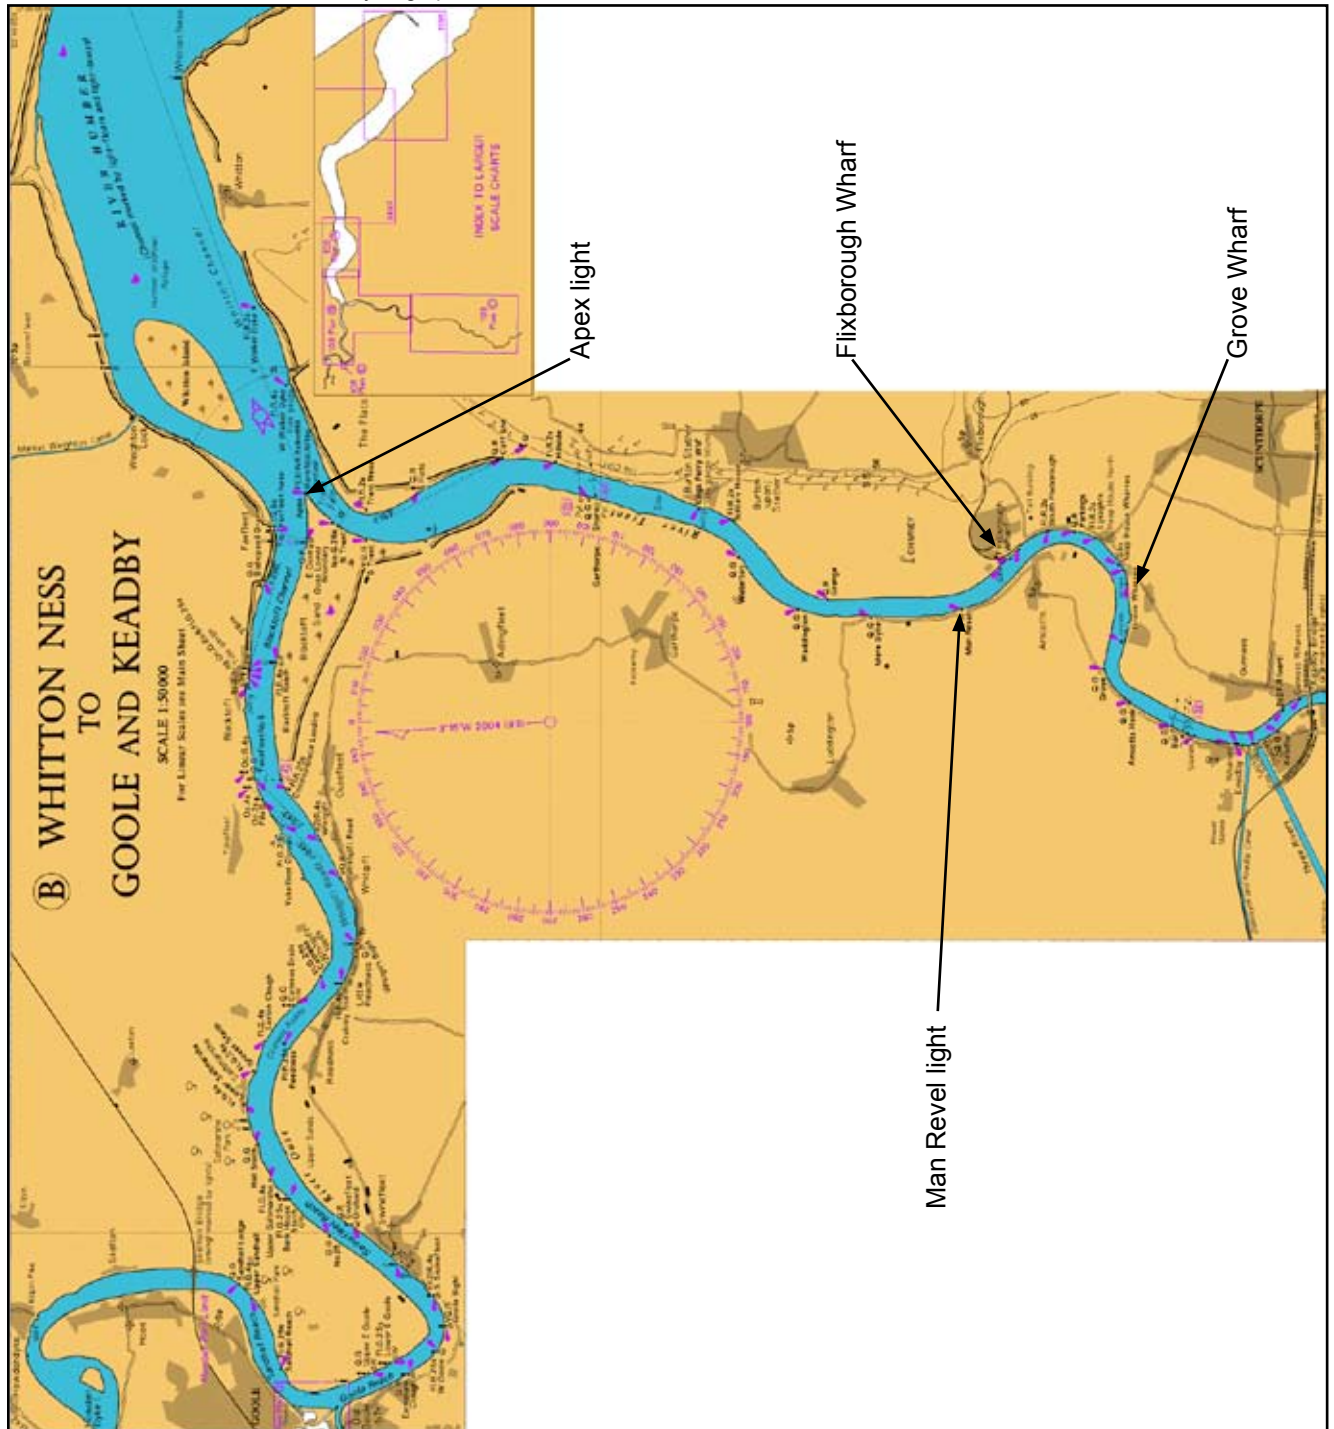
The master and pilot discussed the reduced visibility and agreed it was safe to continue the passage. The pilot's only concern was passing outbound vessels once in the confines of the Trent, but no such movements were planned. Visibility improved to about 200m in the vicinity of Apex Light (**Figure 4**), but soon decreased again to about 20m as she entered the Trent.

Man Reval light (**Figure 4**) was passed just after 0400 at a speed of 8 knots. *Sea Mithril* was on the right-hand side of the river where the water was deepest. Soon afterwards, course was adjusted to manoeuvre closer to the left-hand side of the river in order to remain in the deeper water. The pilot advised the course alterations via a combination of helm orders and compass courses to steer. Neither riverbank, nor any shore lights were visible.

On approaching Flixborough Wharf (**Figure 4**), in case any vessels were berthed alongside, the pilot advised the master to reduce engine speed from half to slow ahead. The pilot also gave the master 20 minutes' notice for arrival at Grove Wharf. Accordingly, the chief officer started to call the remaining crew for standby.

Extract of chart BA 109 showing the River Trent and the upper reaches of the River Humber

The largest scale United Kingdom Hydrographic Office (UKHO) chart of the Trent and the upper Humber is British Admiralty (BA) chart 109 Plan B with a scale of 1:50,000 (**Figure 4**). The chart shows little detail of the upper Humber and the Trent, and contains no depth information in the Trent due to the rapid changes in the course of the river, which makes it impractical to keep up to date. A new edition of this chart is expected to be produced by the UKHO in September 2008.

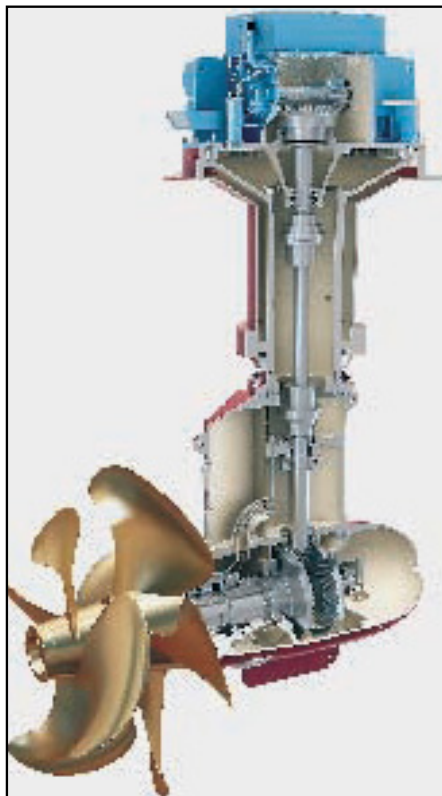
Figure 11

Sea Mithril is powered by two engines driving a series of shafts connected to two azimuth pods (**Figure 11**). The speed of the propellers and the azimuth of the pods are controlled by single levers sited on the bridge (**Figure 12**). The ship is steered by changing the direction of the pods via the levers.

Typical azimuth pod

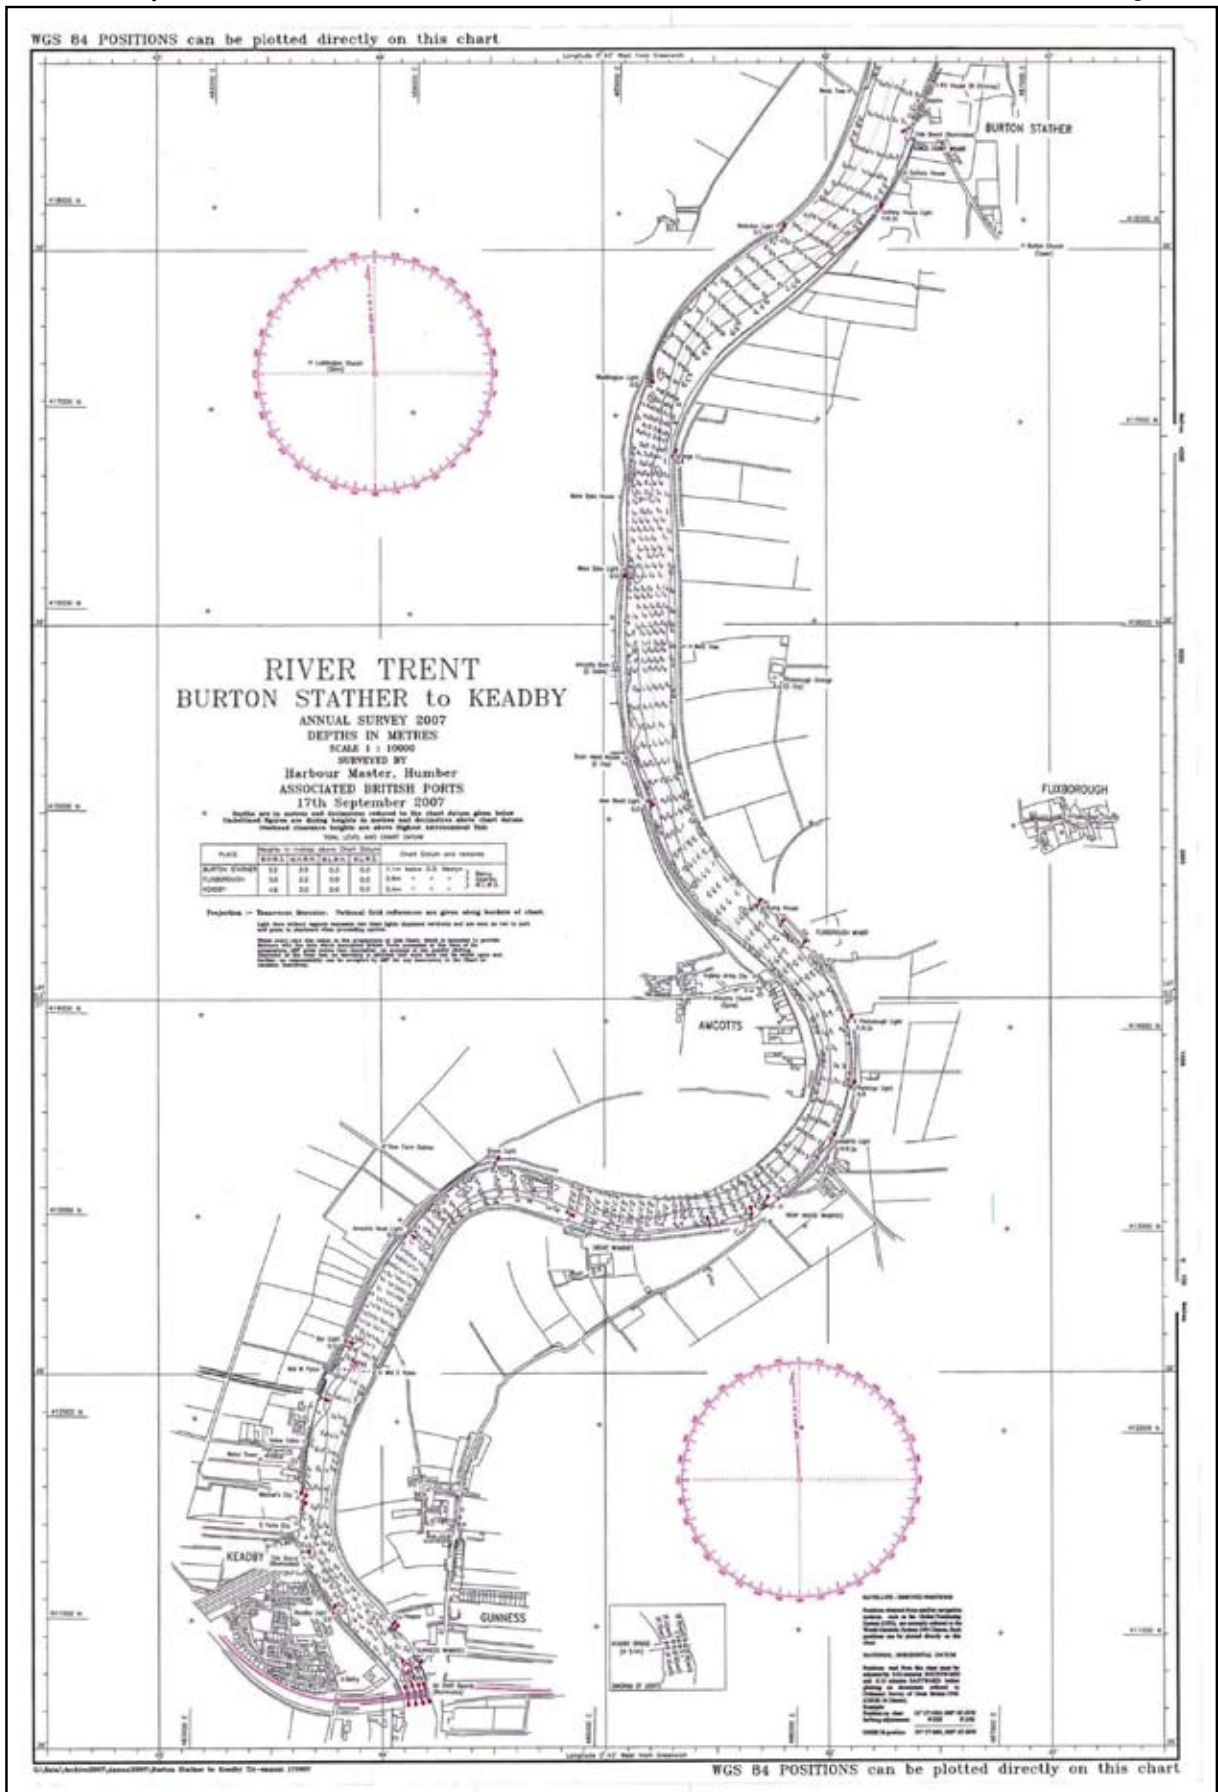
ABP Humber also produces charts of the Humber, Trent and Ouse. Their chart of the section of the Trent in which *Sea Mithril* grounded is of scale 1:10,000 (**Figure 13**). The chart of the upper reaches of the Humber and the approaches to the Trent has a scale of 1:25,000. These charts are regularly updated to incorporate periodic surveys completed by the port authority's hydrographic department and are primarily intended for use by its pilots, who are required to carry copies of the charts when conducting

ABP Humber produced chart of the section of the River Trent (scale 1:10,000)

pilotage acts. Although the charts can be purchased by other river users on request, their availability is not widely advertised. Consequently they are not frequently held on board visiting ships. However, a local notice to mariners strongly advises mariners to ensure they possess up to date navigational information before entering the Humber.
