Report on the investigation of the  
grounding of the cargo vessel

***Sea Mithril***

on the River Trent

**Report No 16/2008**  
**September 2008**

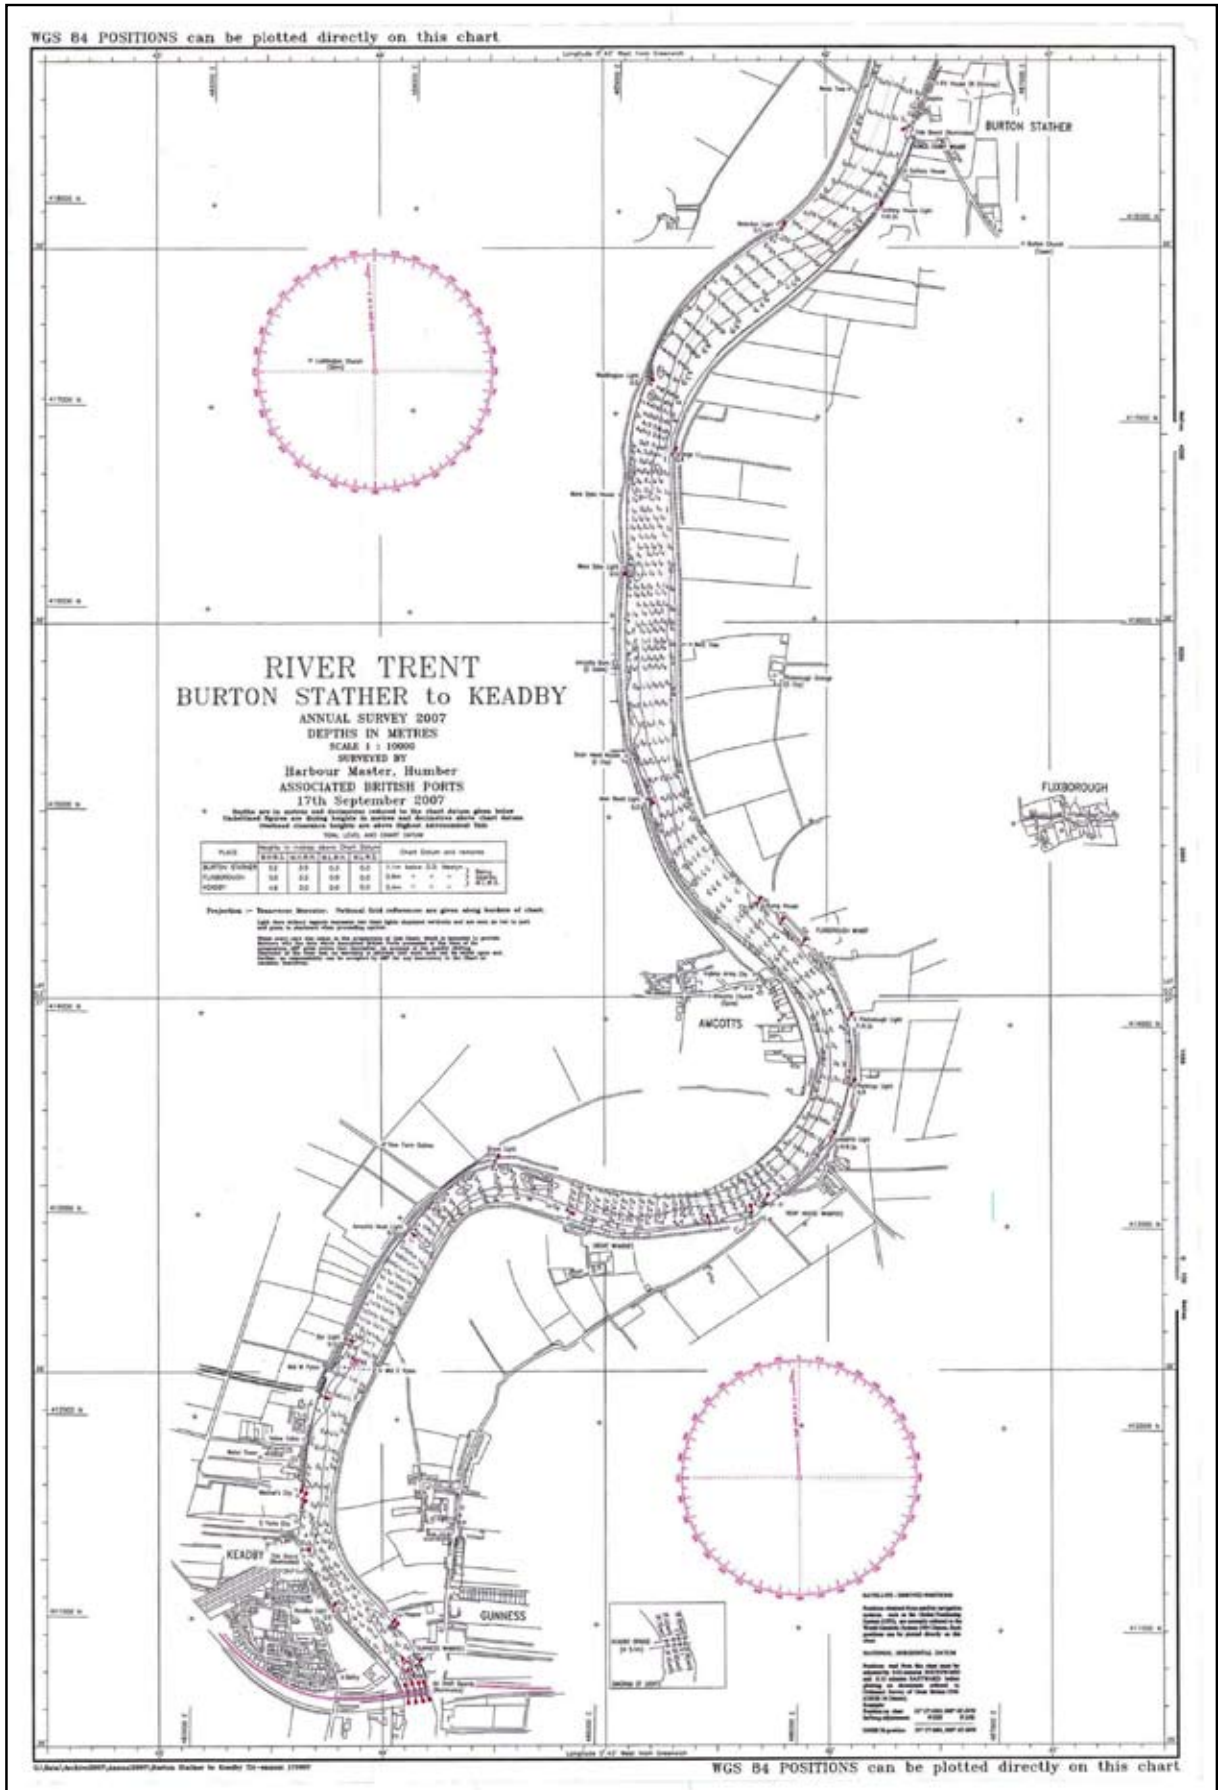
ABP Humber also produces charts of the Humber, Trent and Ouse. Their chart of the section of the Trent in which *Sea Mithril* grounded is of scale 1:10,000 (**Figure 13**). The chart of the upper reaches of the Humber and the approaches to the Trent has a scale of 1:25,000. These charts are regularly updated to incorporate periodic surveys completed by the port authority's hydrographic department and are primarily intended for use by its pilots, who are required to carry copies of the charts when conducting

ABP Humber produced chart of the section of the River Trent (scale 1:10,000)
