Report on the investigation of the  
grounding of the cargo vessel

***Sea Mithril***

on the River Trent

**Report No 16/2008**  
**September 2008**

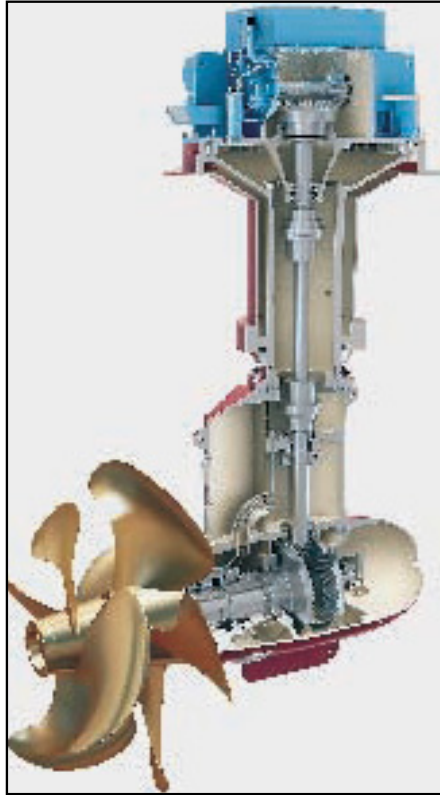
Figure 11

*Sea Mithril* is powered by two engines driving a series of shafts connected to two azimuth pods (**Figure 11**). The speed of the propellers and the azimuth of the pods are controlled by single levers sited on the bridge (**Figure 12**). The ship is steered by changing the direction of the pods via the levers.

Typical azimuth pod

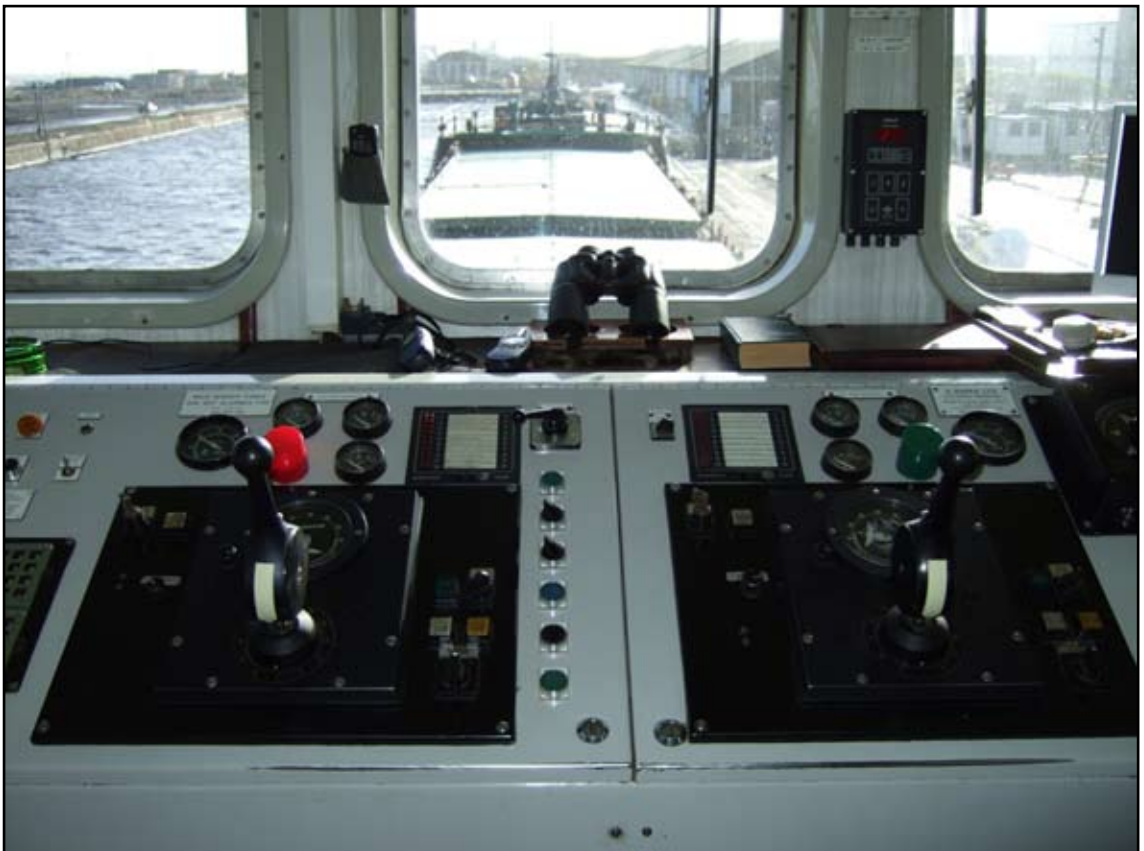
Figure 12

*Sea Mithril's* wheelhouse azimuth pod controls
