Report on the investigation of
the collision between
Lady Hamilton of Helford
and
Blithe Spirit

Falmouth Bay, Cornwall, England

3 October 2007

Report No 8/2008
April 2008

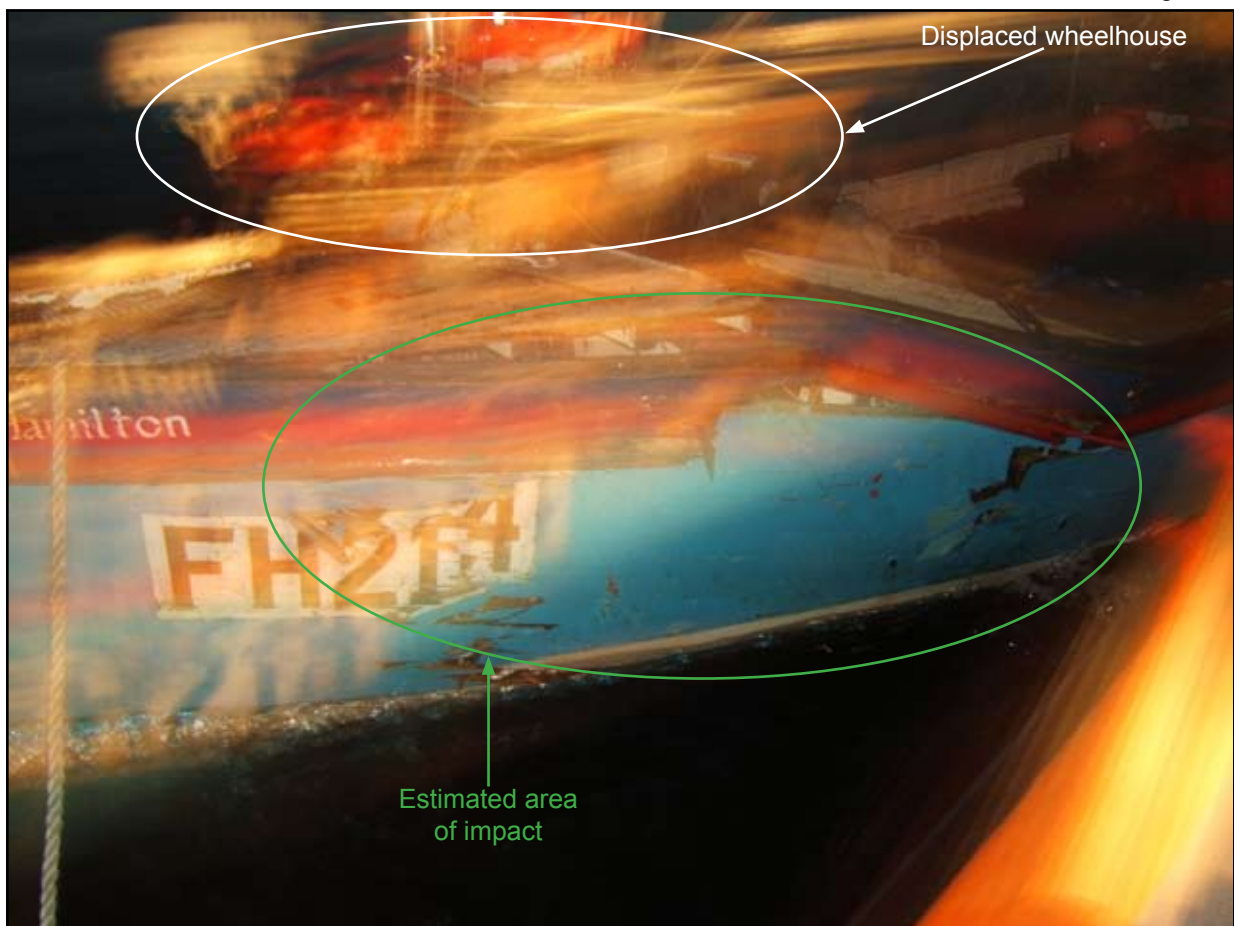
Figure 2

The two deckhands transferred to *Arrow* at 0634 while the skipper attached a line to the bow cleat of his vessel. He then also transferred to *Arrow*, and *Lady Hamilton of Helford* was taken in tow to the north east, towards Maenporth. However, after being towed for less than 200m, she foundered at 0646 in an upright attitude in position 50° 06.41’N 005° 02.59’W. A photograph of the vessel taken on a digital camera moments before she sank is at **Figure 2**. The crew of *Lady Hamilton of Helford* were transferred to the inshore lifeboat at 0655.

Photograph taken of *Lady Hamilton of Helford* before she foundered
