Report on the investigation of
work undertaken in a dangerous enclosed/confined space
and the consequent attempted rescue on board

ERRV Viking Islay

resulting in the loss of three lives
at the Amethyst gas field, 25 miles off the East Yorkshire coast, UK
23 September 2007

Report No 12/2008
July 2008

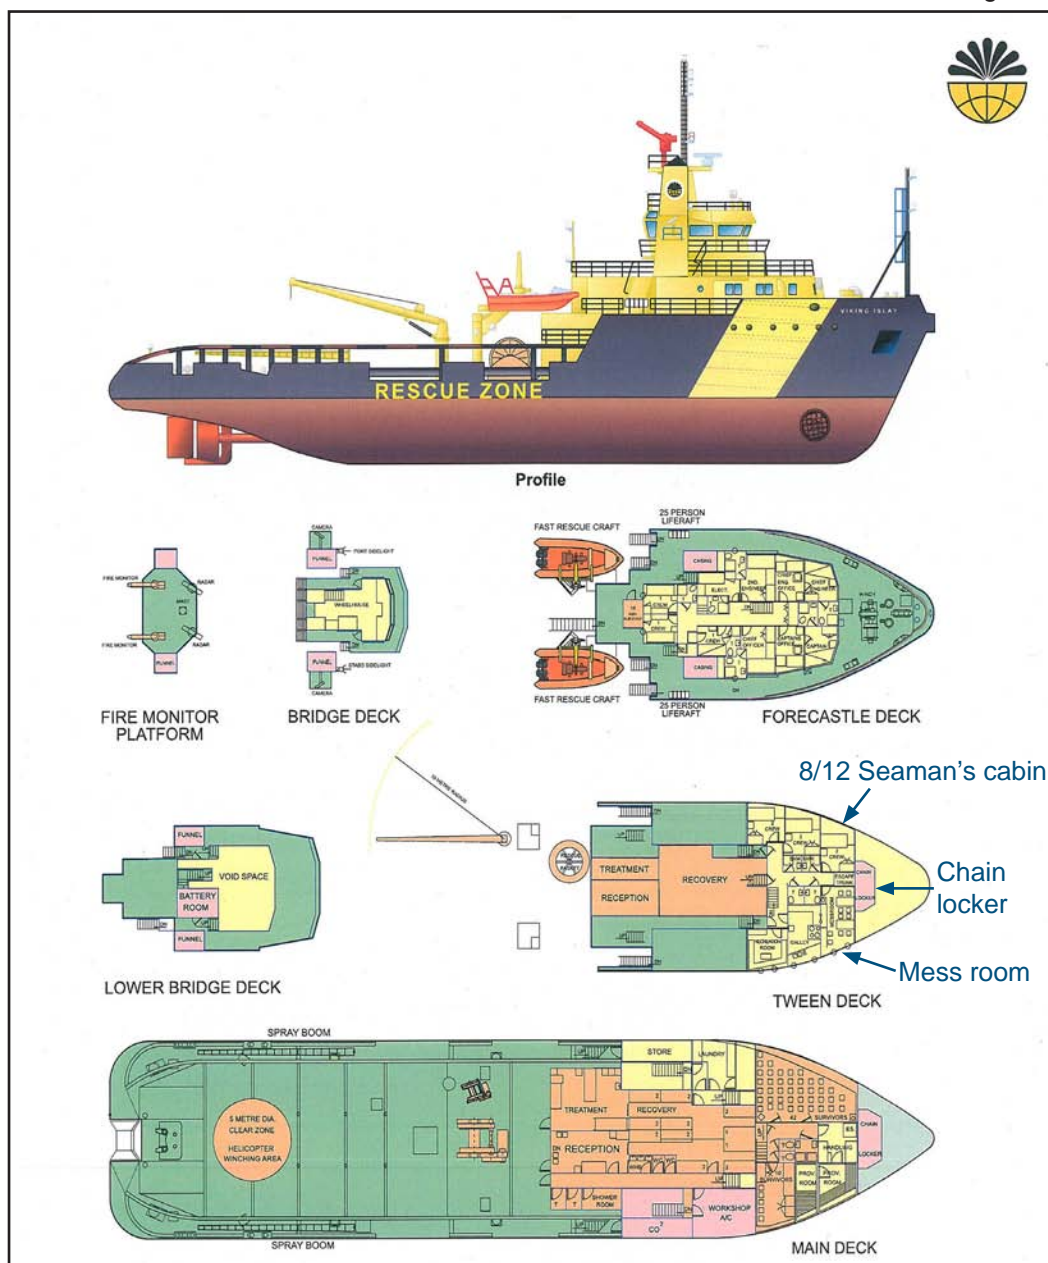
Figure 3

Side and plan views of *Viking Islay*

Due to the motion of the ship during the night, the starboard anchor chain began to bang against something within the chain locker, probably the spurling pipe. This disturbed the 8/12 seaman², Mr MacFadyen, whose cabin shared a common bulkhead with the chain locker. It is possible that others were aware of the noise, as the mess room also abutted the same bulkhead (**Figures 3 and 4**).

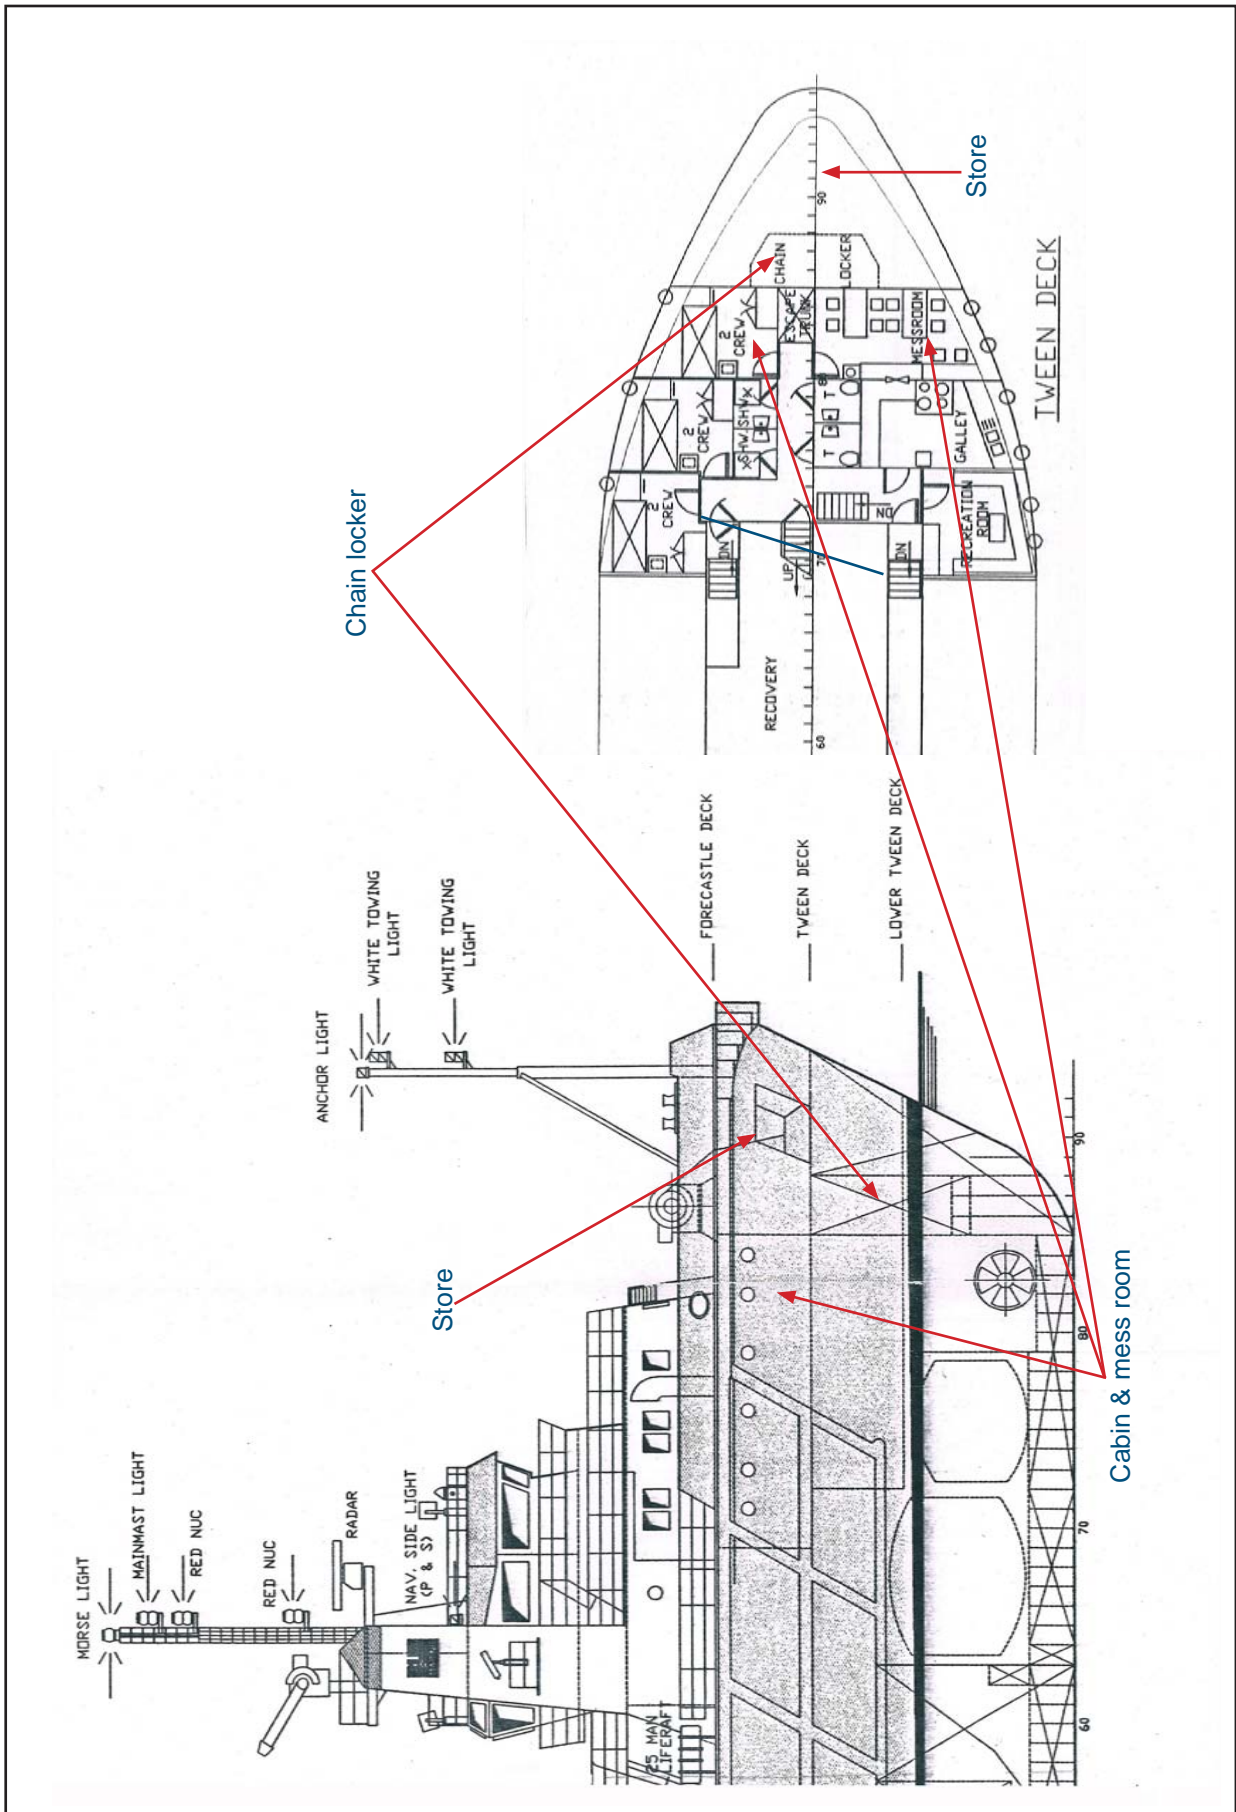
Figure 4

Viking Islay - bow profile and plan

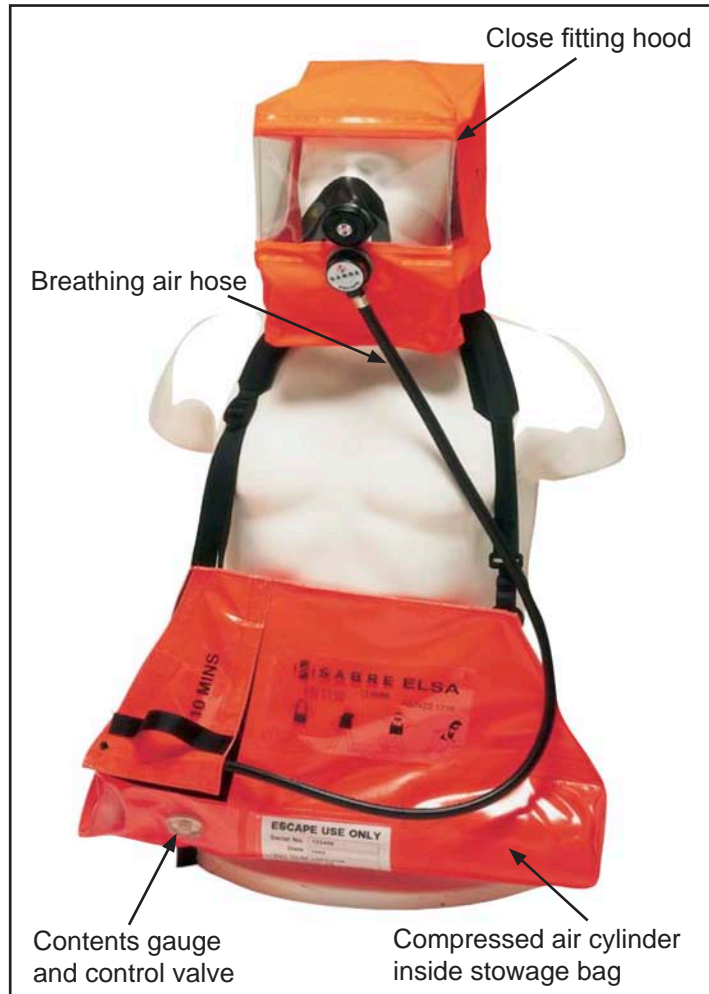
Figure 10

The Sabre ELSA is a self-contained, open circuit, compressed air, constant flow EEBD. It comprises a compressed air cylinder with a combined reducer/cylinder valve, attached to a close fitting escape hood by a breathing hose. The whole unit is contained within a stowage bag ready for immediate use. The high-visibility bag is clearly marked **ESCAPE USE ONLY (Figures 10 and 11).**

¹² Paragraph 2 of the Annex to MSC/Circ.849 of June 1998 states: *An EEBD is a supplied-air device only used for escape from a compartment that has a hazardous atmosphere...EEBD's are not to be used for fighting fires, entering oxygen deficient voids or tanks, or worn by fire fighters.* This is repeated in Annex 1 of MGN 215 (M+F), dated March 2002.

Sabre ELSA type EEBD

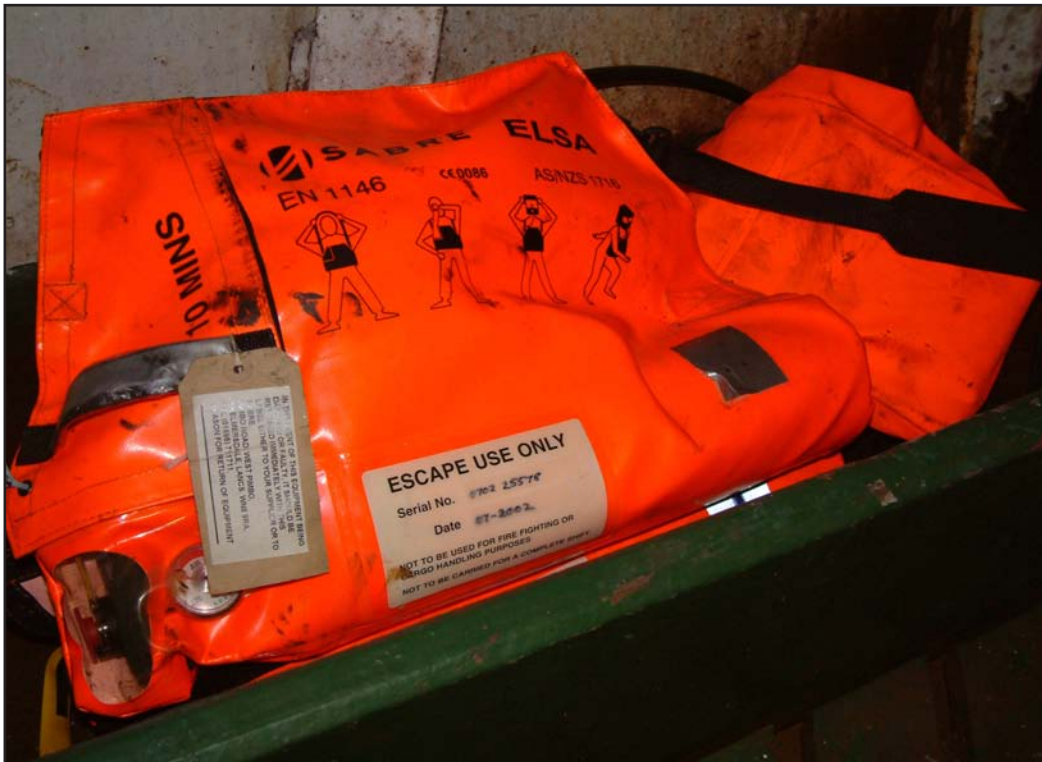
Figure 11

Sabre ELSA type EEBD

The 10 minute duration of the ELSA is achieved by means of a reducer/cylinder valve which restricts the flow of air from the cylinder to the mask, so that once activated a steady flow of air is provided to the wearer¹³. It is not a demand valve system.
