Report on the investigation of
the fire and subsequent sinking of

Lady Candida

off Corsica

Report No 4/2008
February 2008

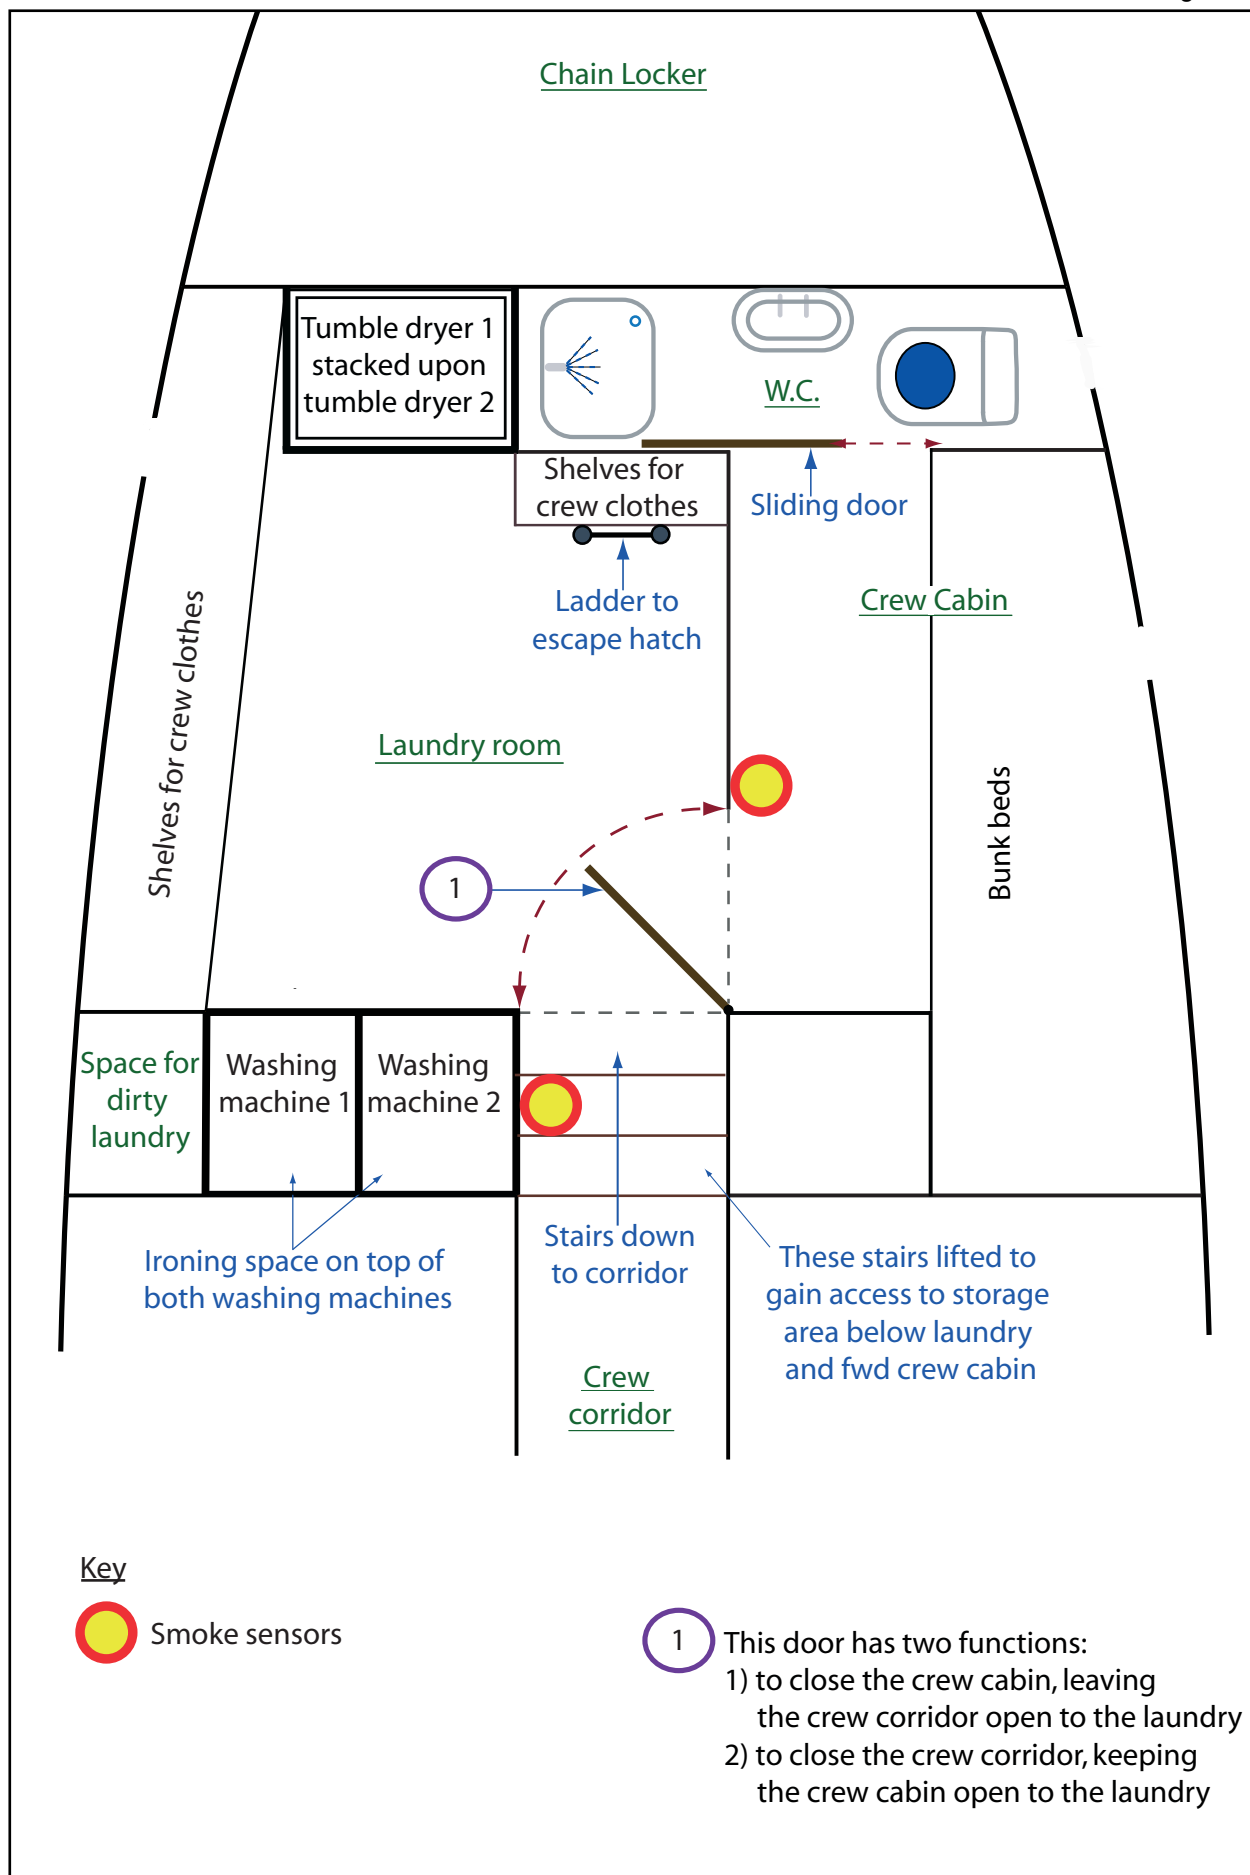
Figure 6

Internal access to the laundry was by an alleyway (**Figure 3**). At the forward end of the alleyway, a flight of three steps led to the laundry room and a crew cabin, which shared a common two-way door (**Figure 6**). The main control panels for the 110V DC windlass (**Figure 7**), which had a history of overheating, were sited behind the stairs.
