Report on the investigation of
two accidents during berthing and unberthing
of

Logos II

St Helier, Jersey

Report No 1/2008
January 2008

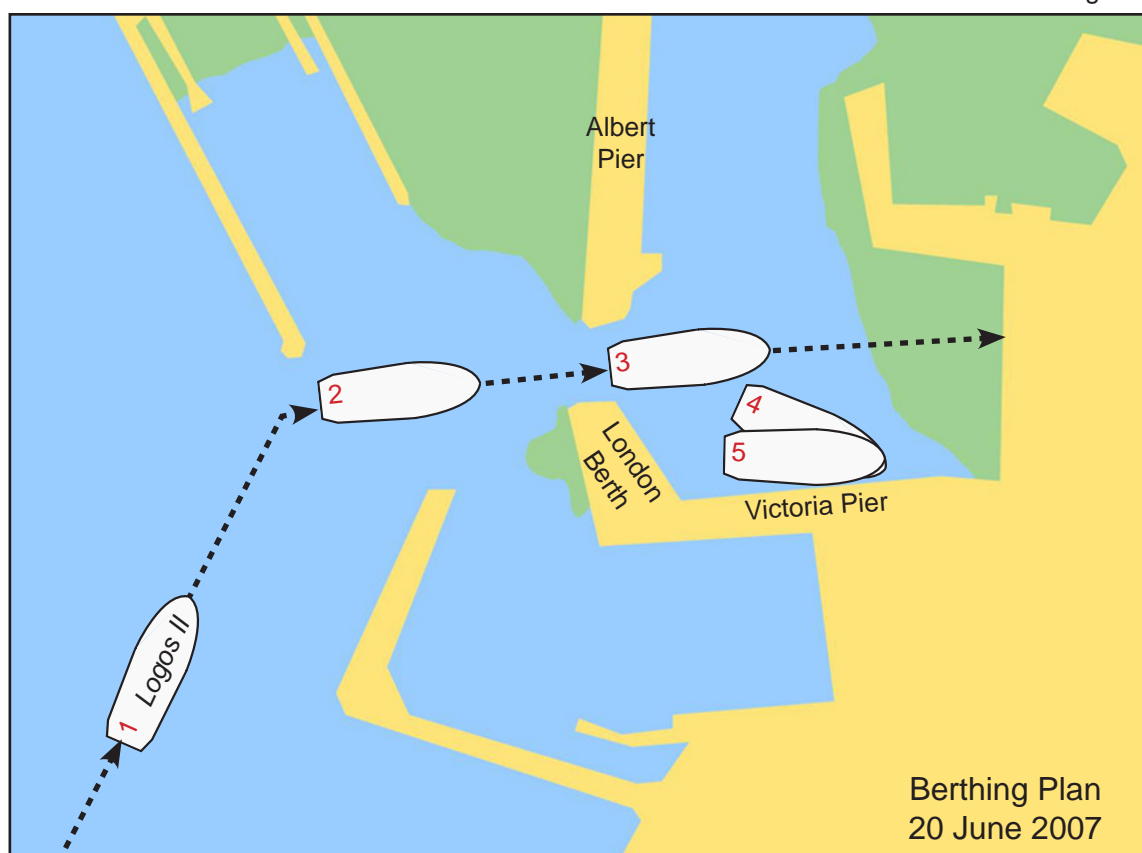
Figure 3

Diagram of the berthing plan of *Logos II*

The master and pilot then exchanged information. The master gave the DHM a pilot card (**Annex A**) and advised him that *Logos II* had two inward turning controllable pitch propellers with a single rudder amidships. The master also highlighted that the vessel's stern was easily influenced by the wind. The DHM then briefed the master that the vessel would enter and stop in the inner harbour where she would be met by *Titan* and *Marineco Toomai*. The intention was to position *Marineco Toomai* on the port quarter to hold the stern up against the fresh southerly breeze, and for *Titan* to push the bow towards the quay. Once sufficient lines were made fast forward, the stern would be pushed in with the assistance of the tug aft (**Figure 3**).

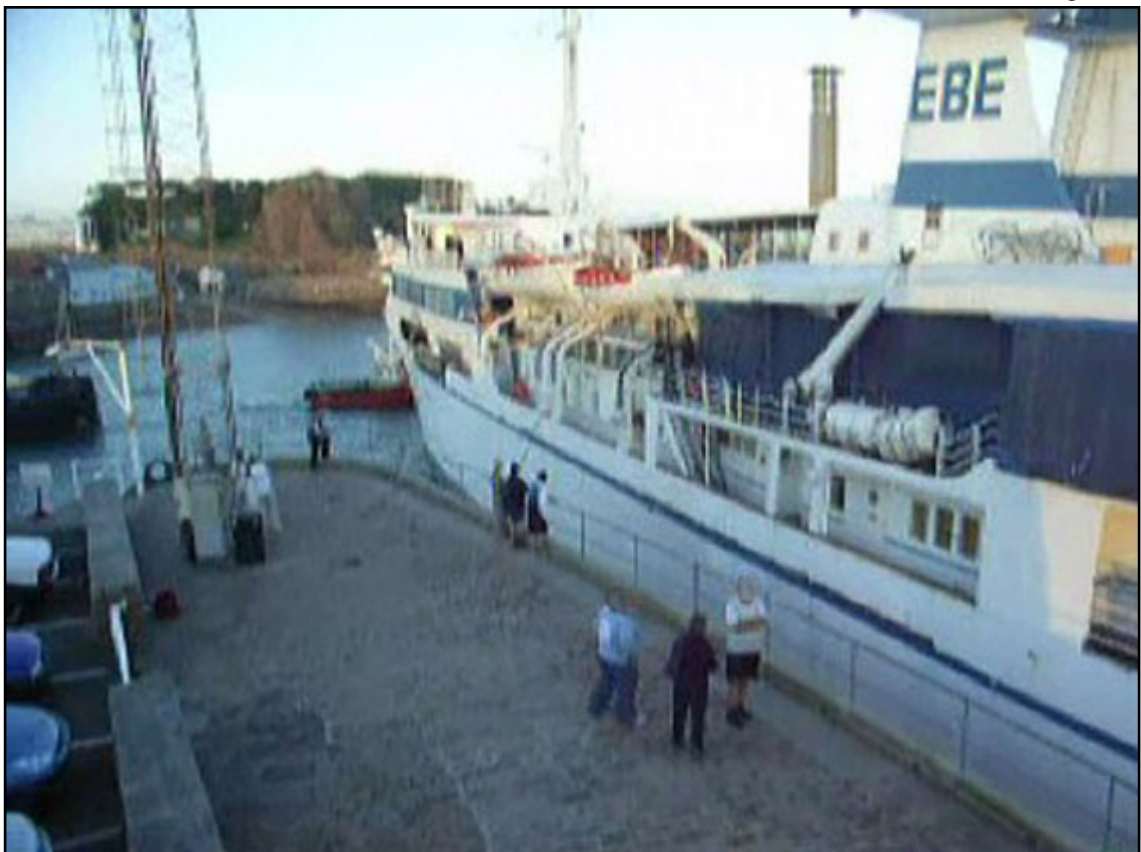
Figure 4

Titan pushing *Logos II* on entry through the pier heads (image captured from video)

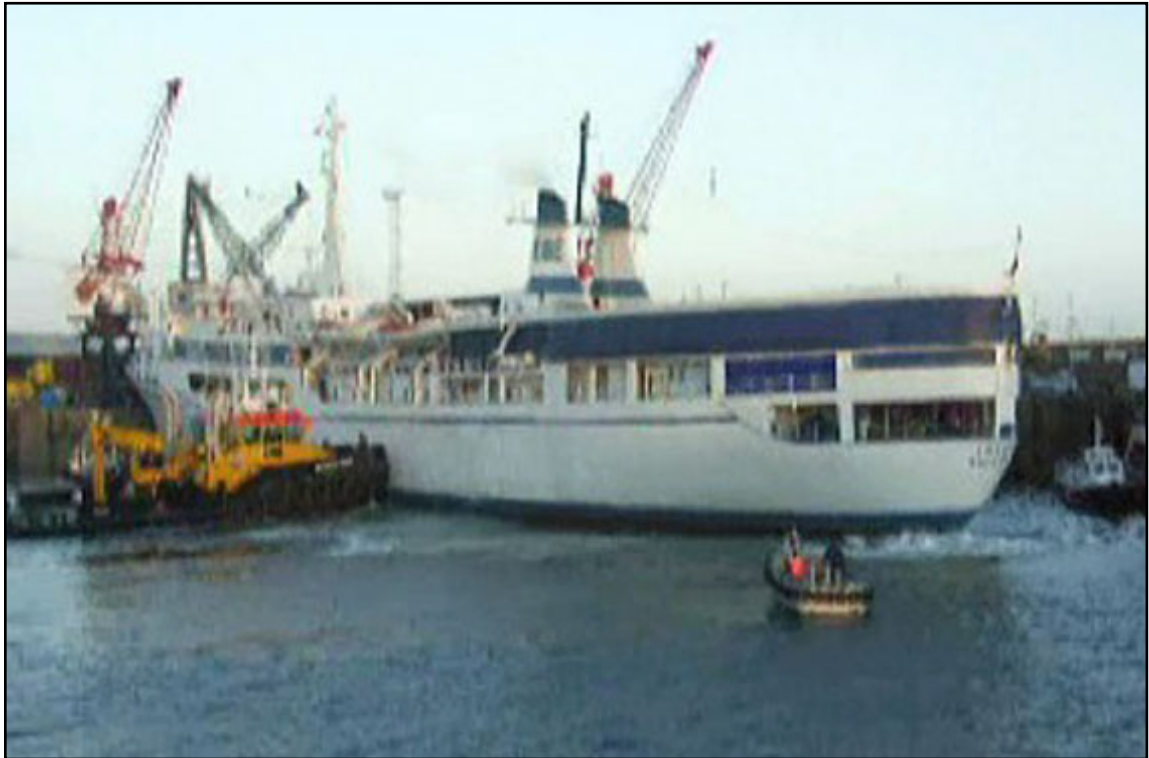
Figure 5

On clearing the pier heads, *Marineco Toomai* took up a position just aft of amidships (**Figure 5**) on the port side of *Logos II*. At 2043, the DHM instructed both tugs to push the vessel towards Victoria Pier. His instruction to *Marineco Toomai* was: 'can you push easy on the stern, we will to push her bodily down' [sic]. The DHM looked over the port side on several occasions as *Logos II* closed Victoria Pier, but was unable to accurately determine the position of *Marineco Toomai* due to obstructions in his line of site. He assumed she was in her assigned station; he did not check directly with the tug and was not informed otherwise. Soon after, *Halcyon*, a harbour work boat which had been requested by the DHM to standby to assist, positioned herself on the port quarter of *Logos II* and also started to push (**Figure 6**). This action was not requested or seen by the DHM.

Marineco Toomai pushing from amidships (image captured from video)

After *Logos II* had stopped in the inner harbour, she was pushed bodily towards Victoria Pier by *Titan*, which was positioned on the port bow, *Marineco Toomai*, positioned just aft of amidships (**Figure 5**), and by *Halcyon* on the port quarter (**Figure 6**). As she neared the berth with her bow canted towards the quay as intended, it is highly likely that the speed of approach increased as the vessel came into the lee of the harbour wall (**Figure 2**), and the effect of the fresh southerly breeze was lost. The influence of *Halcyon* would have been minimal due to her size.

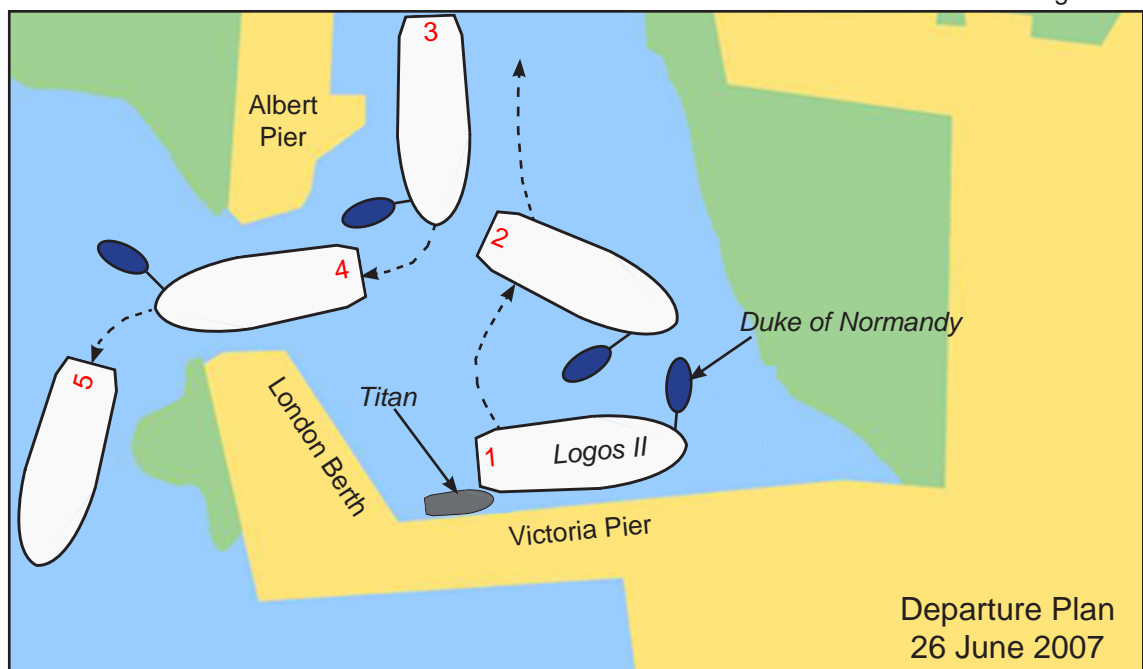
Figure 10

Diagram of the departure plan of *Logos II*

The advancement of the time of departure in view of the height of tide and forecast wind conditions indicated the departure was well considered by the pilot. Indeed, the intended plan (**Figure 10**) worked well until the vessel approached the gap between the pier heads. Given the difficulty experienced by the AHM to turn *Logos II* away from Victoria Pier head, which was probably due to the poor manoeuvring characteristics of the vessel, his instruction to *Duke of Normandy* to pull the bow to the north was logical. It was unfortunate that the tow line parted as the tug attempted to manoeuvre on to the starboard bow of *Logos II*.
