Report on the investigation of the collision between

***Gas Monarch and Whispa***

6 miles ESE of Lowestoft

**Report No 25/2007  
December 2007**

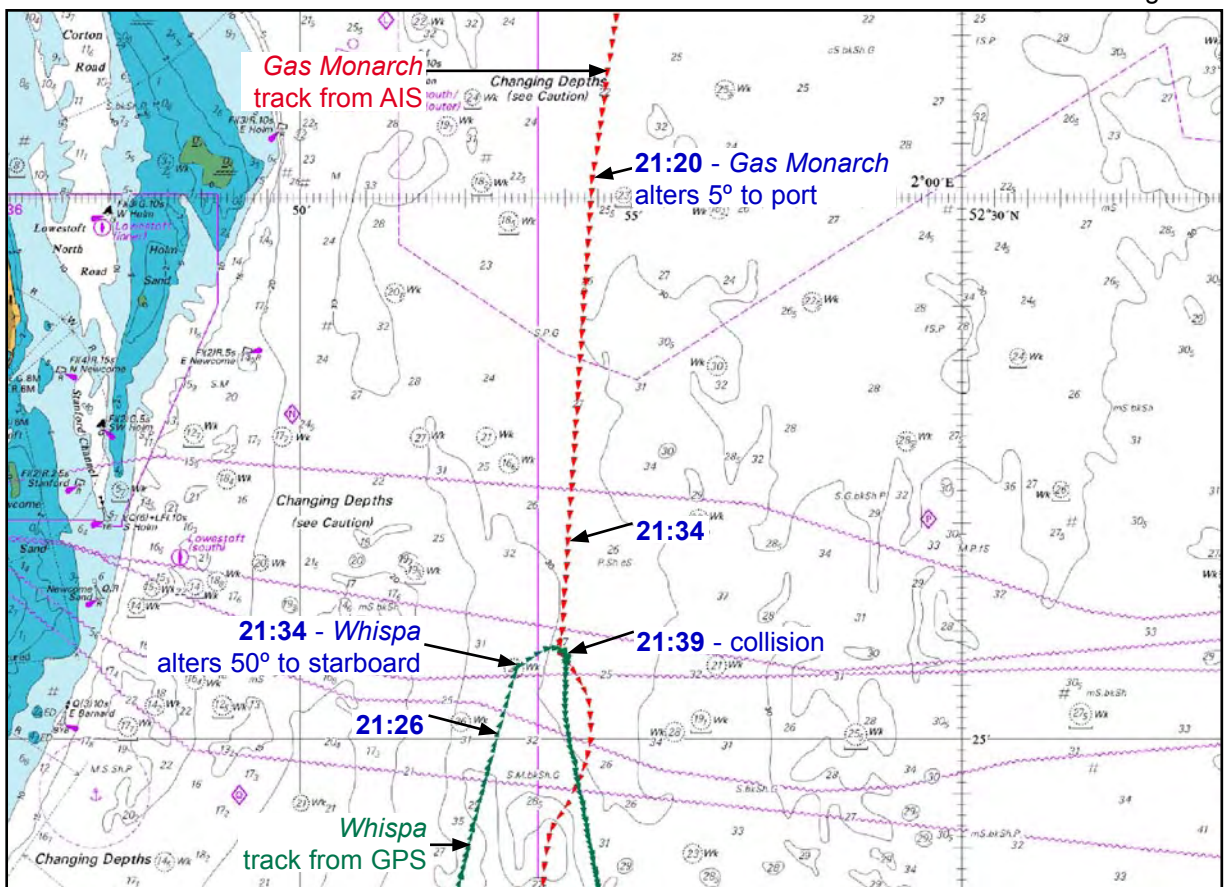
Figure 4

about 5.5 miles (**Figure 4**), the 3/O altered 5° to port to create a starboard to starboard passing situation. By appraising the contact's radar trails, the 3/O estimated the resulting CPA would be approximately 1nm on *Gas Monarch's* starboard side. As the vessels closed to 3 miles (**Figure 4**), the trails of *Whispa's* radar contact indicated to the 3/O a reduced CPA of 0.7nm to starboard. When the vessels were just less than 3 miles apart, the yacht's radar contact was lost from both radar screens of *Gas Monarch*.

The 3/O informed his AB that the contact was lost from the radar screens and that he should be vigilant. As *Gas Monarch* closed on *Whispa*, the 3/O continued his routine navigational duties, and some 3 minutes before the collision applied a routine fix of the ship's position to the chart. Soon after this, *Whispa's* port masthead tricolour light appeared fine on *Gas Monarch's* starboard bow. The 3/O grabbed the Aldis lamp and shone it on *Whispa* and, at the same time, instructed the AB to place the steering to manual and go hard to starboard, followed by a hard port order once the ship started to swing. The evasive action was unsuccessful and the two vessels collided at 2139.

Relative tracks of *Gas Monarch* (reproduced from AIS) and of *Whispa* (reproduced from GPS)

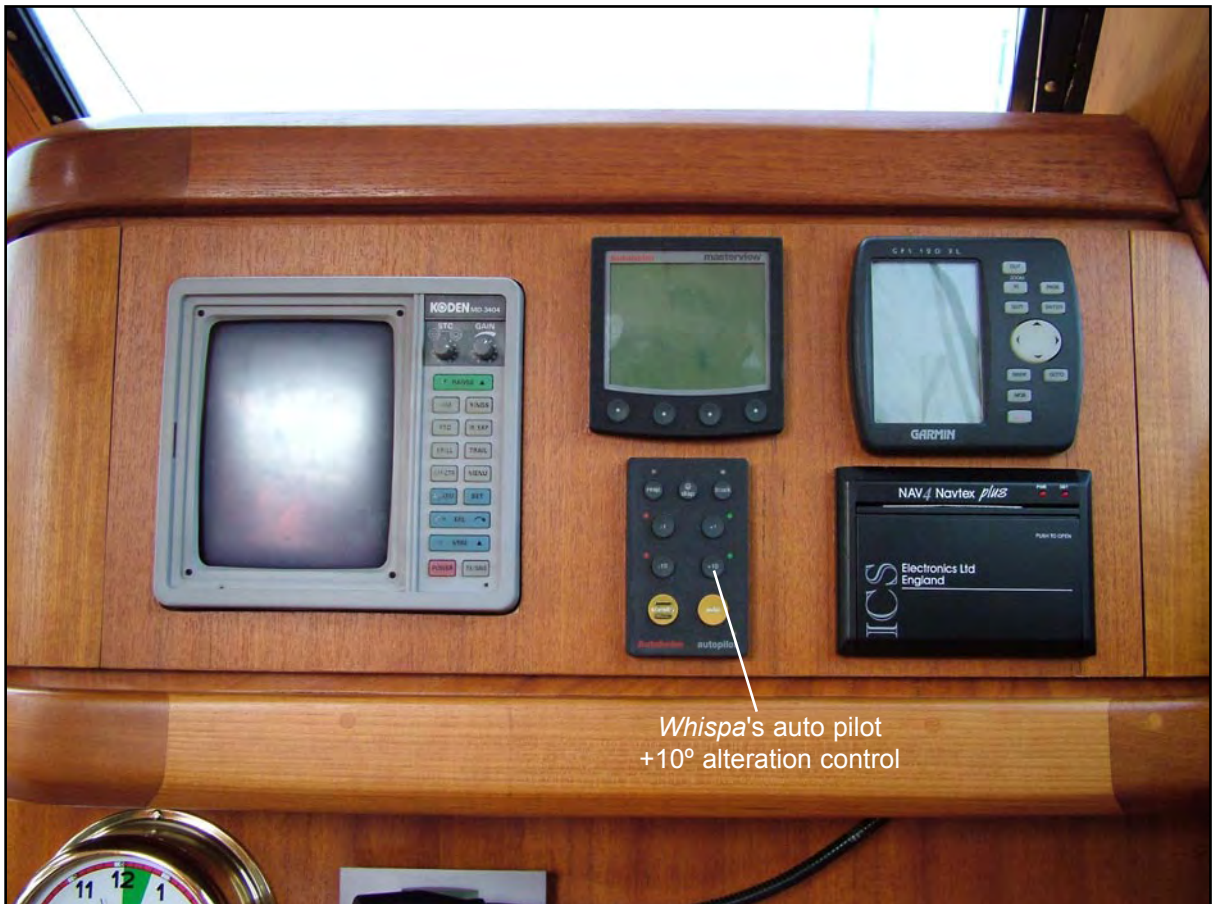
Figure 5

*Whispa*'s skipper believed that a collision situation was unfolding, and before the contact entered his radar's alarmed guard zone, which was set at 2.5 miles, altered *Whispa*'s course 50° to starboard by pressing the autopilot 10° course alteration button 5 times in succession (**Figure 5**). The yacht skipper then reduced the range on the radar to 3nm, which he believed would display range rings at 0.5 mile intervals, and continued to monitor the contact. However, instead of tracking clear down his port side as expected, the contact appeared to still be coming towards the yacht, now from a relative bearing of 50° on the port bow. As the vessels drew closer, *Whispa*'s skipper altered a further 20° to starboard, but still the radar contact continued to close on a steady bearing. The yacht skipper rushed from the navigation station to the cockpit, put the engine on to full ahead, switched off the autopilot and put the yacht on a course 085°. As he stared into the dark, a spotlight was suddenly shone onto the yacht for some 6 to 8 seconds. The light destroyed the skipper's night vision, but as he threw the vessel hard to starboard he was able to identify a bulbous bow bearing down on him shortly before it collided with *Whispa*'s port quarter.

*Whispa*'s control console

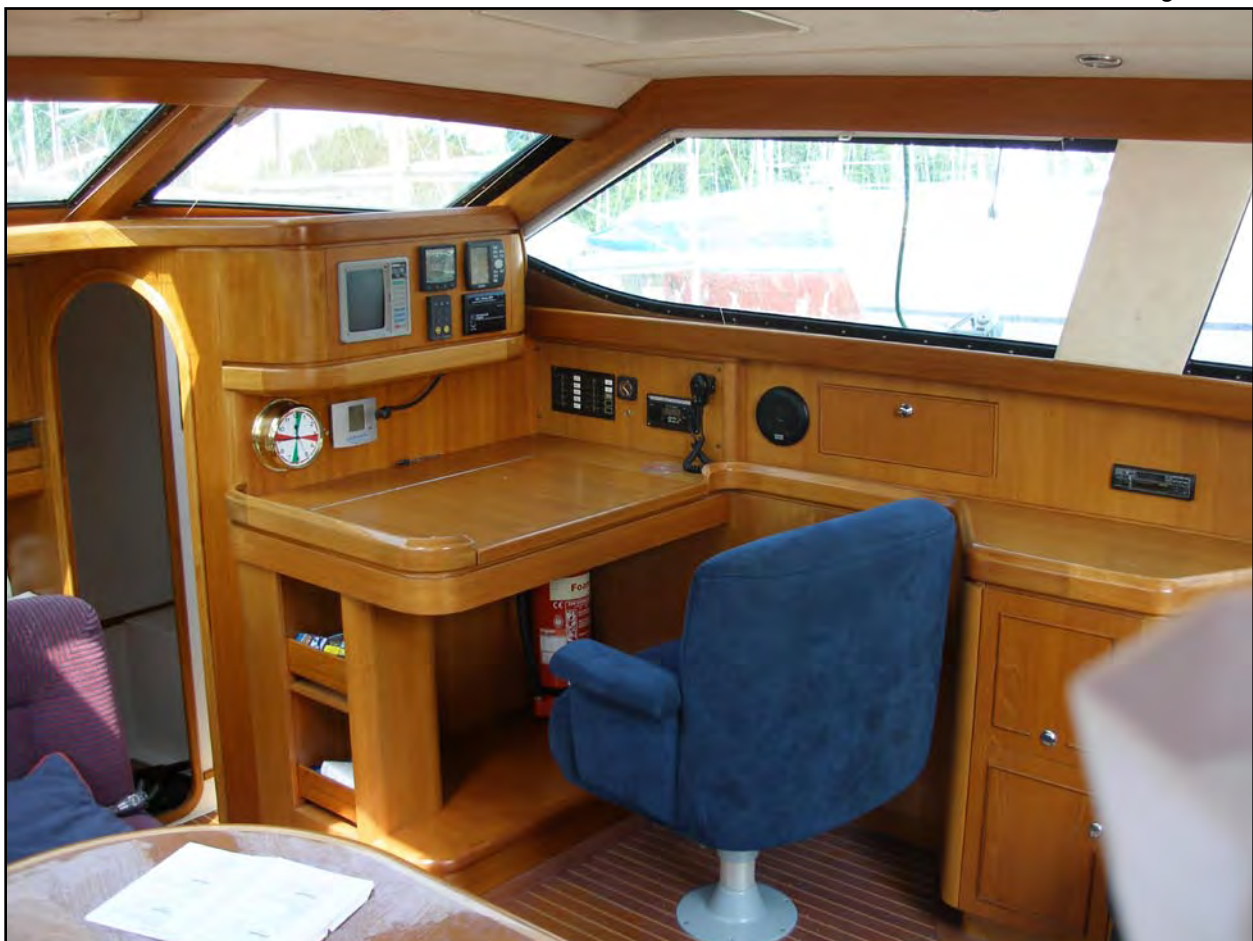
Figure 13

Below decks, in the forward starboard corner of the main saloon, was a navigation station (**Figure 13**) which contained a chart table, VHF radio, GPS, autopilot, Navtex, depth finder and radar screen. The distance from navigation station to cockpit was 5m.

*Whispa's* navigation station

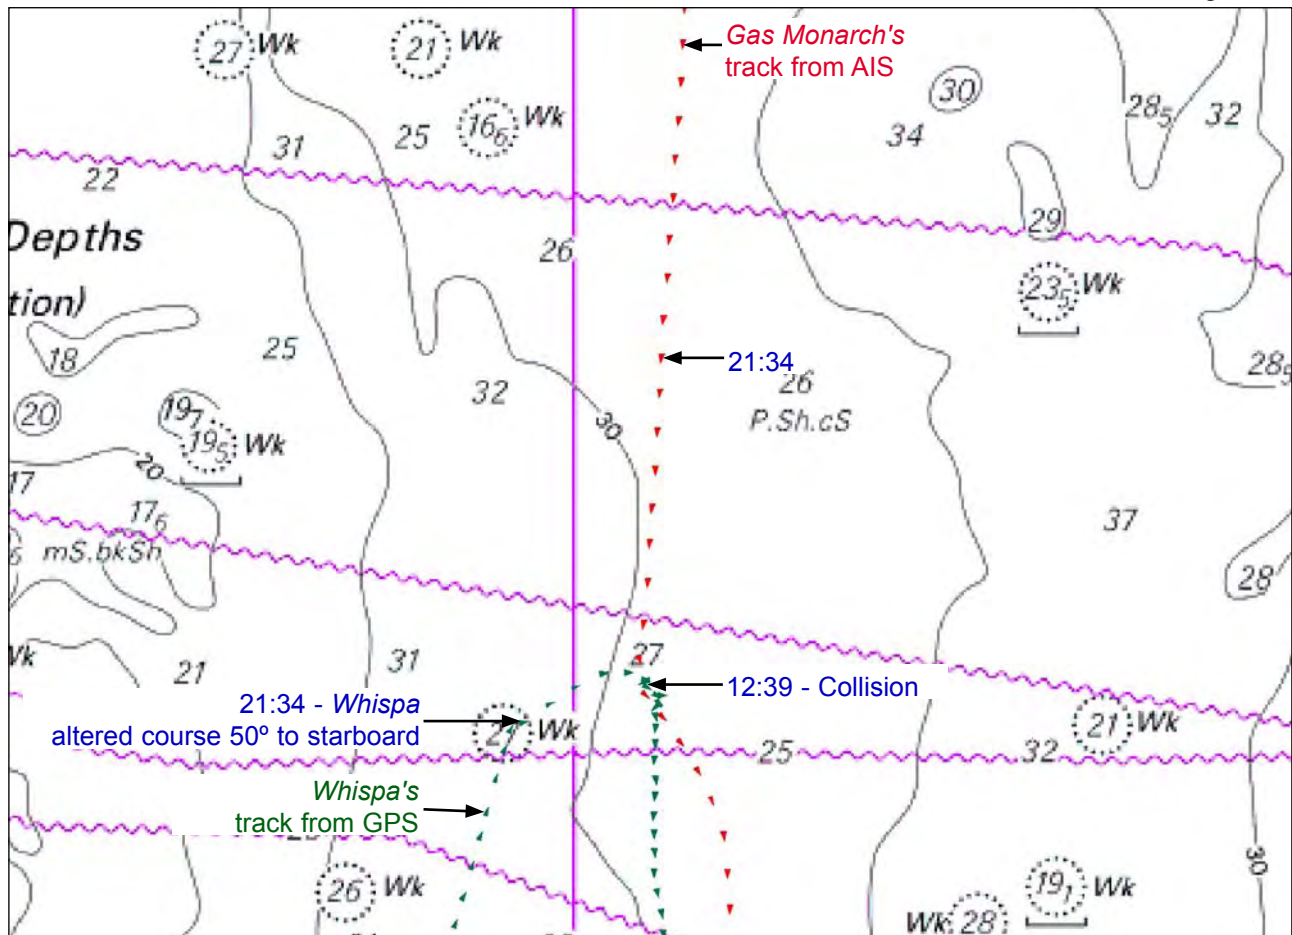
Relative tracks of *Gas Monarch* (reproduced from AIS) and of *Whispa* (reproduced from GPS)
