Report on the investigation

of a major LPG leak from the gas carrier

Ennerdale

> Report No 10/2007 May 2007

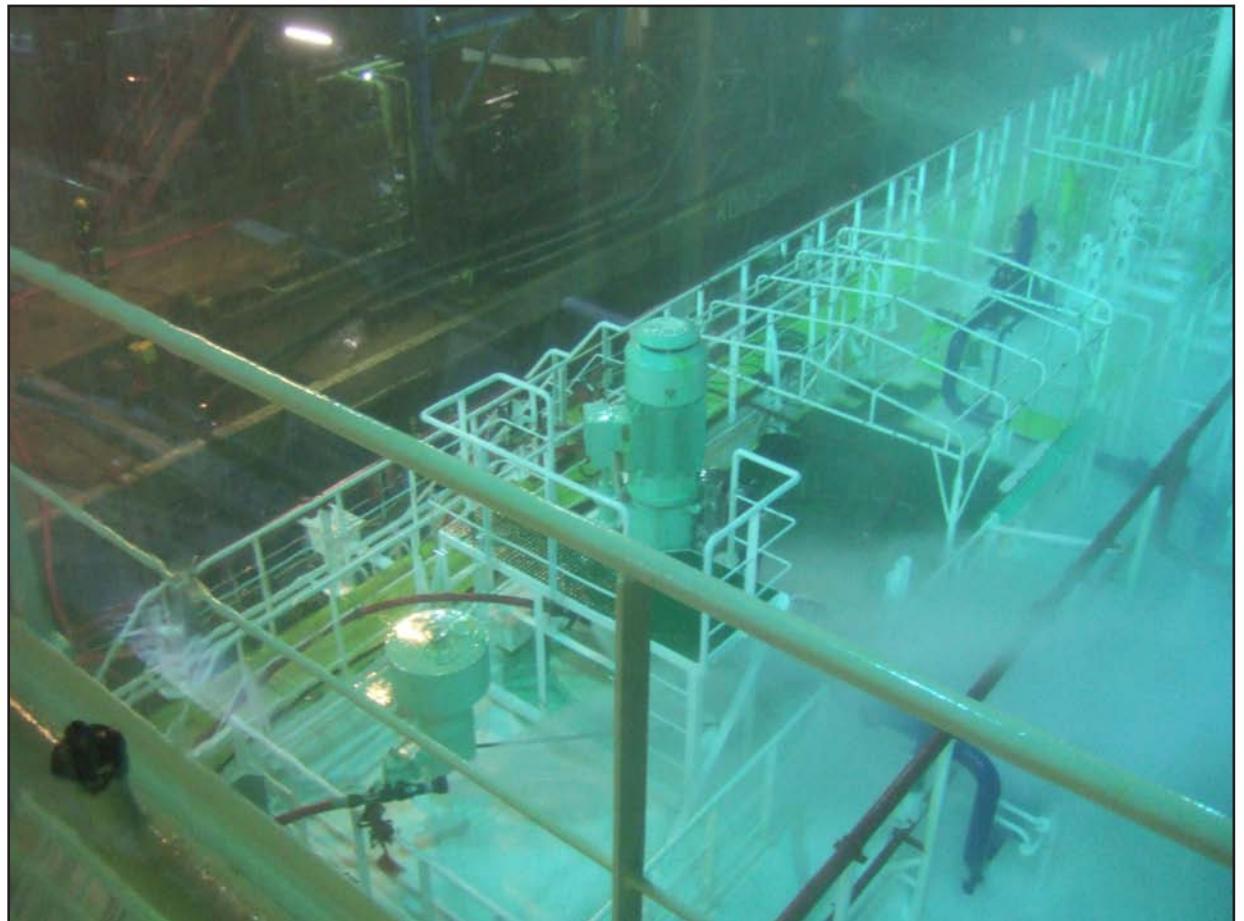
FMT shore monitors and further fire-fighting hoses were employed to increase the water spray on to *Ennerdale* and disperse the gas cloud (**Figure 8**). One of the two tugs which were permanently based at FMT was also continuously employed spraying additional water.

Water spray dispersion of LPG gas

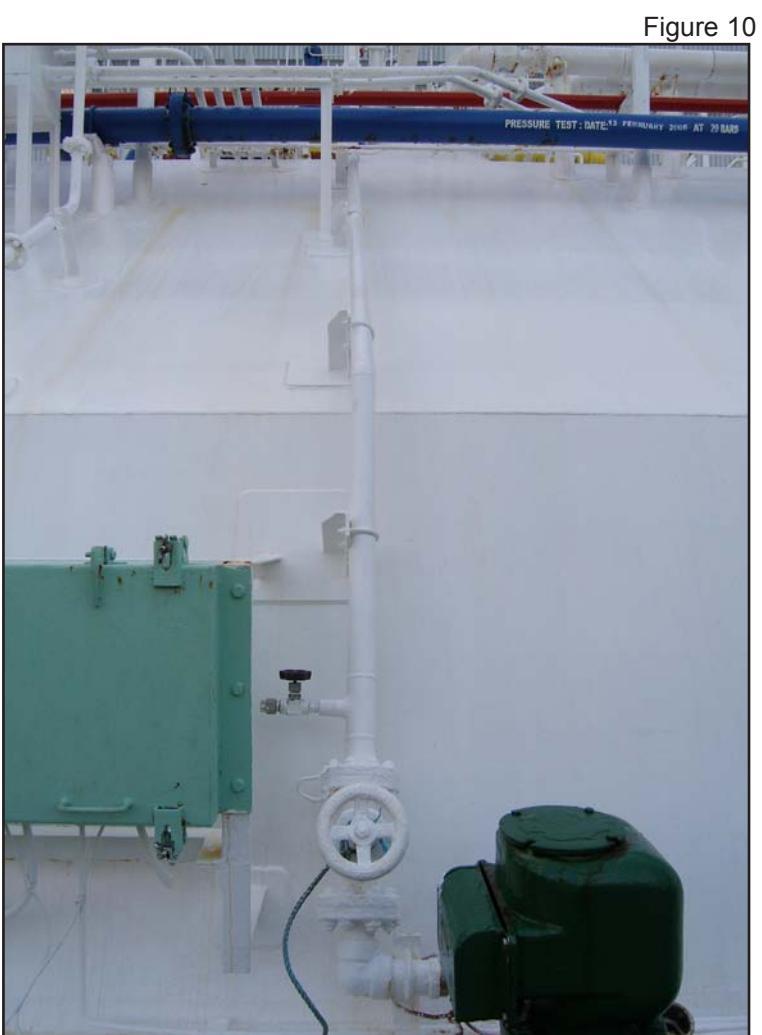
The original design intent (Annex A) for the drawing of liquid samples from the tanks of *Ennerdale* was via the sump drain (Figure 10), or by the use of the slip tubes (Figure 11). Samples of cargo vapour could be taken from the sampling valve on the tank dome.

Sump drain line

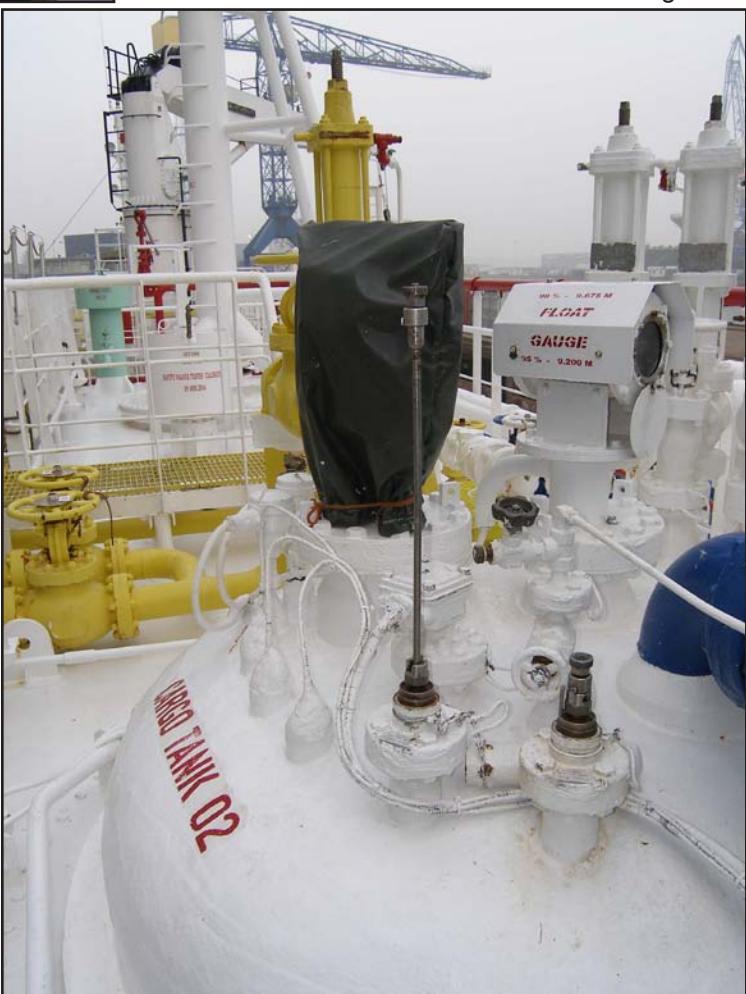
Figure 11

The slip tubes were installed as a back up system if the tank level float gauge failed. They consisted of two graduated tubes which penetrated the cargo tank, one in the lower half of the tank, the other into the upper half. An ullage measure of the tank contents could be taken by raising the tube out of the tank; opening the slip tube vent, releasing gas, lowering the slip tube until liquid was seen emitting from the vent instead of gas; this indicated the liquid level in the tank. The graduations on the slip tube could then be read to provide the ullage reading. When used for sampling, the slip tube would be positioned such that liquid would emit from the vent into a sample container.

During the last 10 years, changes to industry best practice have effectively stopped the regular use of slip tubes for sampling. There were many hazards inherent with this practice, including the fact it was not a closed loop sampling system. There was reliance on one small vent valve between the tank contents and the atmosphere. There have also been accidents where slip tubes have been ejected from tank domes under pressure, leaving an opening into the tank that was difficult to seal.

Slip tubes on tank dome

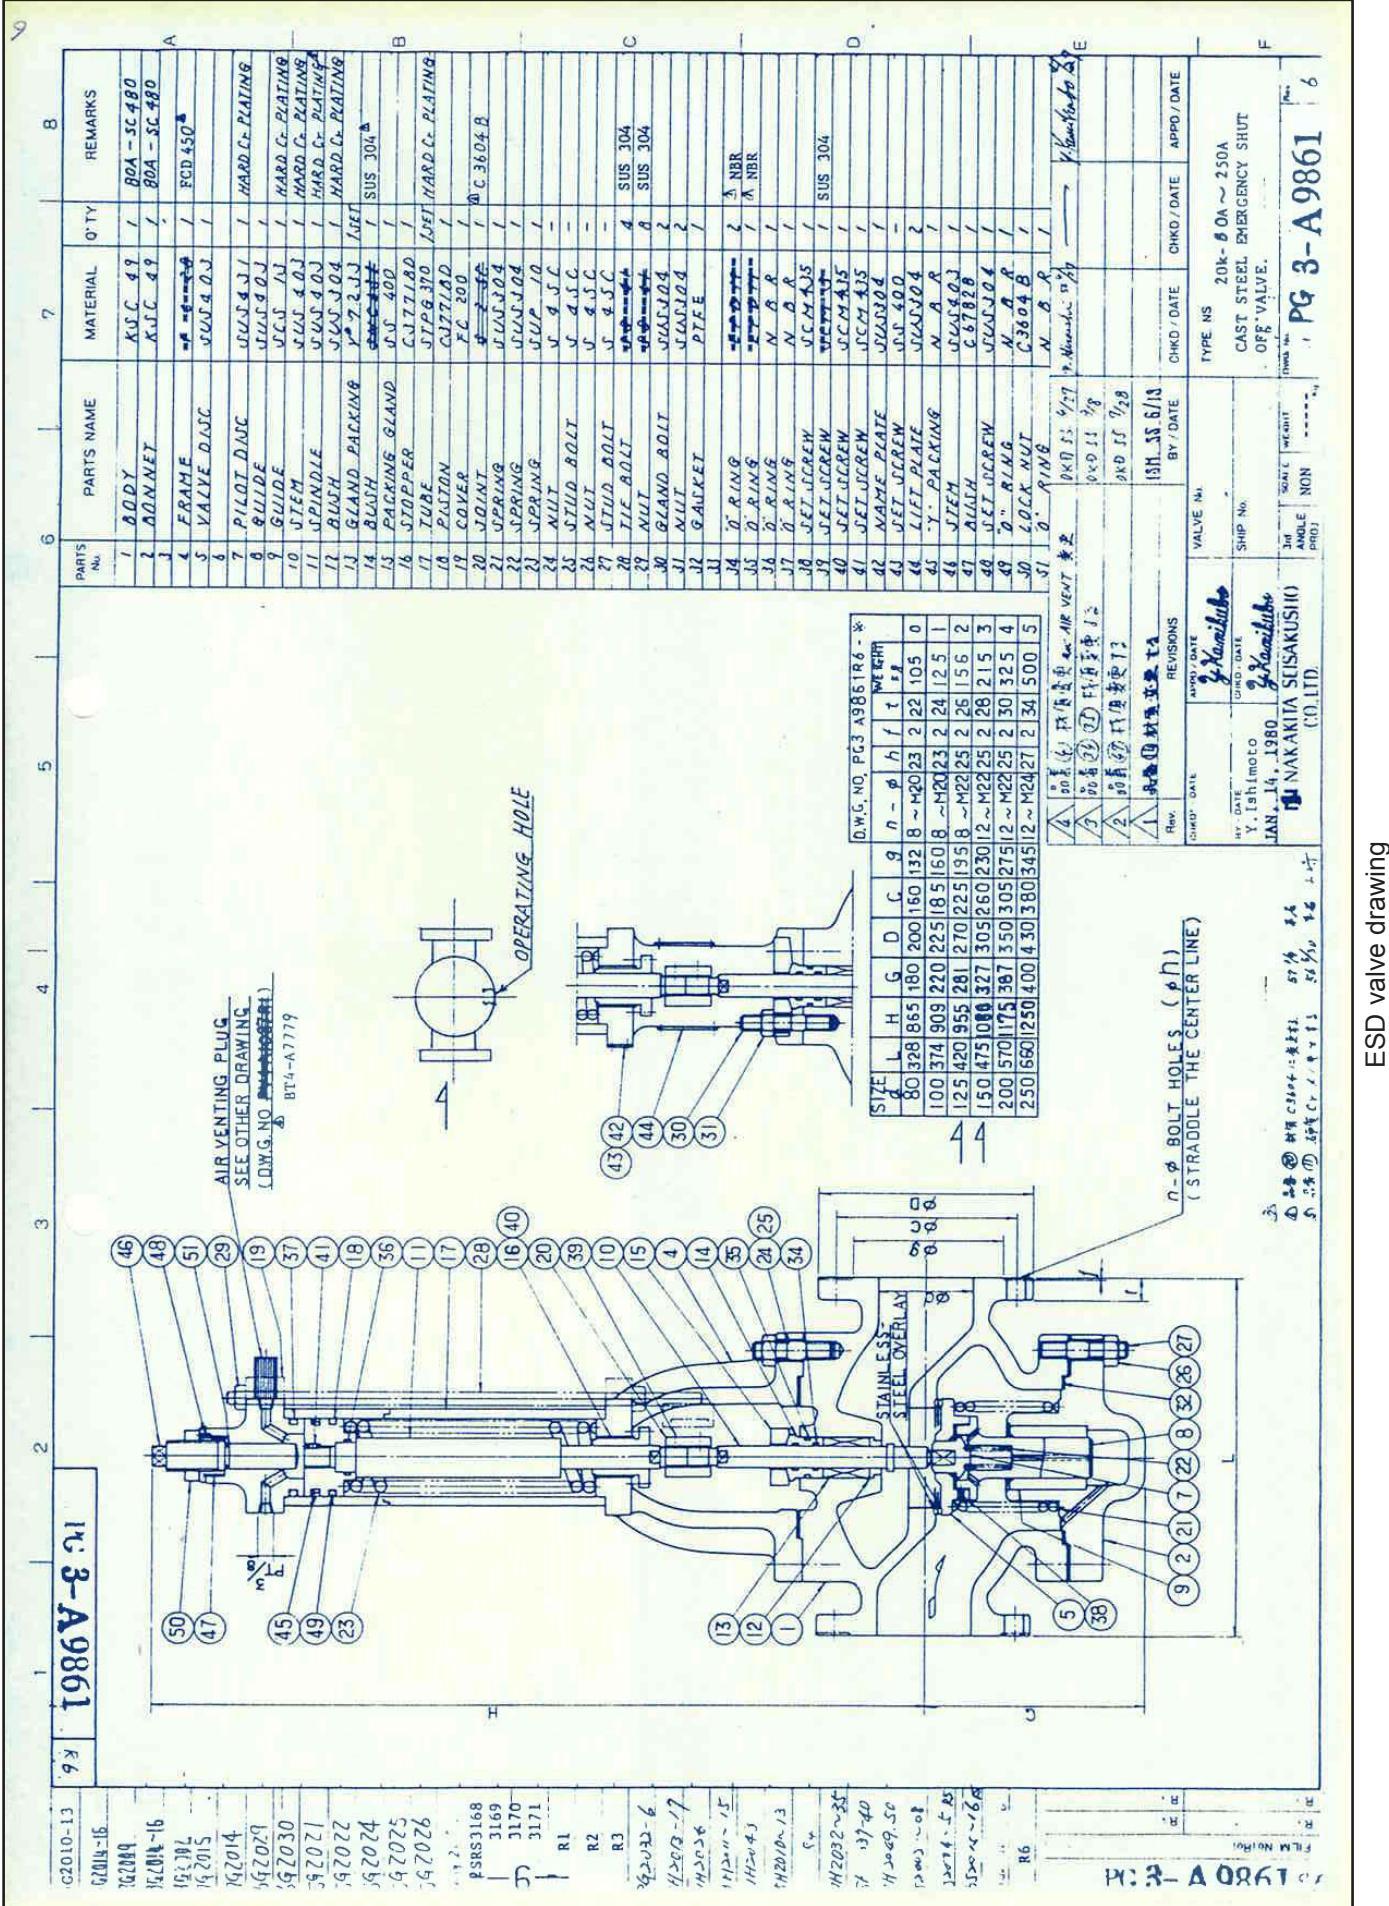
Figure 12

A drawing of the ESD valves fitted to *Ennerdale* is included at (Figure 12). As (Figure 2) indicates, there were 10 ESD valves on the cargo containment system, all of the same design, but three different sizes: 125mm nominal bore on the vapour lines; 150mm nominal bore on the loading and discharge lines; and 200mm nominal bore on the port and starboard liquid loading manifolds.

A single hydraulic system supplied all 10 ESD valve actuators which, when the valves needed to be opened, pushed the valve spindles down into the valve body. In this design of valve, the spindle was not attached to the valve disc as it had first to contact with a pilot valve on the centre of the valve disc (Figure 13). The pilot valve assembly allowed the initial pressure differential either side of the valve disc to be reduced. This enabled the valve disc to be opened with less force and, therefore, required a smaller hydraulic actuator.

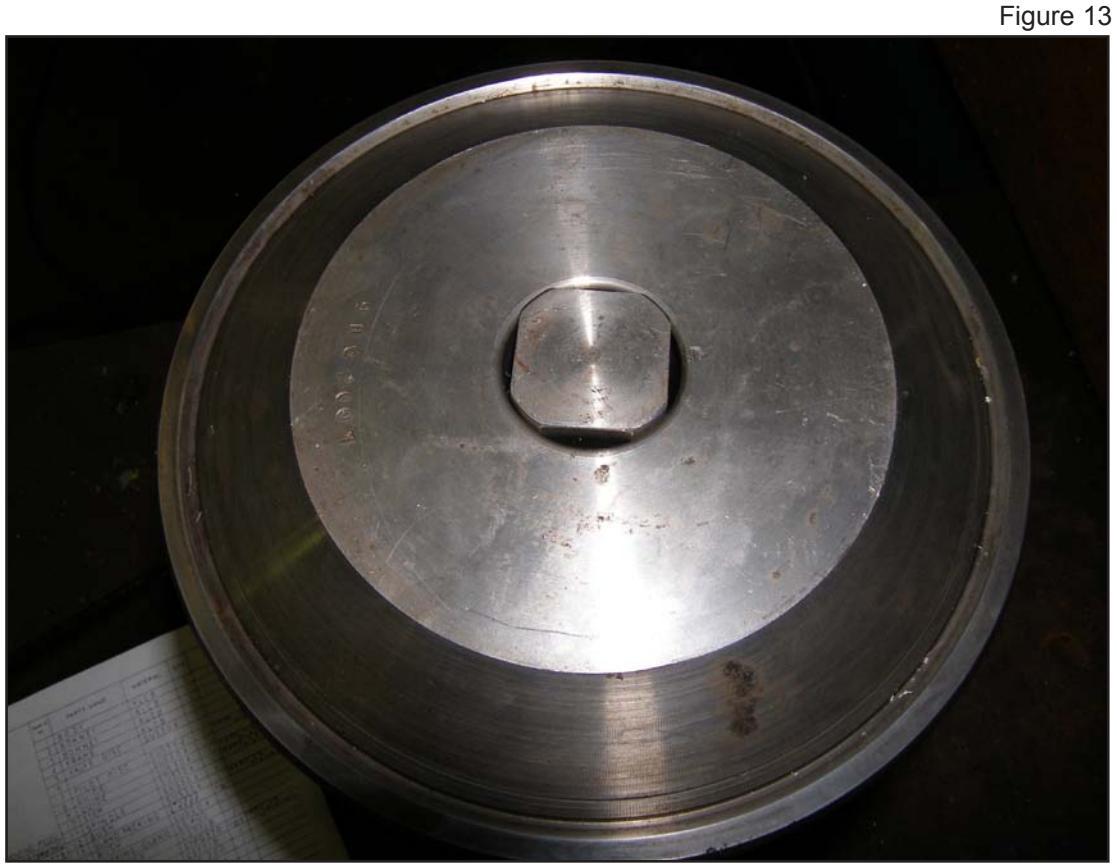
ESD valve disc with pilot valve

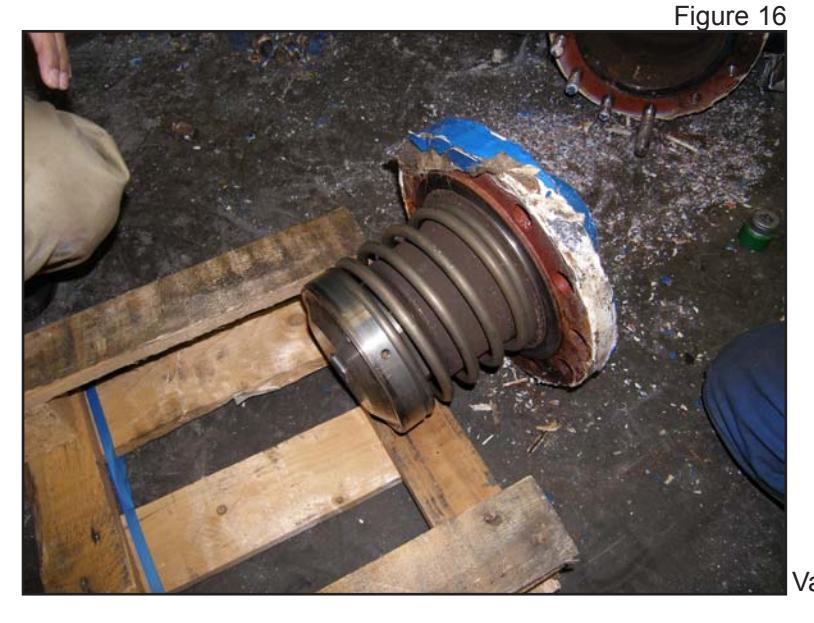
Once in dry dock, all the ESD valves onboard *Ennerdale* were removed and examined. No problems were found except with the ESD valve on the No. 2 discharge line. It was found to be jammed open, and obviously accounted for why the ESD valve had not contained the leak **(Figures 14 & 15)**. The bottom of the valve, which contained the valve disc and spring assembly, was removed **(Figure 16)**. It was discovered that a small burr in the valve guide was preventing the valve disc from rising, under the force of the spring, on to the valve seat **(Figures 17 & 18)**. The burr was adjacent to one of two tack welds that held the guide in position in the bottom of the valve body.

Burr on valve guide
