Report on the investigation of the machinery breakdown  
and subsequent fire onboard

***Maersk Doha***

2 October 2006

**Report No 15/2007**  
**July 2007**

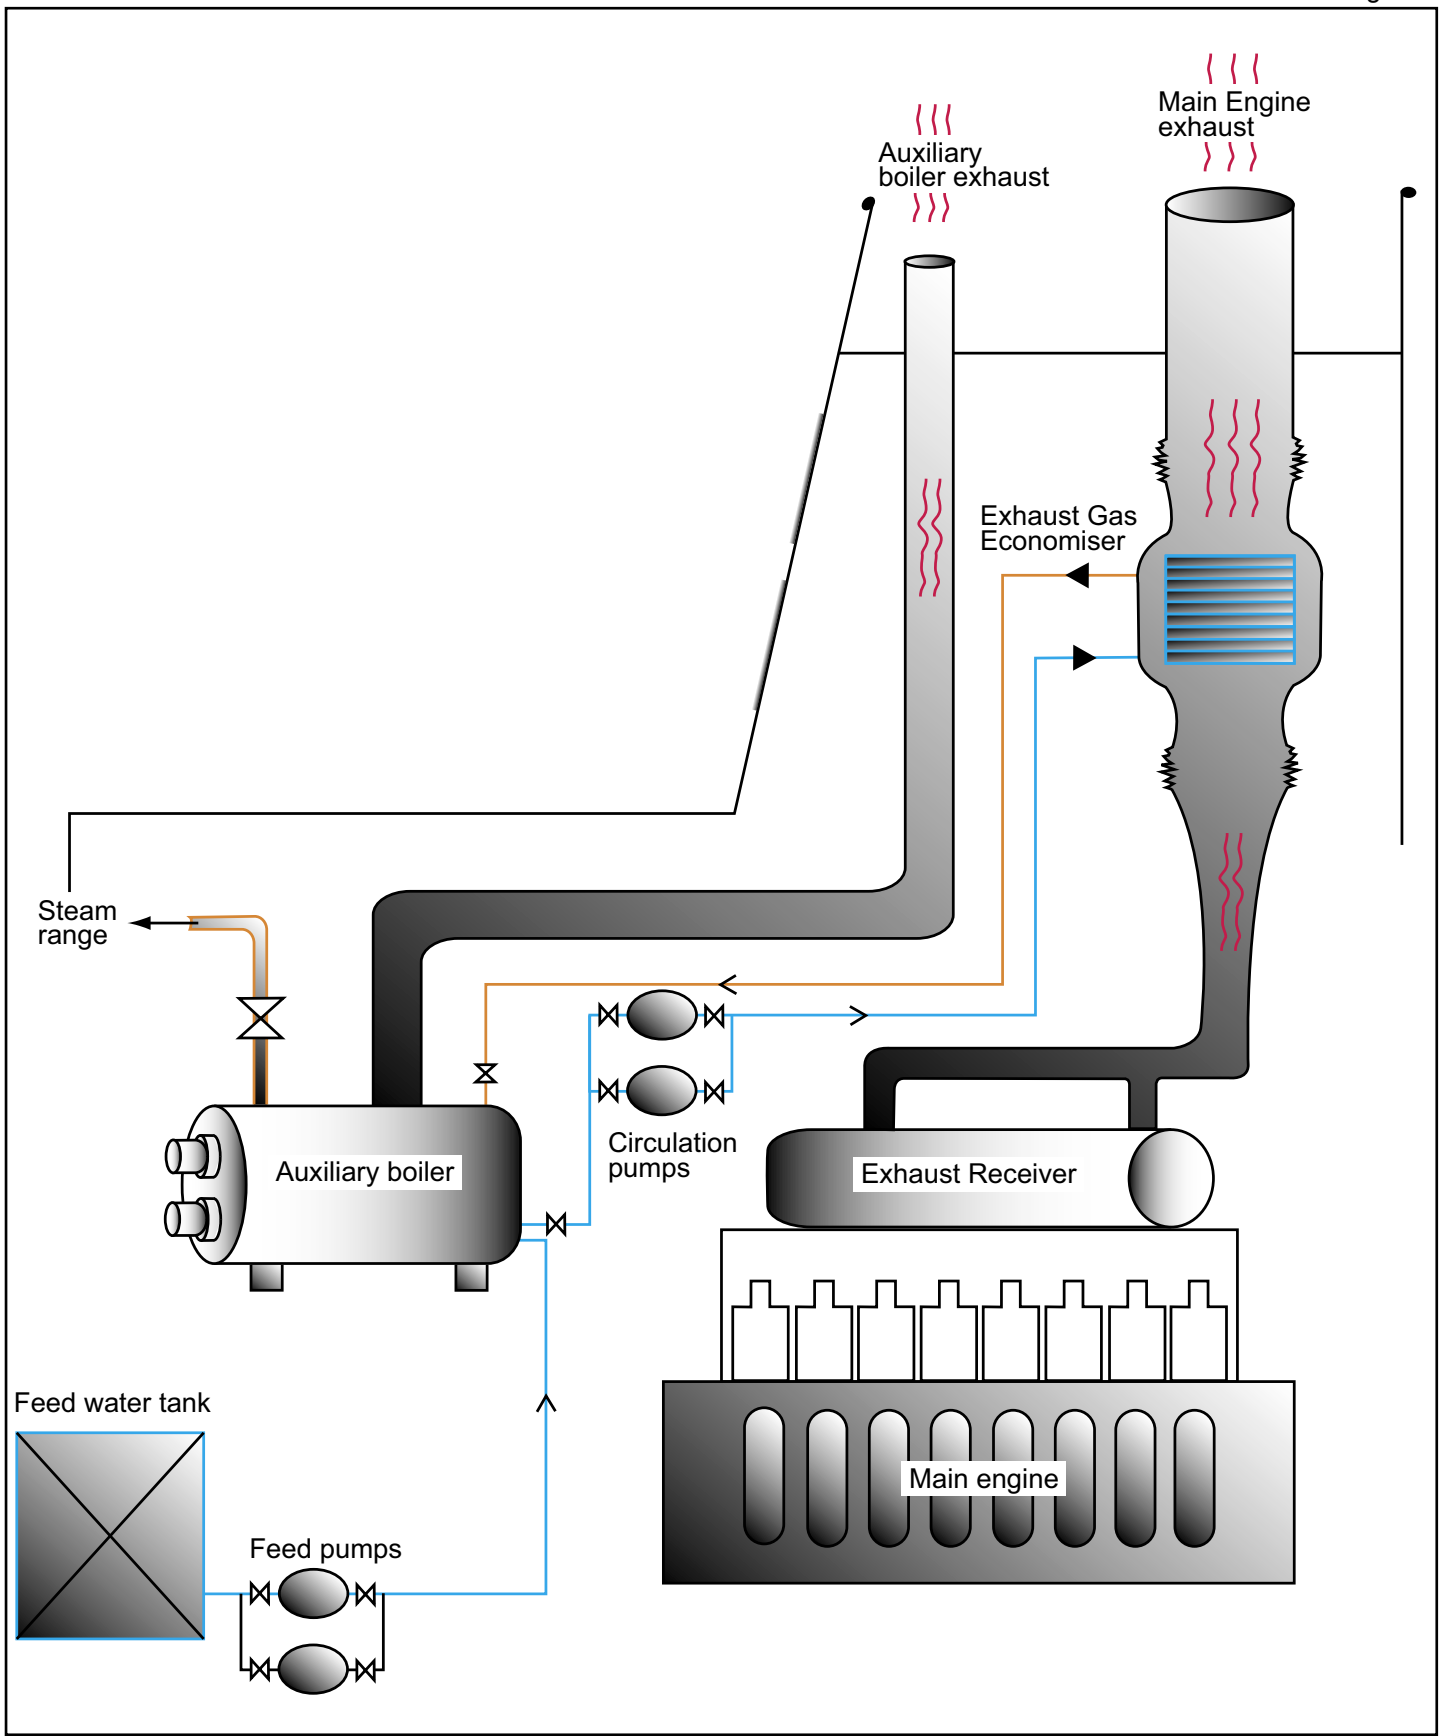
Figure 1

Schematic diagram of the steam generation system

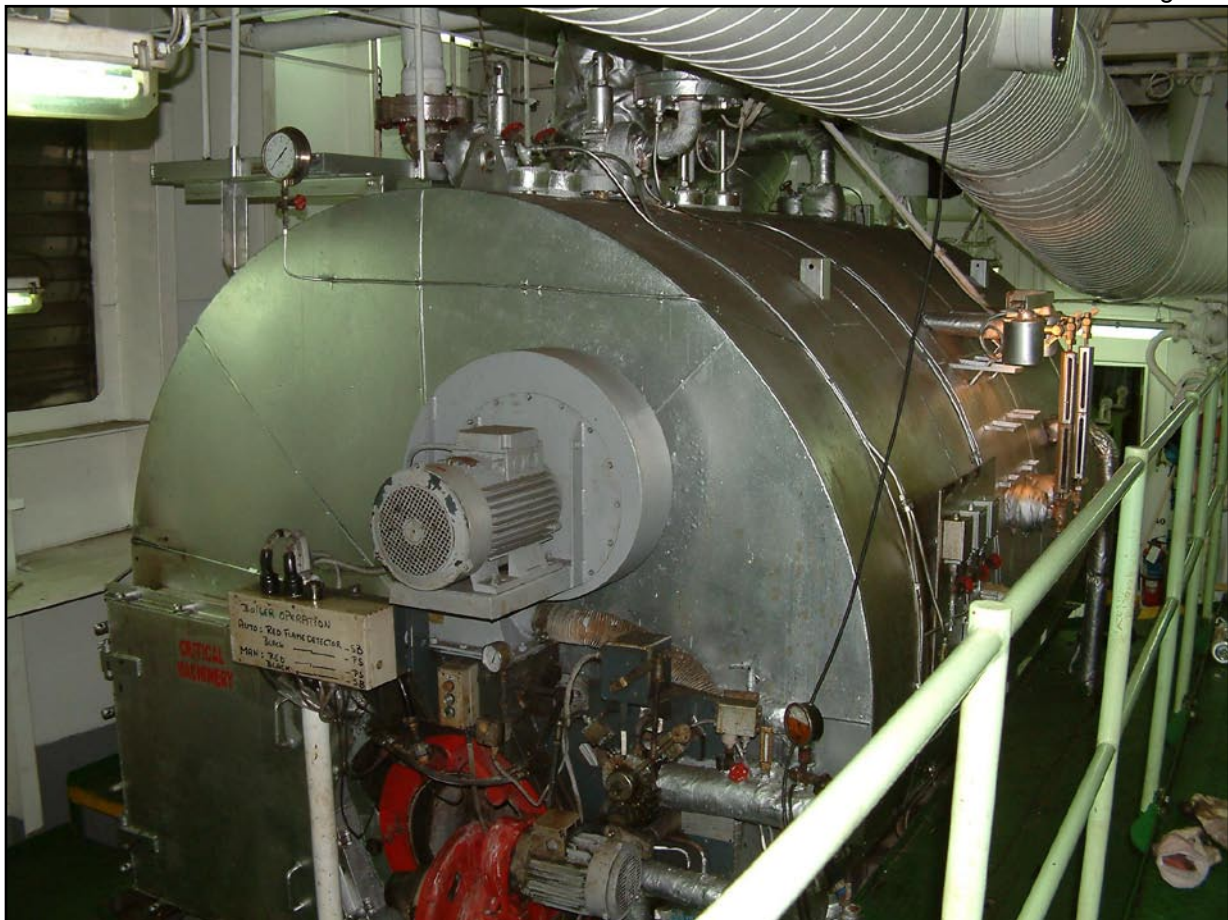
Figure 7

The auxiliary boiler had a horizontal furnace tube mounted inside a water drum to generate steam at 7.5 Bar pressure, a general view is shown at **Figure 7**. Fired by heavy fuel or diesel oil, the fuel was mixed with air and ignited to create a single flame. Hot gases passed down the furnace tube to the other end of the boiler and reversed, travelling through a further two generating tube passes before leaving the boiler and exhausting through a funnel uptake. The furnace tube and generating passes were immersed in the boiler water drum as illustrated in **Figure 8**, with the normal water level above the top of the tubes.

Auxiliary boiler

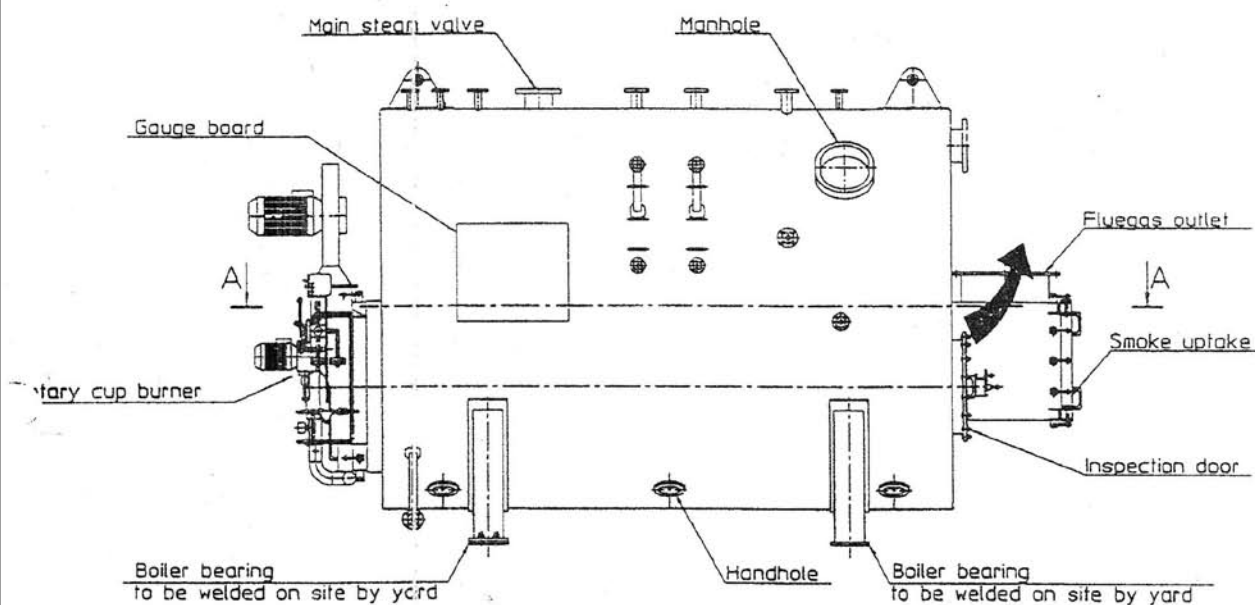
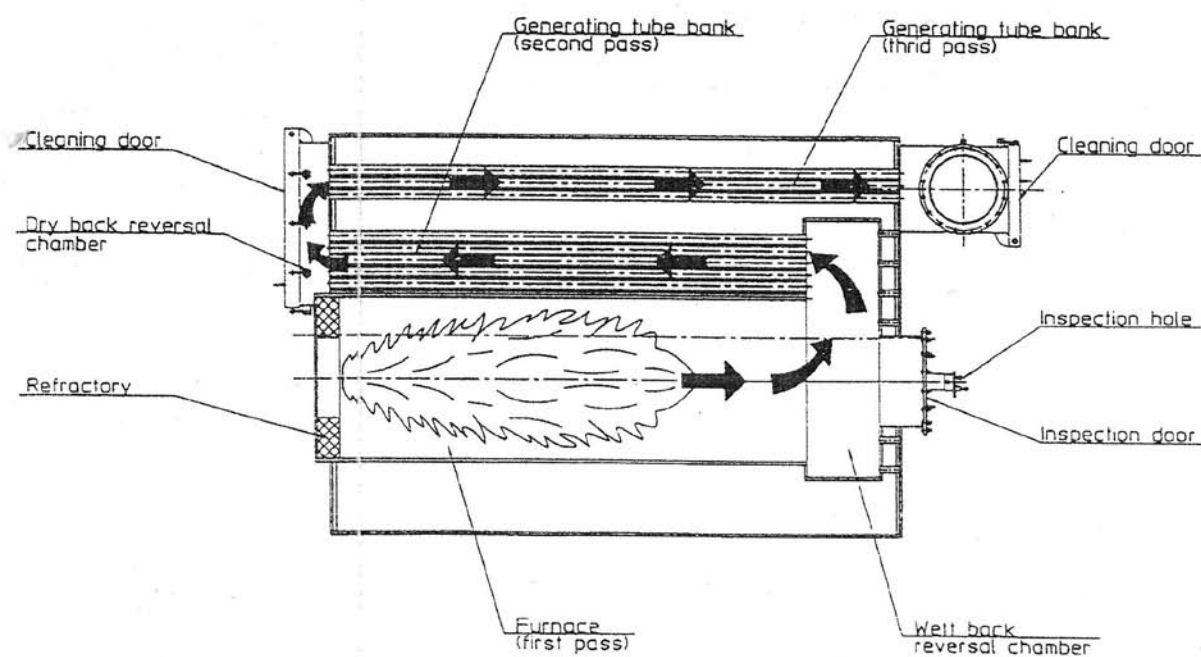
<sup>1</sup> The auxiliary boiler was made up of two horizontal tubes, with one mounted inside the other **Figure 8**. The inner tube formed the furnace with a flame burning at one end. Hot gases passed down the furnace tube to the other end of the boiler and reversed, travelling through a further two generating tube passes before leaving the boiler and exhausting through a funnel uptake. The furnace tube was mounted inside the water tube, so that the heat from the burner transferred outwards to the water and generated steam. The level of water in the outer tube was maintained at two thirds full, with the remaining third acting as a reservoir for the steam generated by the auxiliary boiler and that returning from the EGE.

Schematic diagram of auxiliary boiler taken from manufacturer's manual, onboard vessel

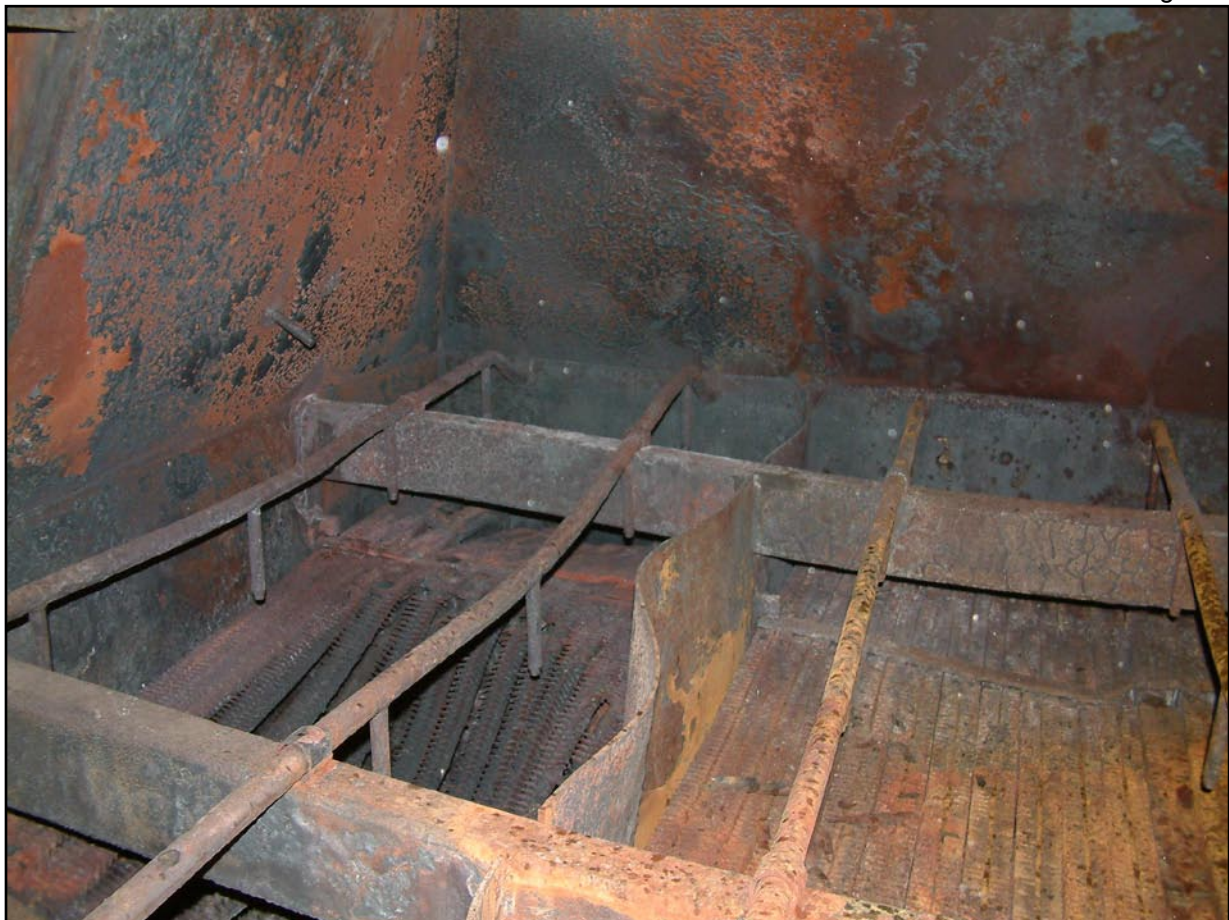
Figure 9

The ultrasonic system used high frequency sounds to induce vibrations in the EGE to prevent soot deposits from accumulating on the tubes, and operated automatically every 30 minutes. Soot blowers connected to the engine air starting system were designed to operate both automatically and manually, and rotated to blast compressed air over the tubes, dislodging the soot which passed out of the EGE with the engine exhaust gases. The water washing system was connected to the salt water fire main, delivering water to clean the tubes through a number of fixed nozzles at the top of the EGE, as shown at **Figure 9**. Any salt deposits were then removed from the EGE by rinsing the tubes with fresh water. Drains underneath the EGE could be opened to collect the dirty water in a holding tank.

Water washing pipework and nozzles at the top of the EGE
