Report on the investigation of the loss of the sailing yacht

***Ouzo***

20/21 August 2006

**Report No 7/2007  
April 2007**

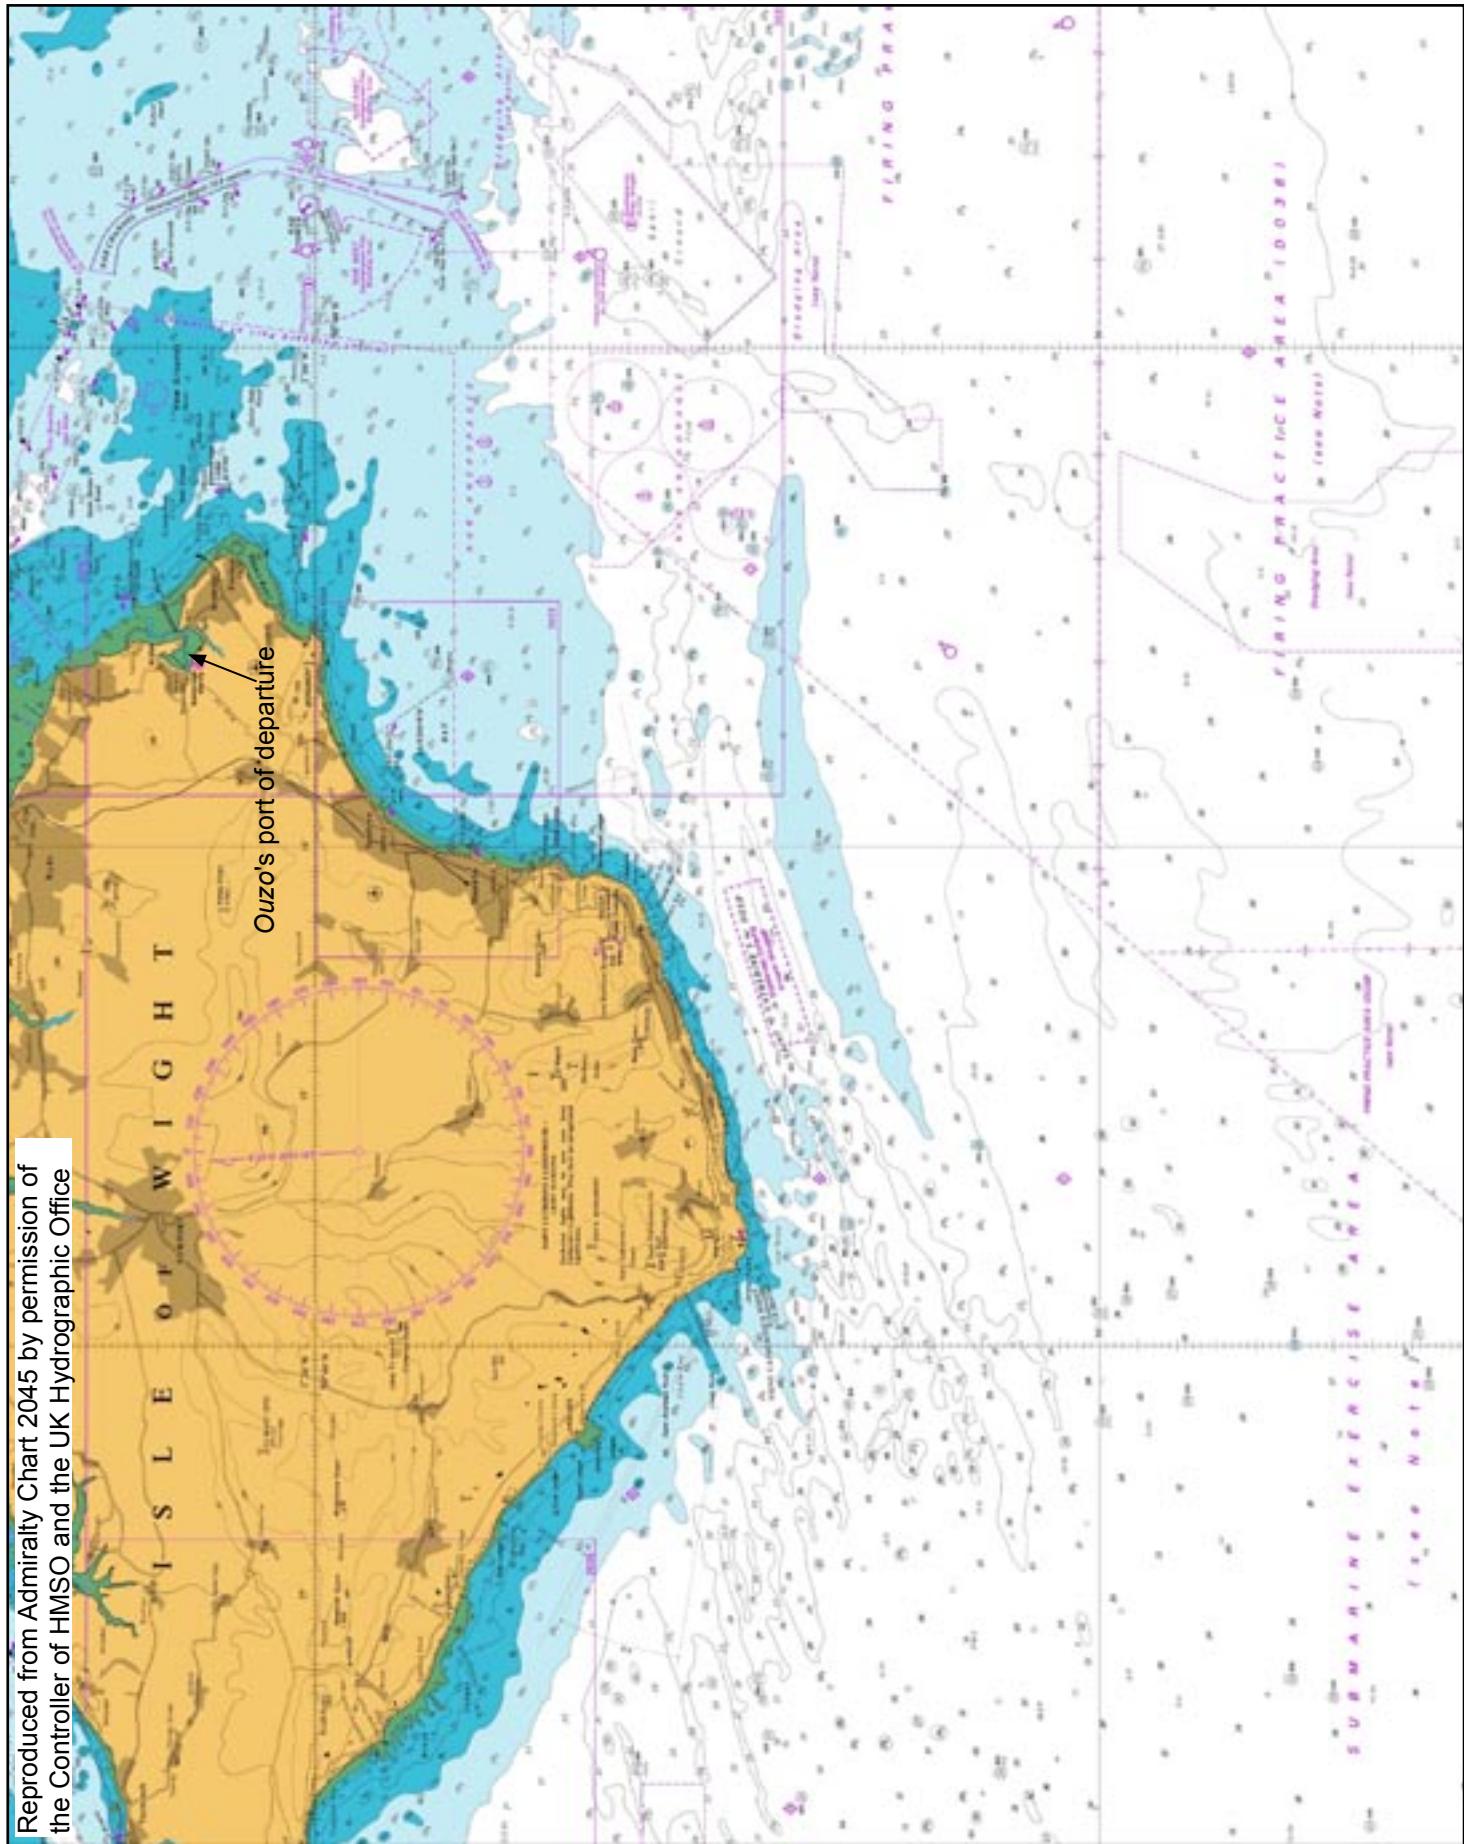
Figure 2

While there is conflicting evidence over the exact time of *Ouzo*'s departure from Bembridge, it would appear that she left her mooring at about 2030 that evening, and sailed out of the harbour under power, arriving off Saint Helen's Fort at 2105. The evidence then indicates that the crew raised the sails and sailed in a southerly direction down the east coast of the Isle of Wight (**Figure 2**).

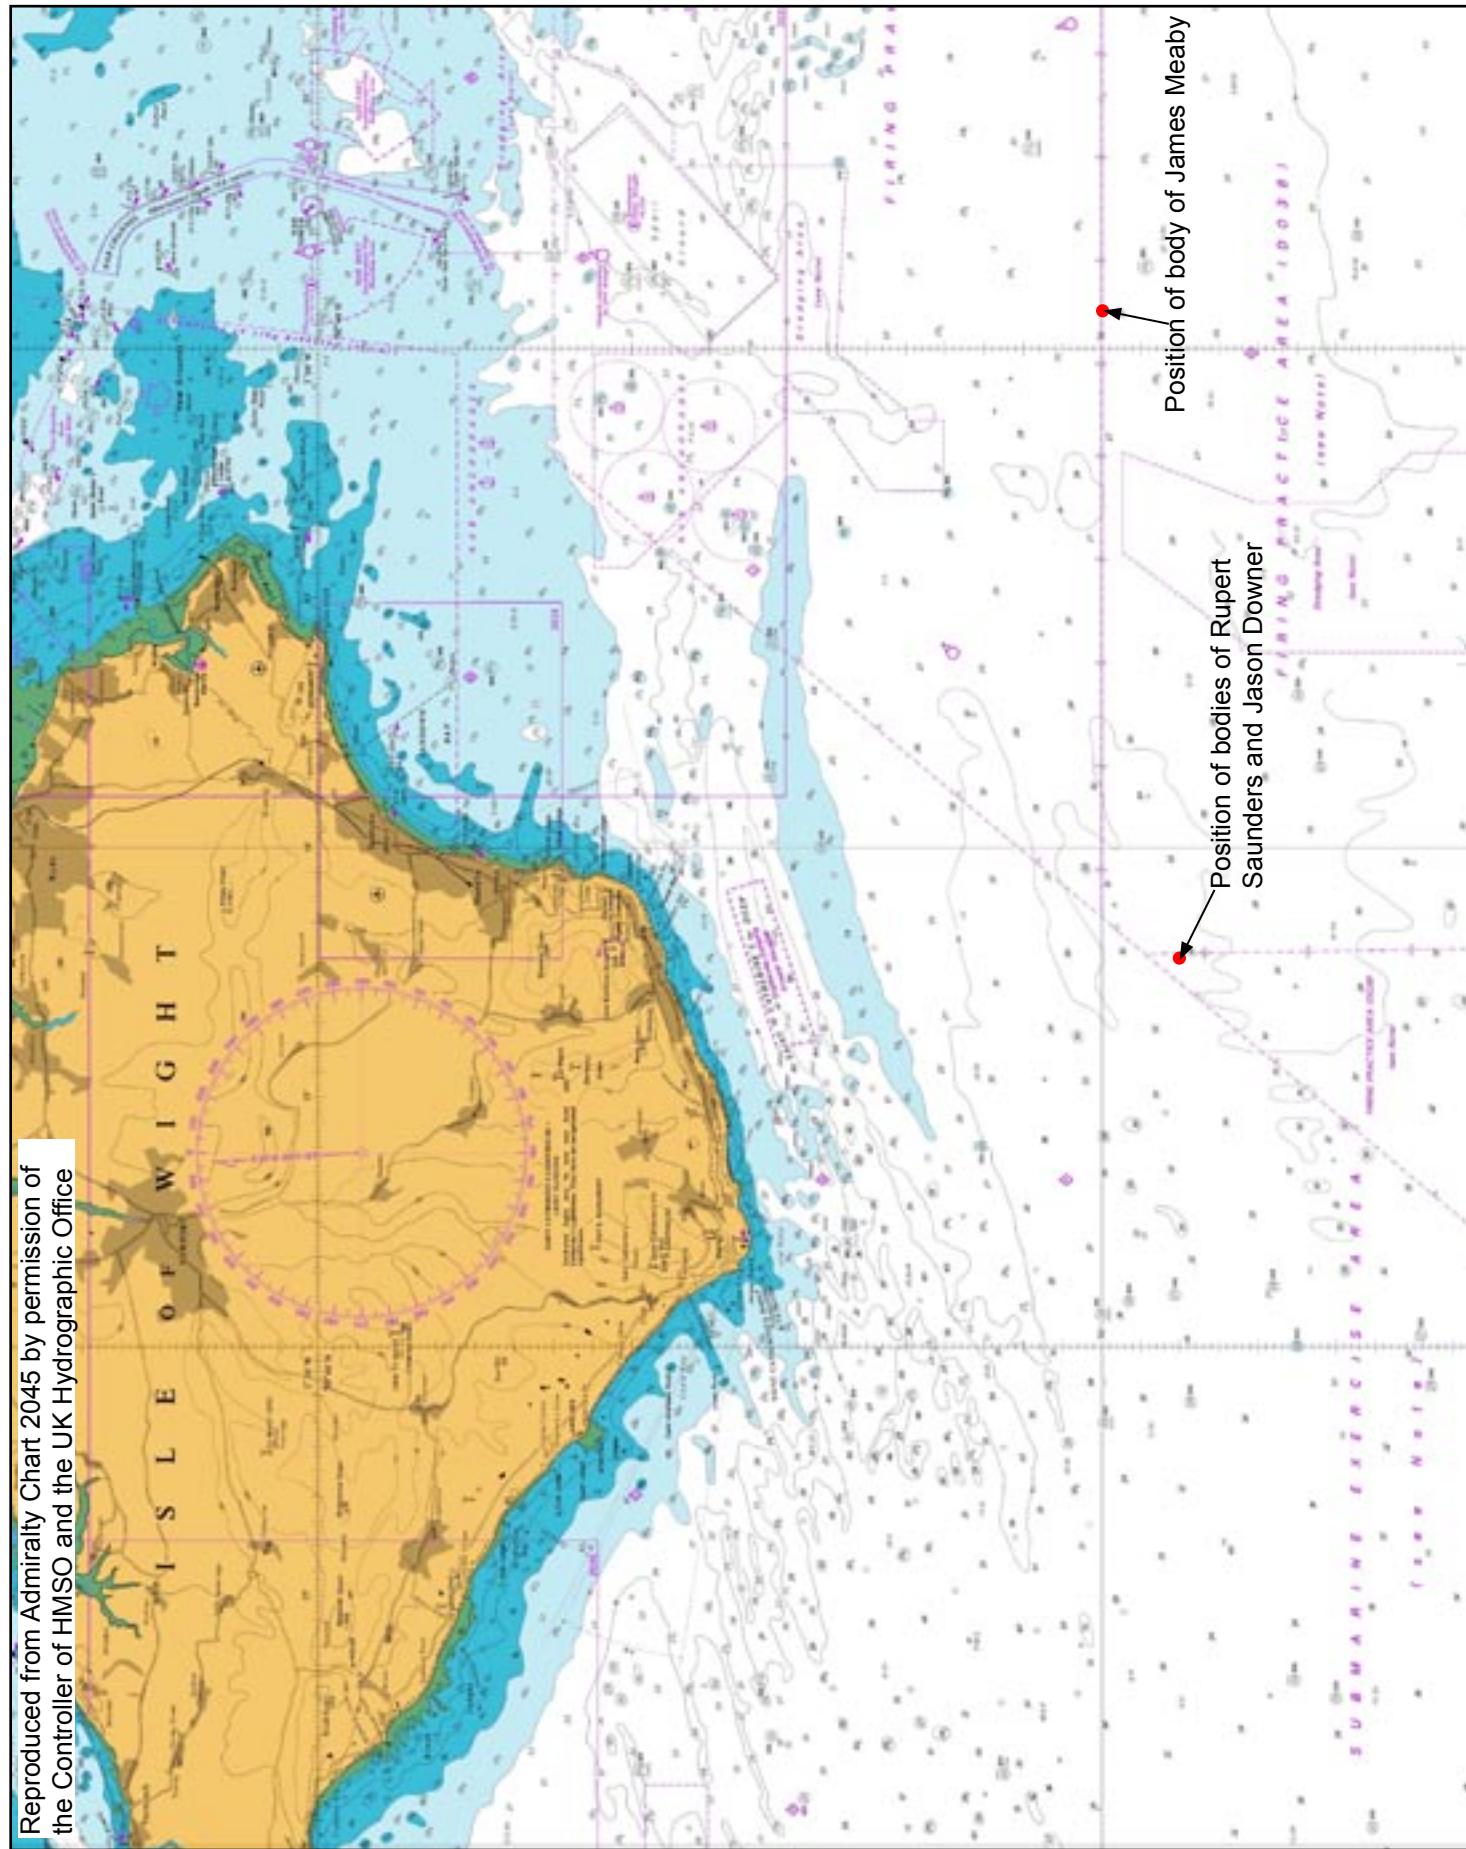
Figure 3

At just before midday on 22 August, 40 hours after the yacht had left Bembridge, the body of a man was found in the sea about 10 nautical miles south of the Nab Tower (**Figure 3**). He was wearing a manually inflated lifejacket and yachtsman's clothing.

At about 1900 in the evening of 23 August, the bodies of Jason Downer and Rupert Saunders were recovered from the sea about 10 nautical miles south-west of the Nab Tower (**Figure 3**).

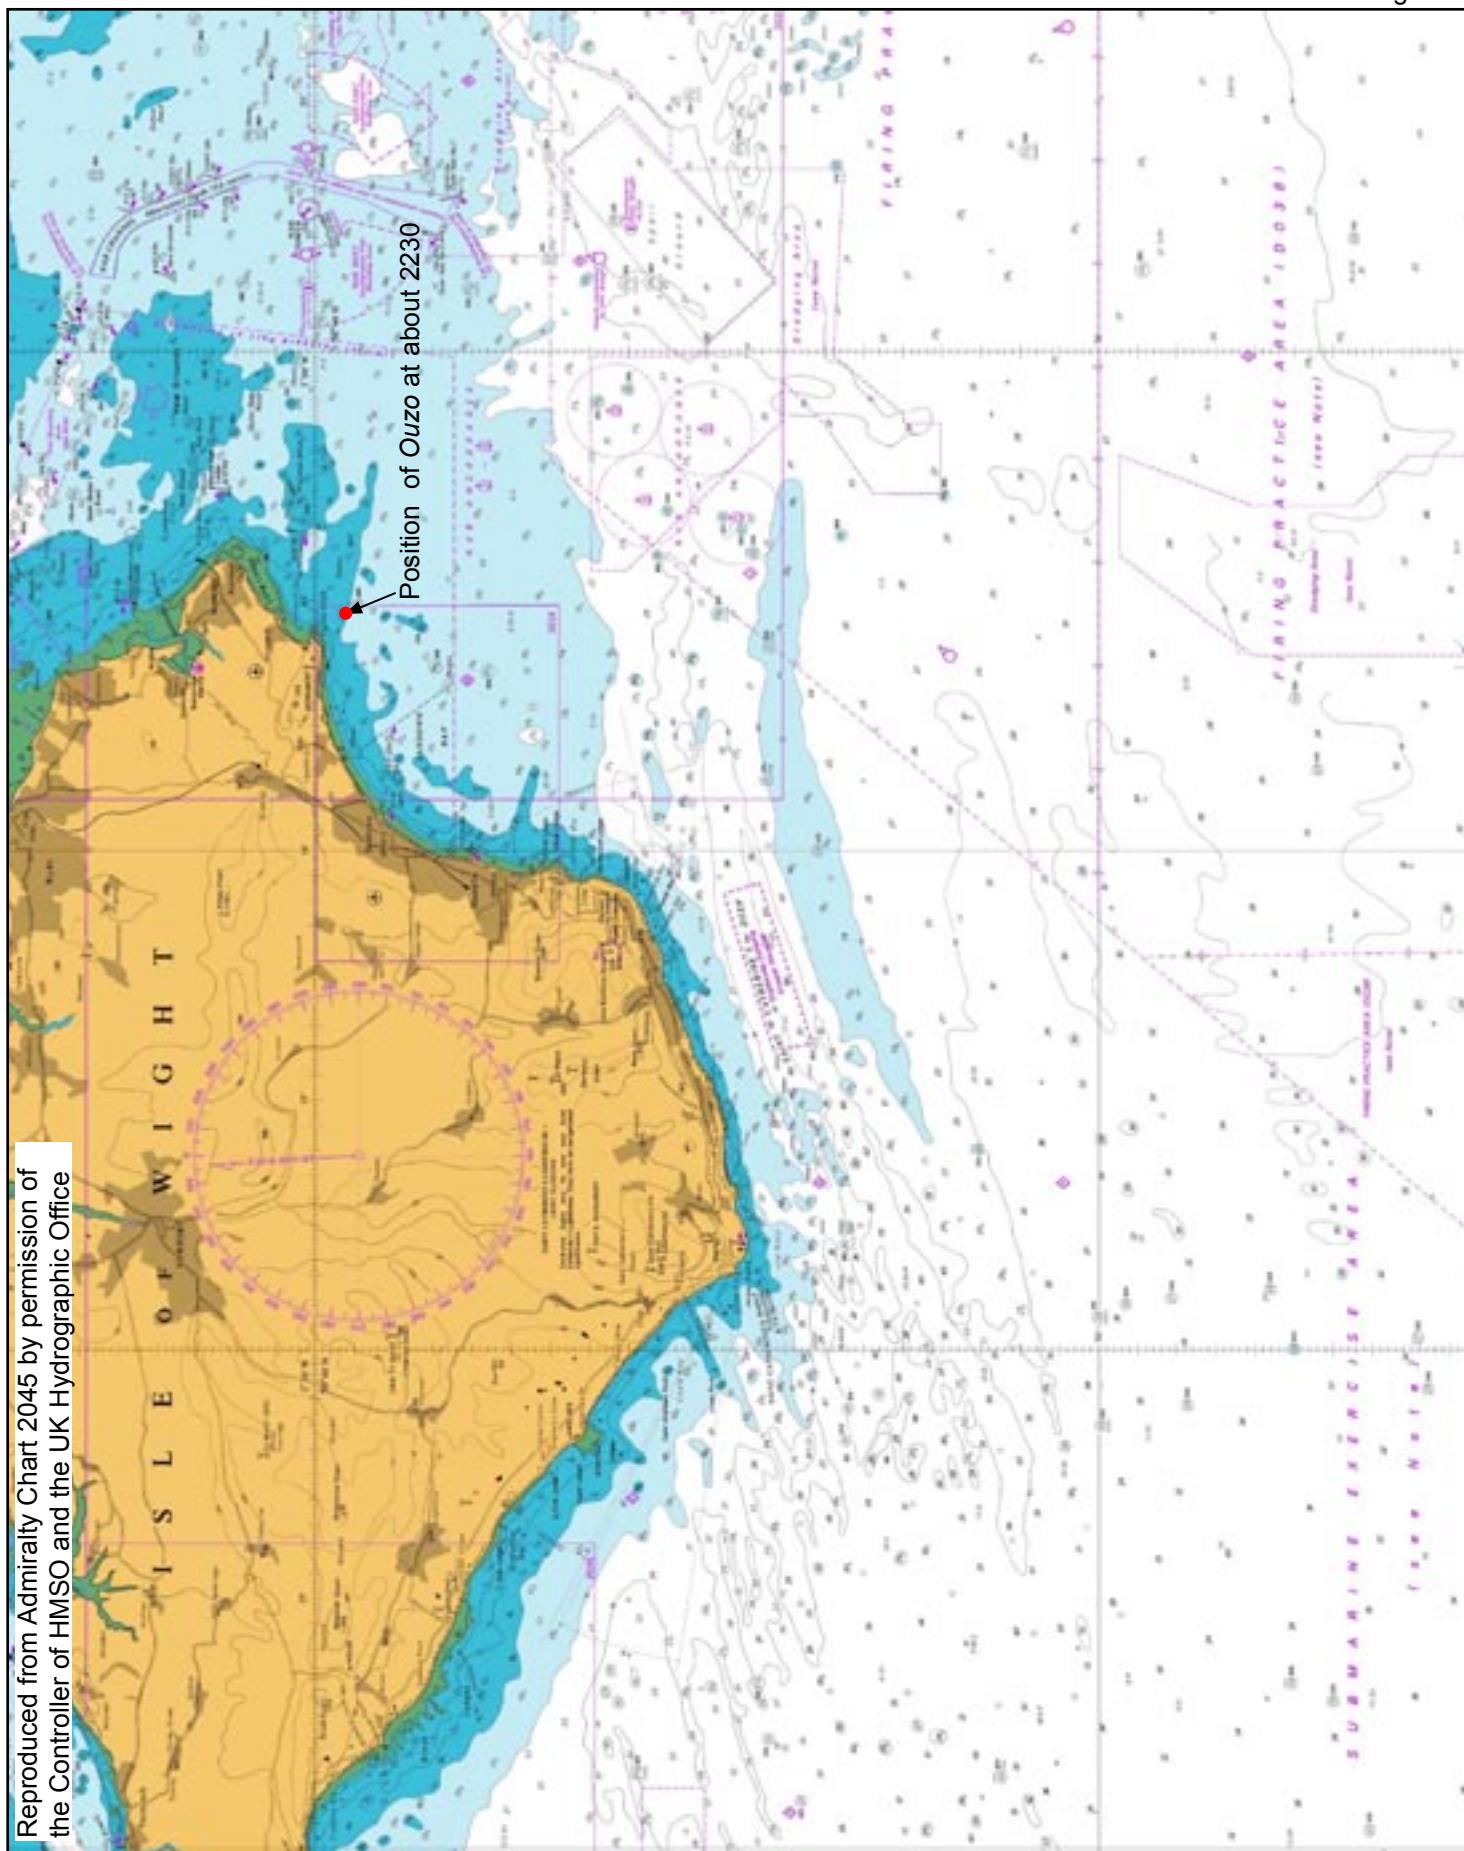
Figure 6

The view that the target, which was lost at about 2230 in Sandown Bay, was that of *Ouzo* was reinforced further when investigations indicated that one of the crew had made a mobile phone call from the yacht shortly after that time. Triangulation of the mobile phone signal data had shown that the vessel was in Sandown Bay when the call was made (**Figure 6**).

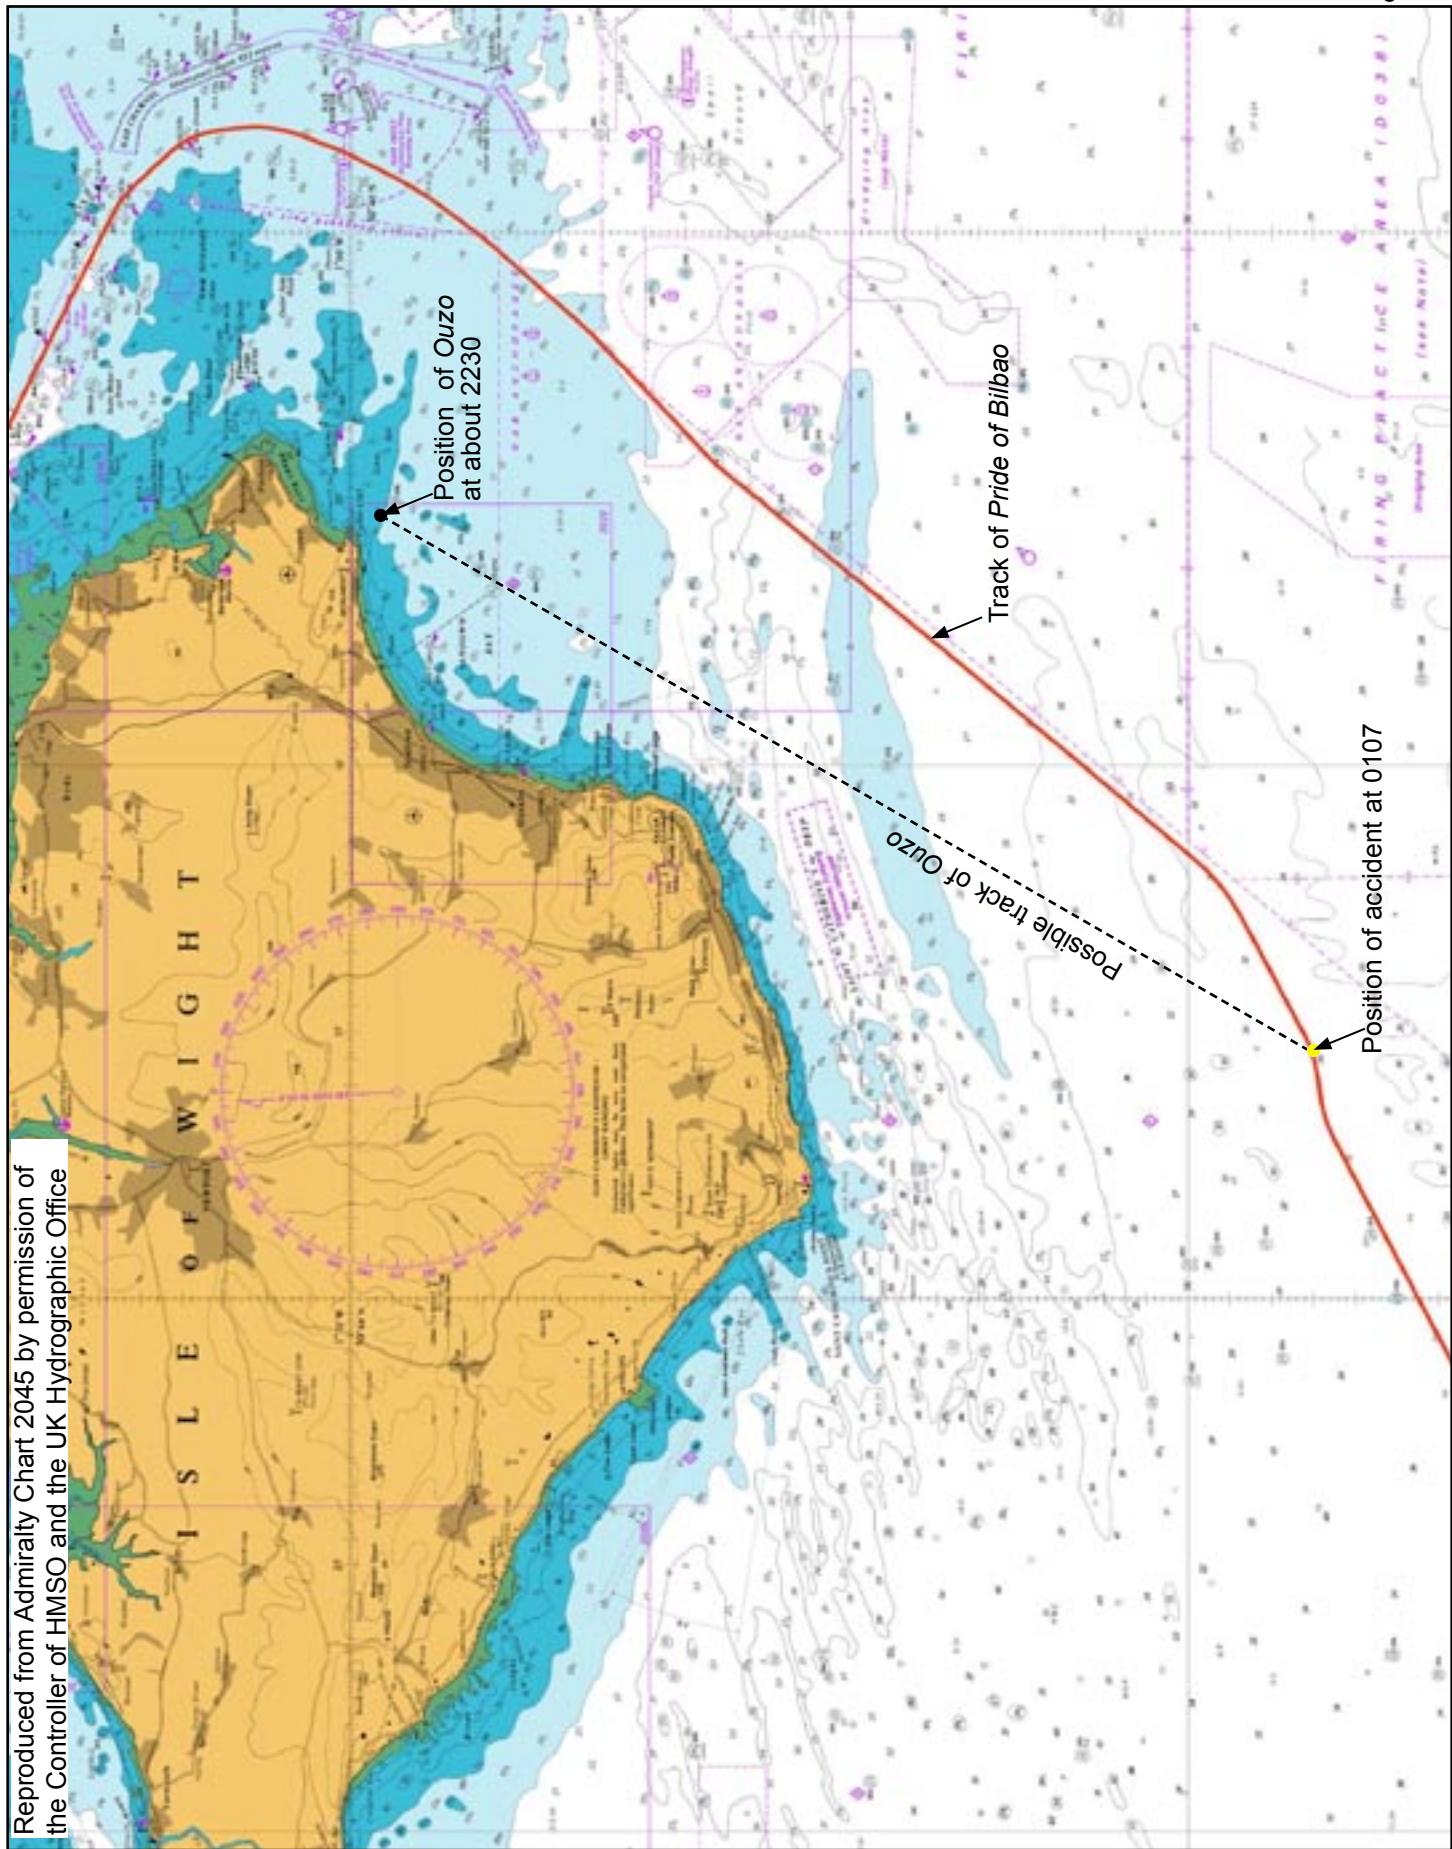
Figure 7

At that time, the tide was starting to be favourable and the wind was west-south-westerly force 5. For *Ouzo* to have been close to *Pride of Bilbao* at 0107 she needed to have covered a distance of 13.3 nautical miles in a south-south-westerly direction from her 2230 position. This equates to a ground speed of about 5 knots. Both the course and speed required to achieve this are entirely feasible for *Ouzo* given the prevailing environmental conditions (**Figure 7**).

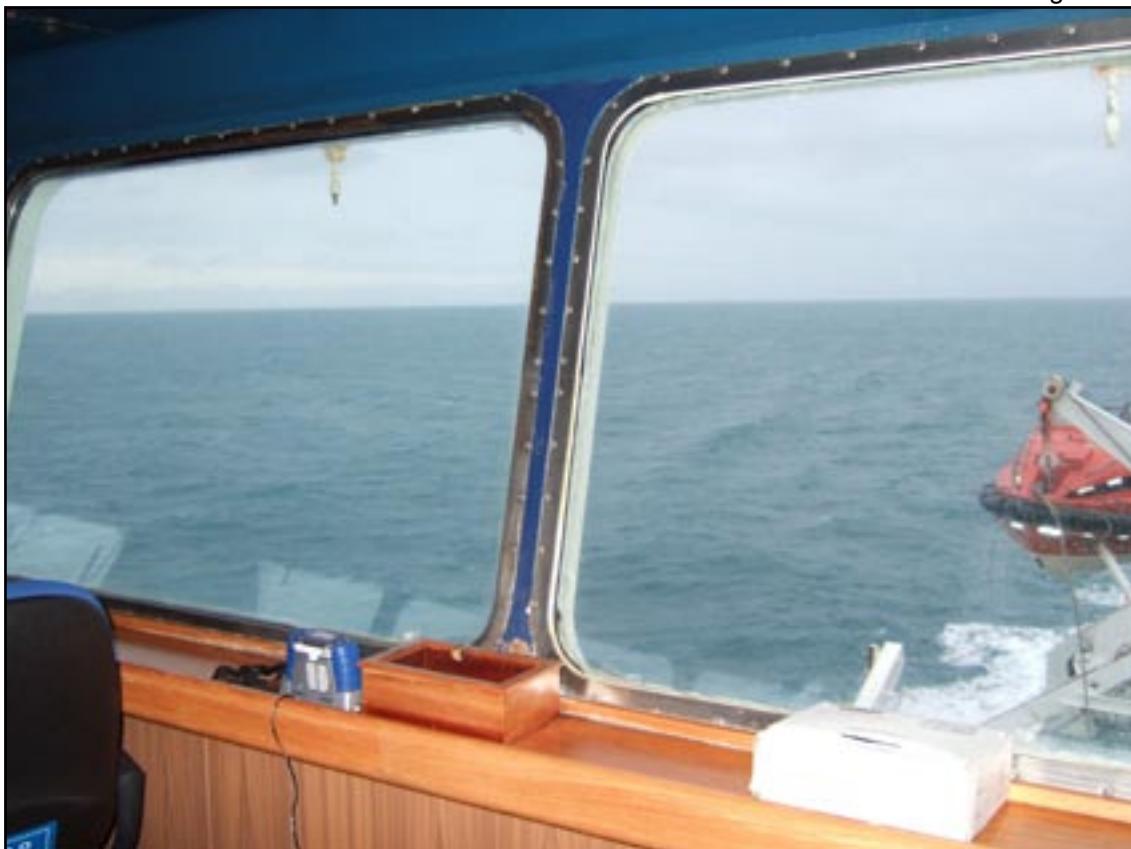
Figure 17

The lookout had run across the bridge to the starboard side as the yacht passed from view to determine where it was. At first, he did not see the yacht or her lights, probably because he was not looking from the extreme outboard vantage point on *Pride of Bilbao*'s bridge, but a few metres inboard. From his position he would only have been unable to see a boat that was very close alongside the hull (**Figures 17 and 17a**).

View from inboard starboard side

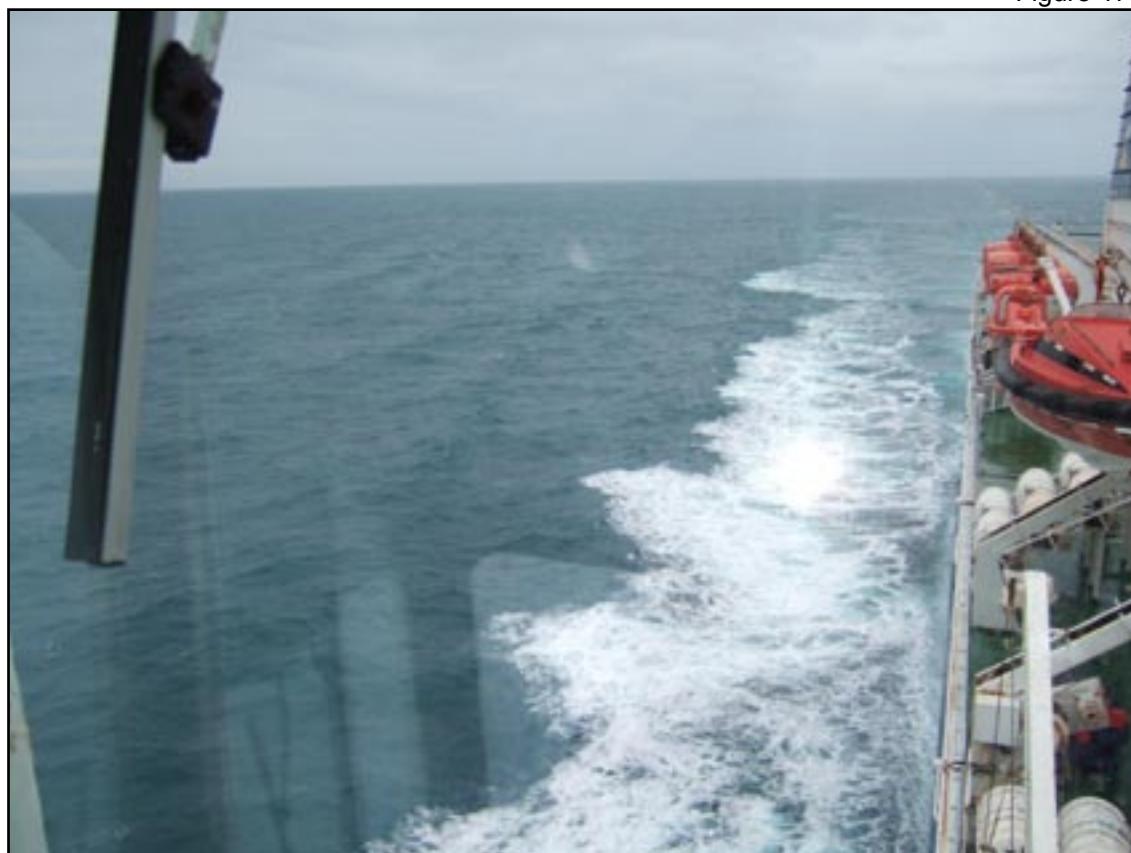
Figure 17a

View aft from extreme starboard side

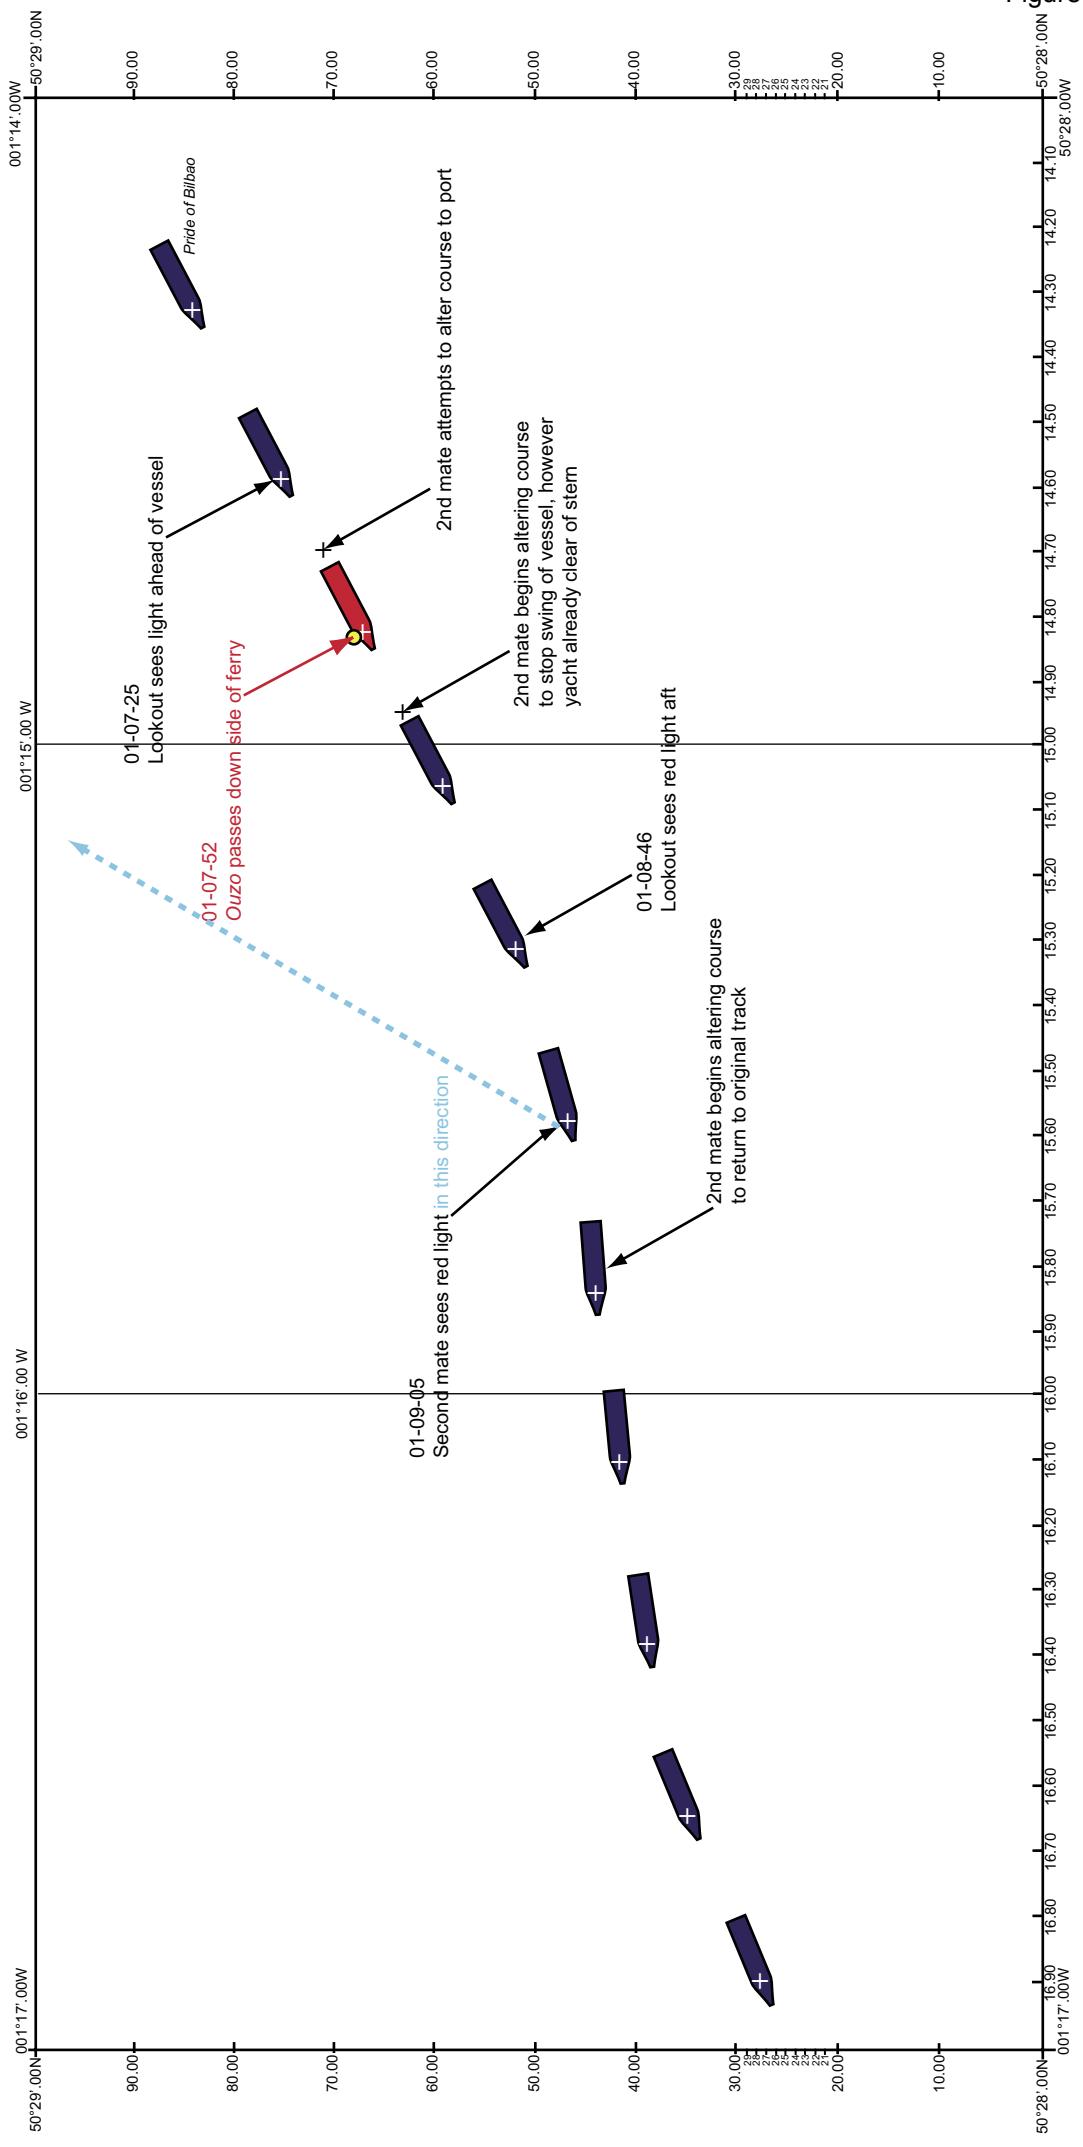
Figure 19

After the incident, the VDR records showed that, in using the autopilot the vessel's heading had changed just 1° to port prior to the yacht passing, and this would have had only a negligible effect on the passing distance with *Ouzo* (**Figure 19**).

Representation of events taken from the VDR records of *Pride of Bilbao*
