Report on the investigation of the grounding of

mv Thunder

at the approaches to the Dee Estuary

**Report No 12/2007
June 2007**

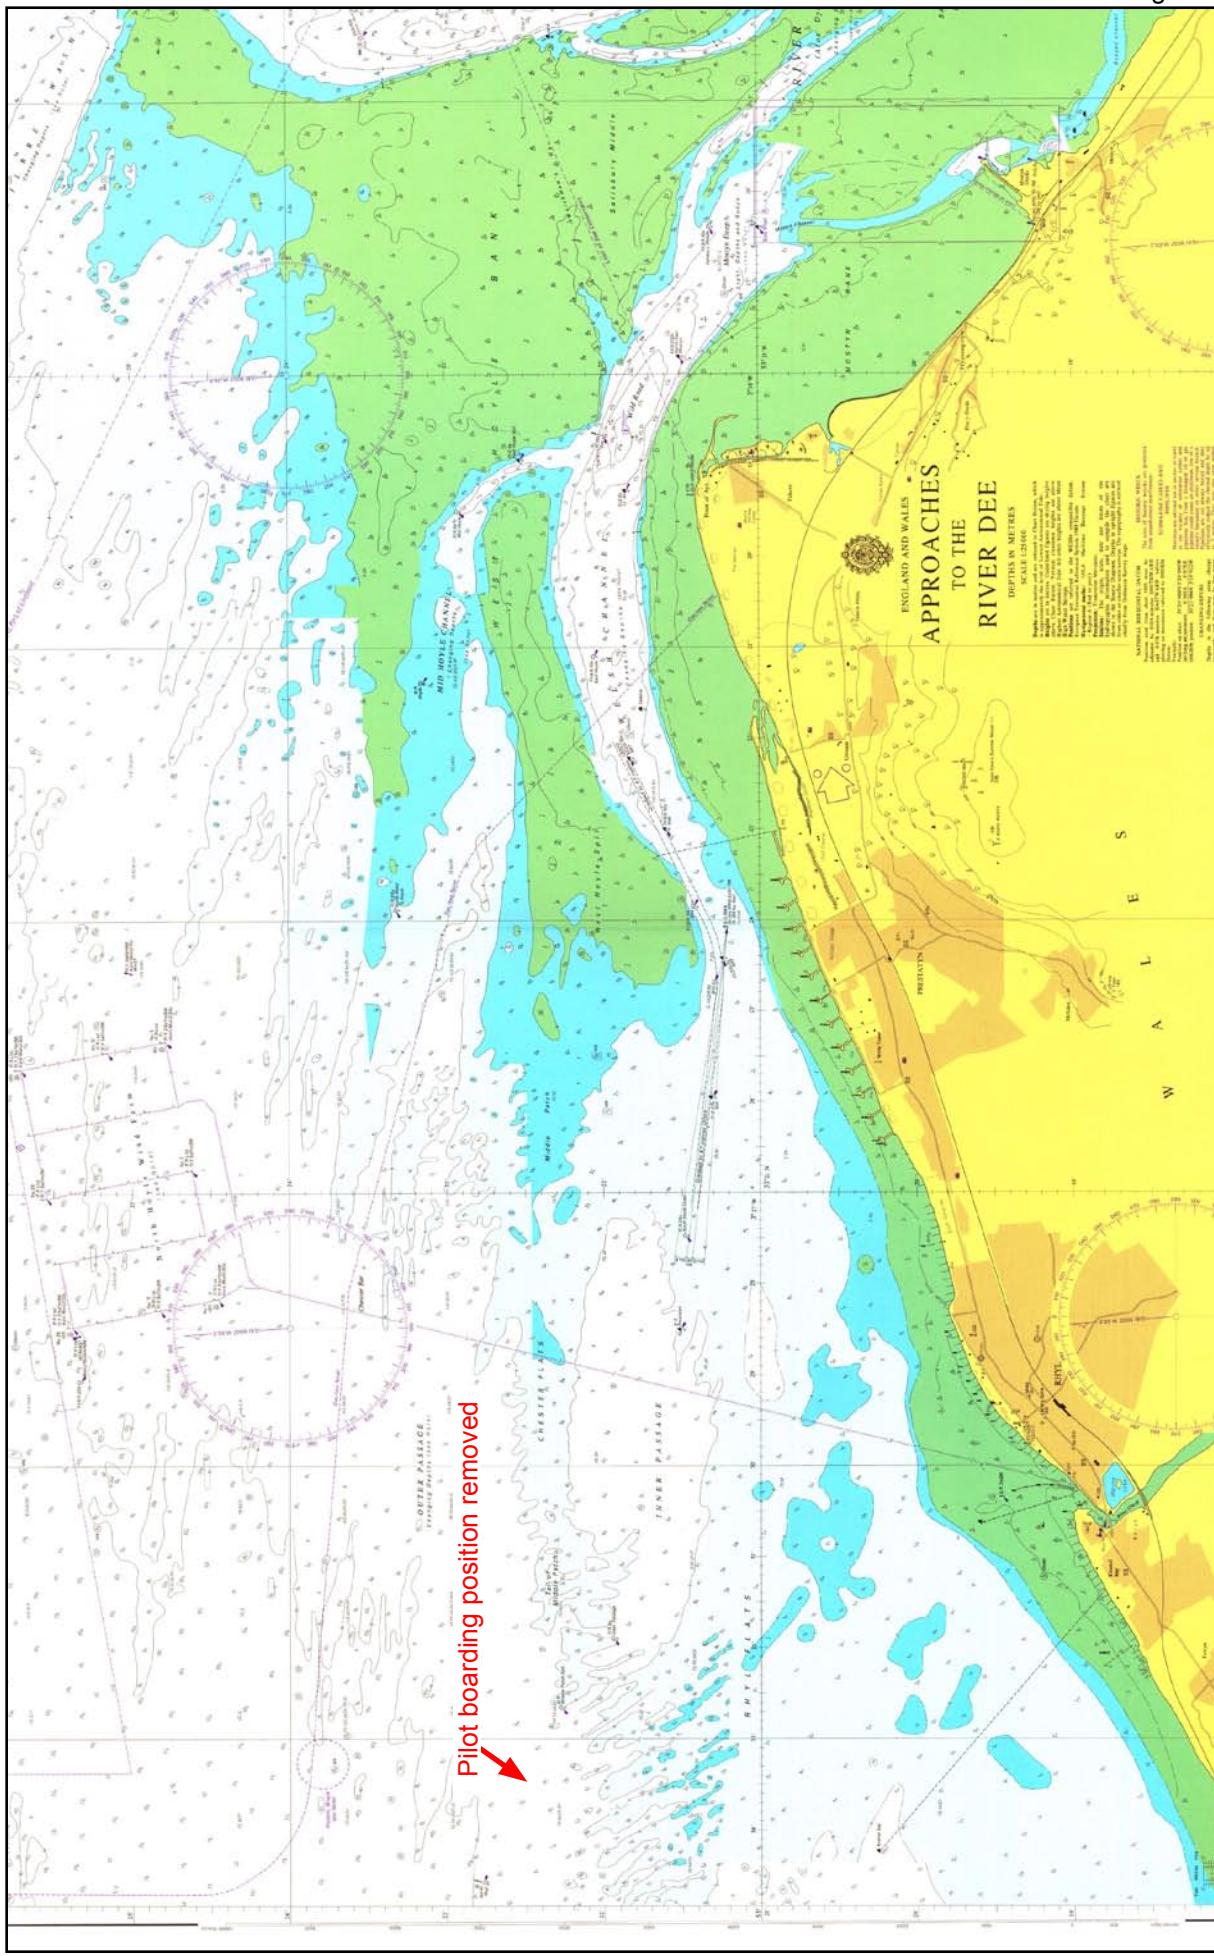
Figure 3

A new edition of BA chart 1953 – edition number 6 (**Figure 3**), was published by the UKHO on 11 May 2006. The chart provided large scale coverage of the Welsh Channel, Wild Road, Mostyn Deep, and a separate plan provided larger scale coverage of the Mostyn Channel up to and including Mostyn Docks. Due to the late change of orders, this chart was not available to *Thunder*'s master. Although the master had requested its provision from the Mostyn agent and the vessel's cargo operator, Echoship, the vessel's owner was unaware that the master was not in possession of BA chart 1953.

BA Chart 1953 Edition No 6

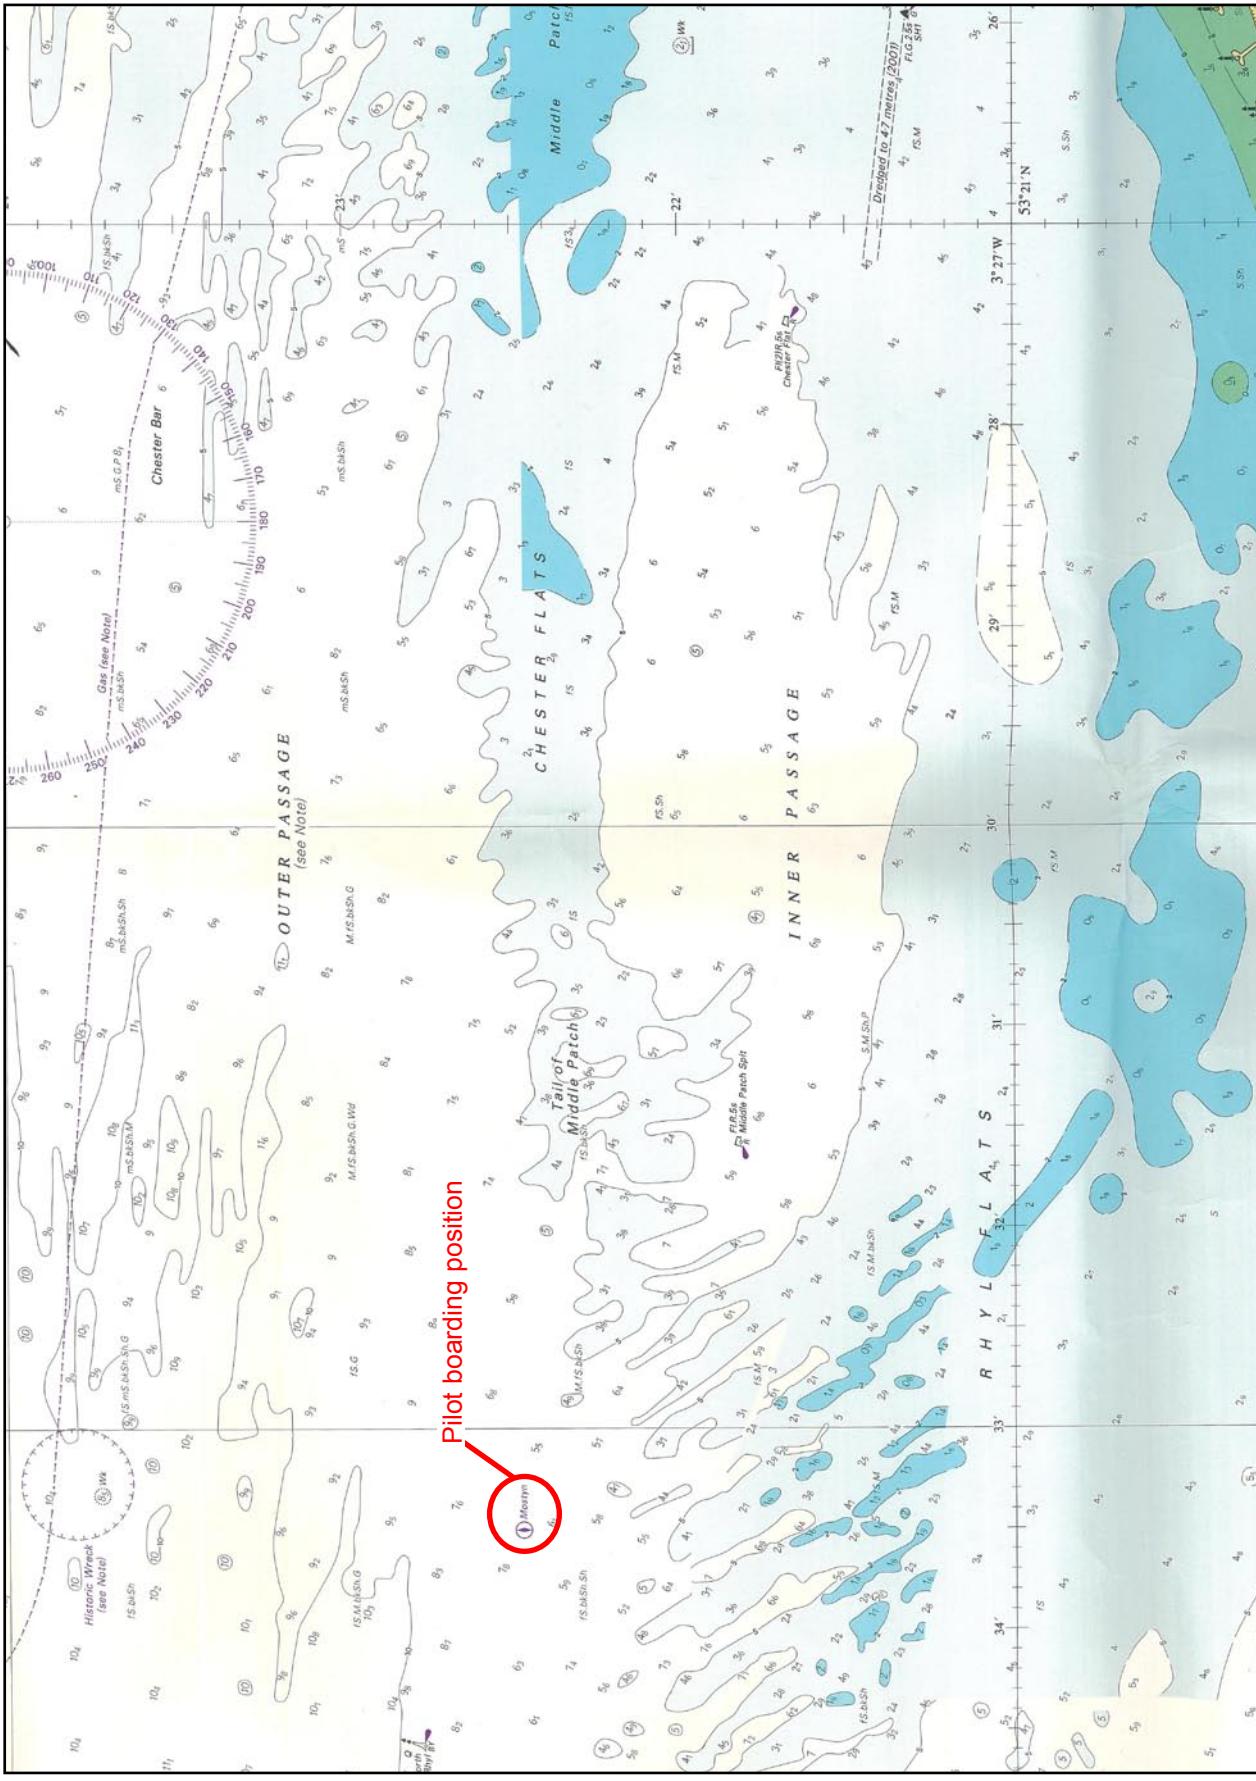
Figure 4

The previous edition of BA chart 1953 – edition number 5 (**Figure 4**), was published on 25 October 2001. This chart displayed pilot boarding points for Mostyn in the centre of the channel at Wild Road, and seven cables south east of the North Rhyl buoy. On edition 6, the pilot boarding position near the North Rhyl buoy had been removed, and two directional lights had been added: the West Hoyle Spit (Earwig) light beacon (perch pile)³, and a second light located ashore 4.5 cables southwest of Mostyn Docks. On edition 6, the recommended anchorage at Wild Road remained in the same position, while the recommended anchorage in the Mostyn Deep had been moved 4 cables west to the south side of the channel.

Extract of BA Chart 1953 Edition No 5

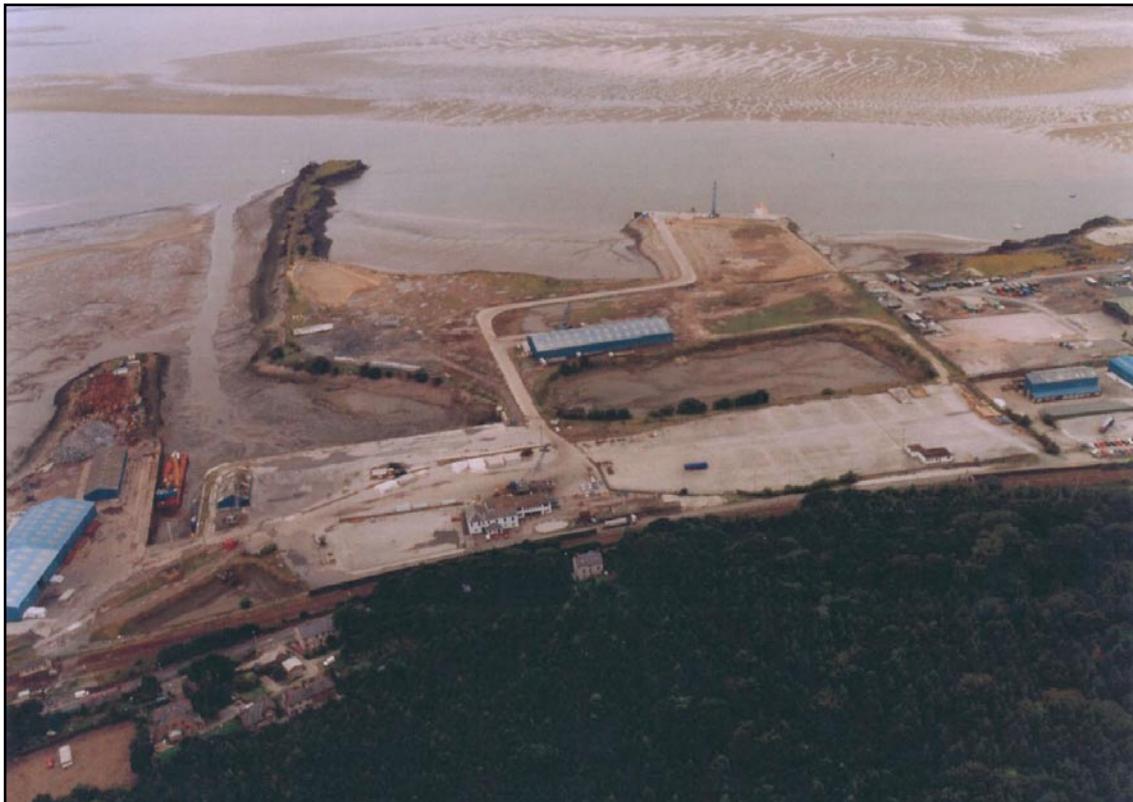
Figure 5a and b

The Port of Mostyn is privately owned and has, historically, been associated with the import and export of local steel products, ro-ro passenger ferry operations, offshore wind farm construction and maintenance, and underwater pipe-laying. It is tidally constrained, and has required significant dredging of the inner channel to allow access for larger vessels (**Figures 5a and 5b**).

Port of Mostyn during redevelopment C1998

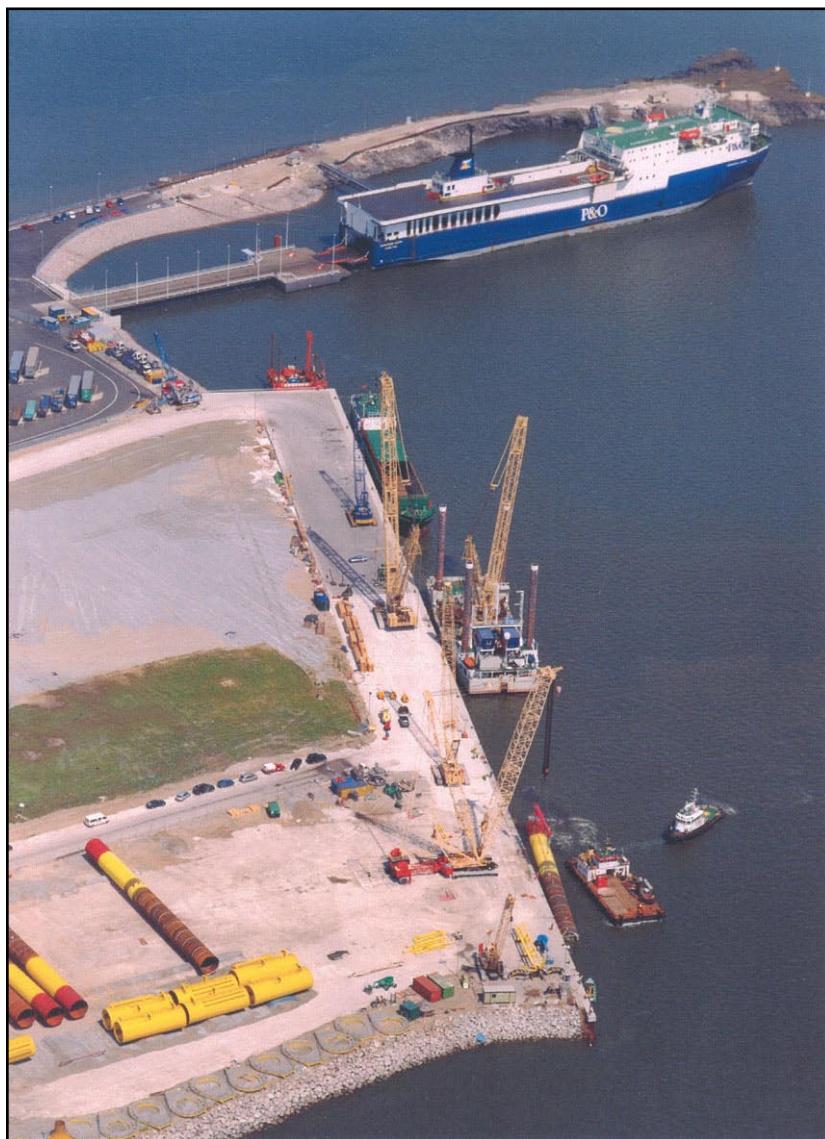
Port of Mostyn post redevelopment

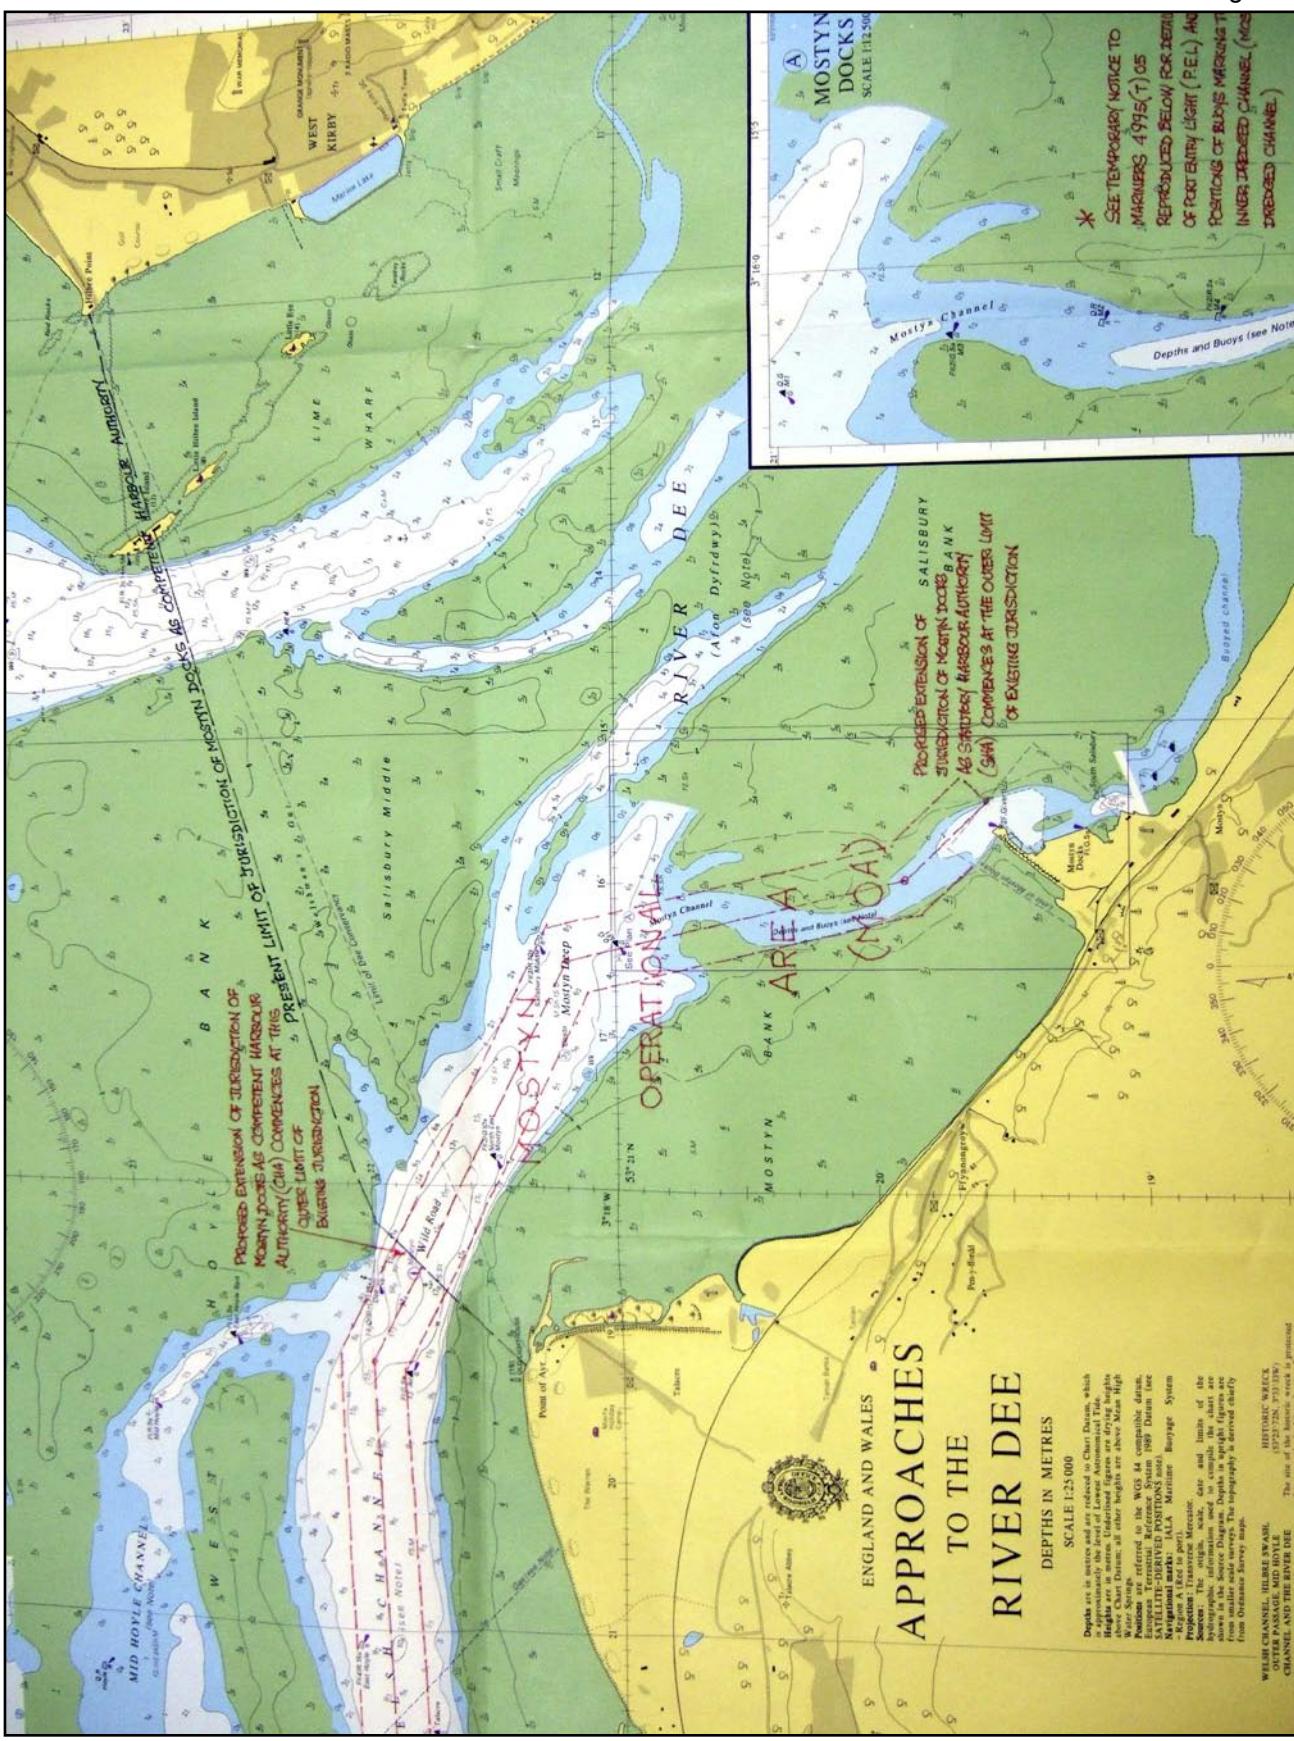
Figure 6

For a vessel to enter the Port of Mostyn, it must pass through the SHA of the Dee Conservancy before it can enter the smaller SHA of Mostyn. The area of the Dee Conservancy that the vessel must pass is the Mostyn Deep and the Mostyn Channel. This area is known as the Mostyn Operational Area (MOA) (**Figure 6**), and it is the subject of a specific agreement between the Dee Conservancy and the Port of Mostyn. However, Mostyn is the CHA for pilotage in the whole of the Dee estuary⁴, as defined by The Mostyn Docks (Pilotage) Harbour Revision Order 1989.

Chart showing the Mostyn Operational Area and the present limits of jurisdiction as the competent harbour authority
