Report on the investigation of  
the capsized and foundering of

**fv *PAMELA S*, IH 308**

in Carmarthen Bay

**Report No 32/2006  
December 2006**

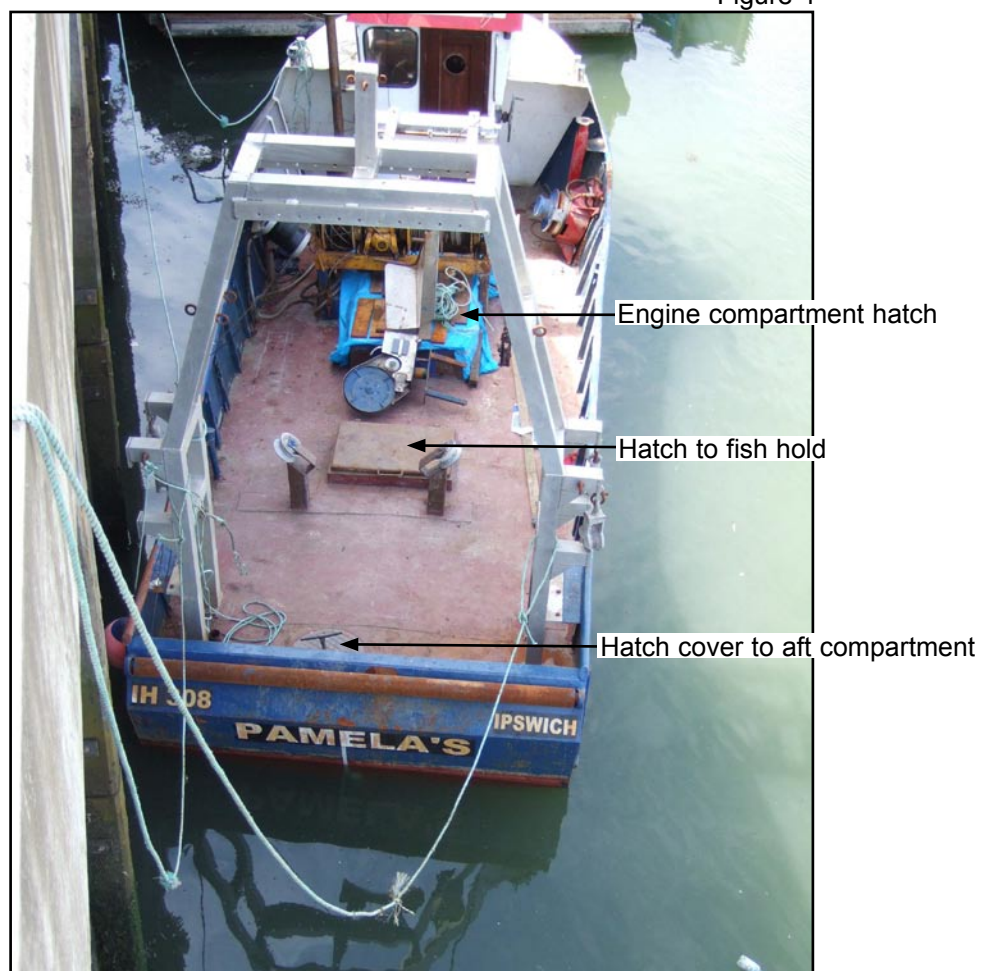
Figure 4

*Pamela S* shown in light condition (with no gear) following inclining trial

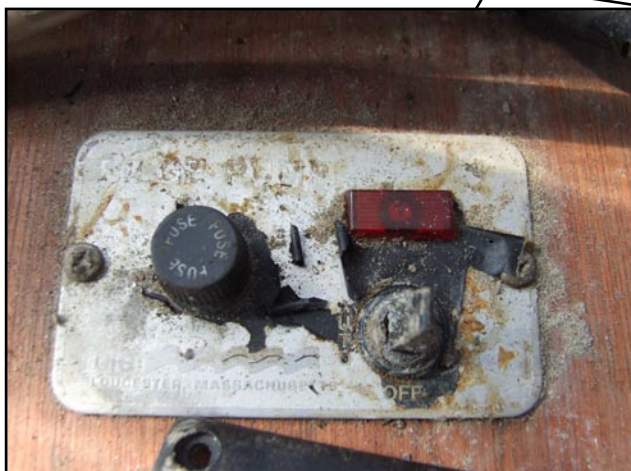
Engine compartment bilge pump switch

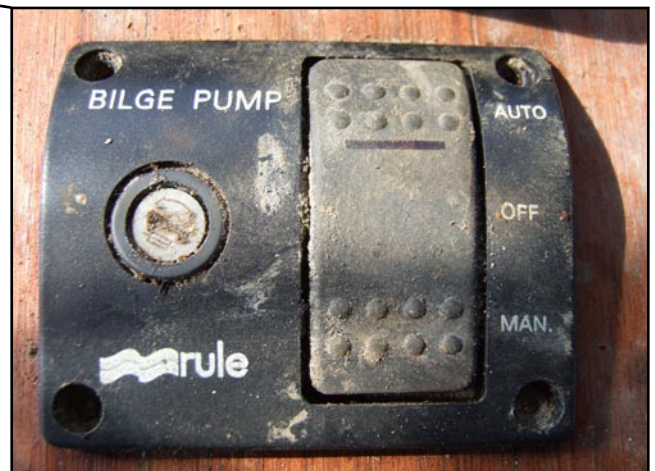
Fish hold and aft compartment bilge switch type

The three bilge pumps discharged via individual 18mm diameter plastic reinforced hoses, which were connected to separate 12mm overboard discharges located in the forward starboard side of the engine compartment approximately 100mm above the waterline.

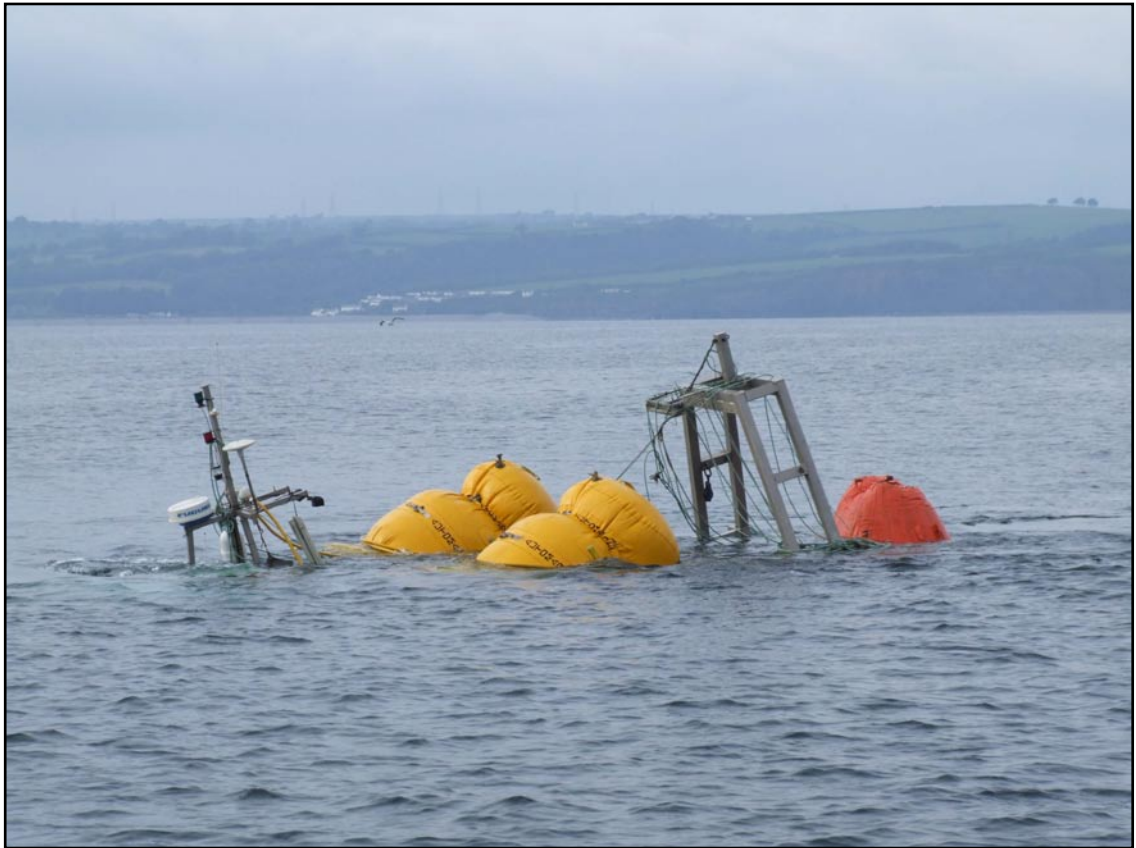
Figure 7

The vessel's insurers agreed to salvage *Pamela S*, and she was raised at 1248 on 27 June 2006 (**Figure 7**) and was subsequently towed into Tenby harbour at 2025 that day. The salvage divers made a report of their observations during the operation (**Annex 2**), which identified the location of various items of equipment on and around the wreck before it was raised.

*Pamela S* - raised from seabed on 27 June 2006

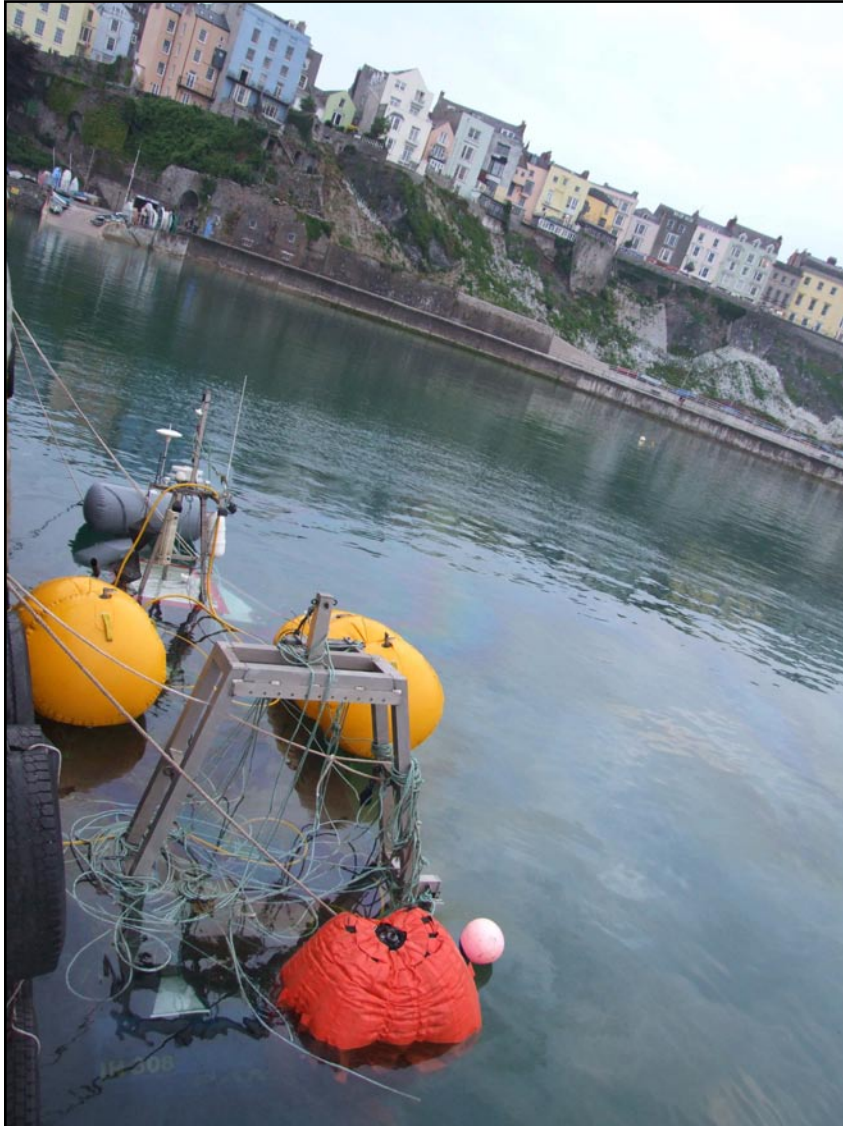
Figure 8

MAIB inspectors were in attendance throughout the salvage operation, and undertook an inspection of the vessel at low water in the early hours of 28 June, as the vessel dried out alongside the harbour wall at Tenby (**Figure 8**).

MAIB inspectors, in conjunction with the MCA, confirmed at this inspection that the vessel's hull was intact and watertight, and once the vessel's compartments had been pumped out, arrangements were made to have her towed to Burry Port, Carmarthenshire, for lifting out of the water.

*Pamela S* alongside at Tenby
