*Star Princess* – Safety Centre

Observations from Warsash reconstruction

## Phase Three – Review of reconstruction

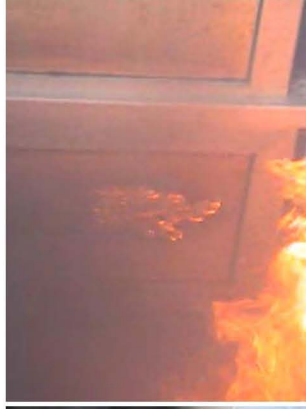
T+ 11.5 min

The data from the ignition trials showed that sustained ignition was observed in only one case, that of the testing of the lighter weight green towelling. In all scenarios involving both the green and blue and white striped towelling, glowing combustion of the towelling was observed.
