Report on the investigation of

Red Falcon's

contact with the linkspan at

Town Quay, Southampton

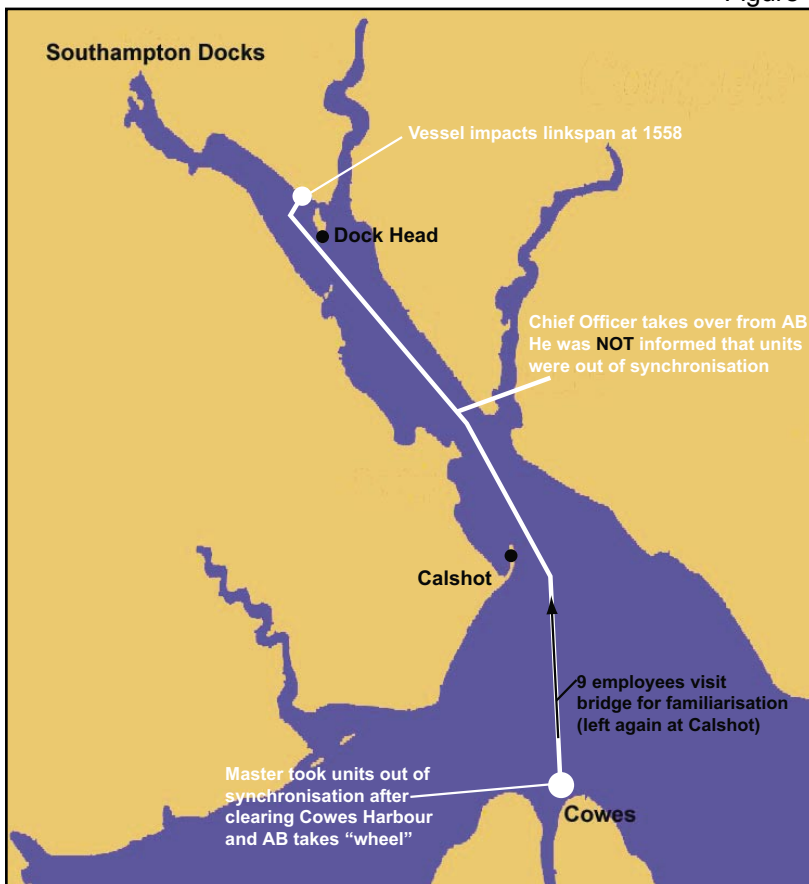
Figure 3

At 1530, *Red Falcon* reached the mid point of the passage as the vessel entered Southampton Water and, with 30 minutes of the voyage to run (**Figure 3**), the chief officer returned to the bridge and took over the steering from the AB. The AB advised him that the vessel was taking slightly more wheel than usual and then went below, leaving the chief officer and master on the bridge.

Chart of route - Cowes to Southampton 10th March 2006

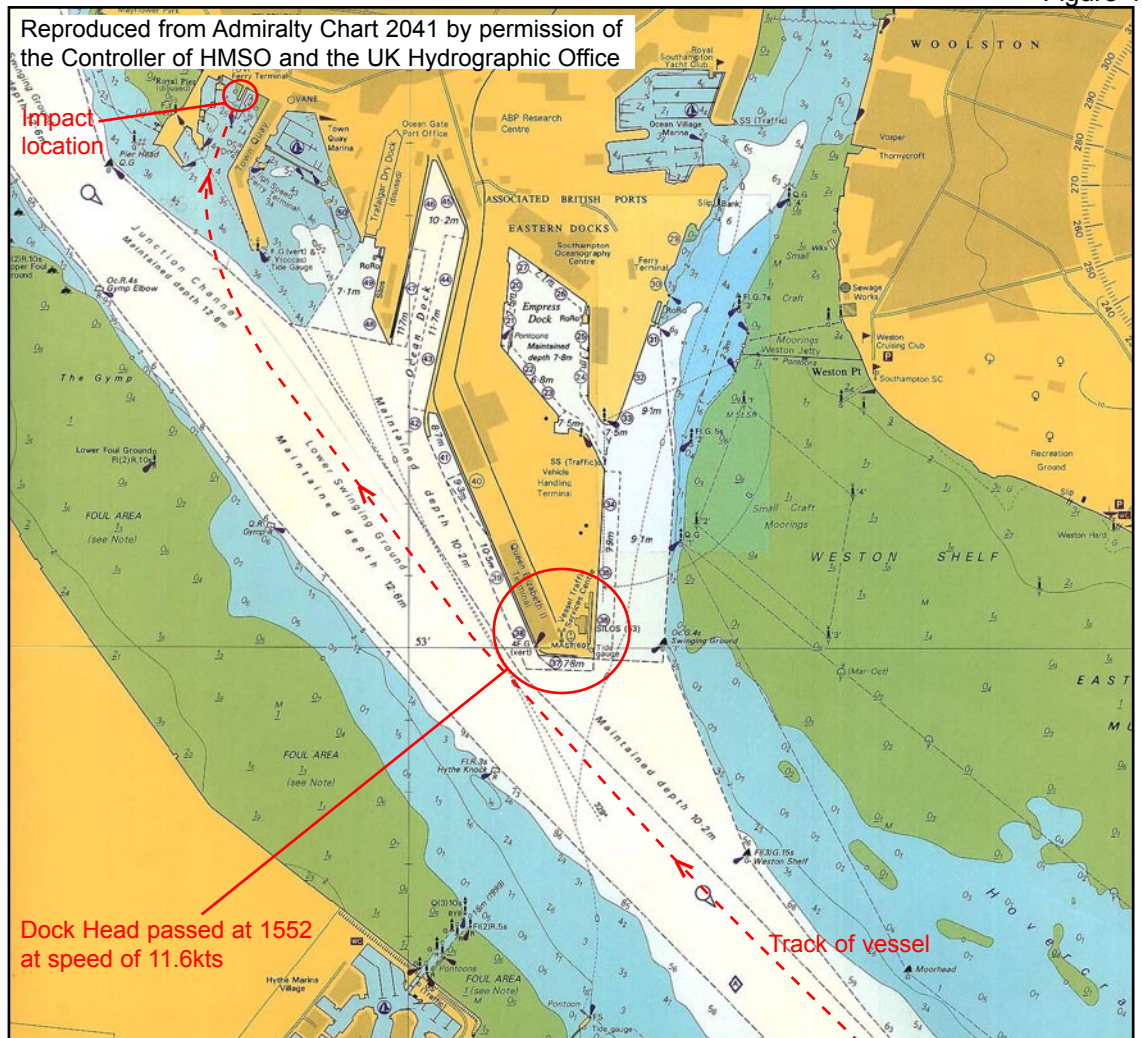
Figure 4

Red Falcon passed Dock Head at 1552 (**Figure 4**), at a speed of 11.6 knots; the chief officer, who was at the centre control console, started to reduce speed as the vessel approached the eastern end of Town Quay. As the chief officer had the conduct of the vessel, the master assumed a support role and took on the radio and lookout duties.

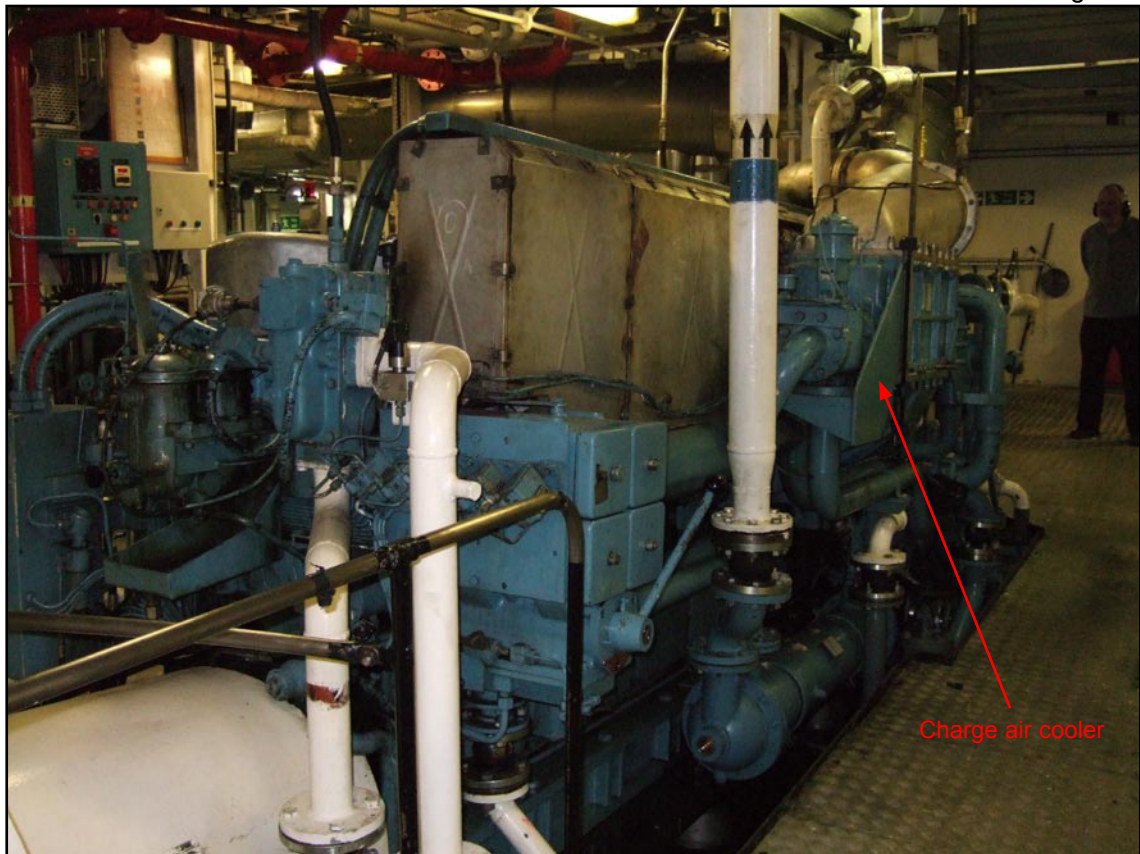
Figure 7

Red Falcon was fitted with two Stork-Wartsila FHD240G, turbo charged and intercooled, eight cylinder diesel engines (**Figure 7**), which provided propulsion power only, via propeller shafts to the Voith Schneider units. Electrical power generation on board was provided by three auxiliary diesel engines.

Aft main engine

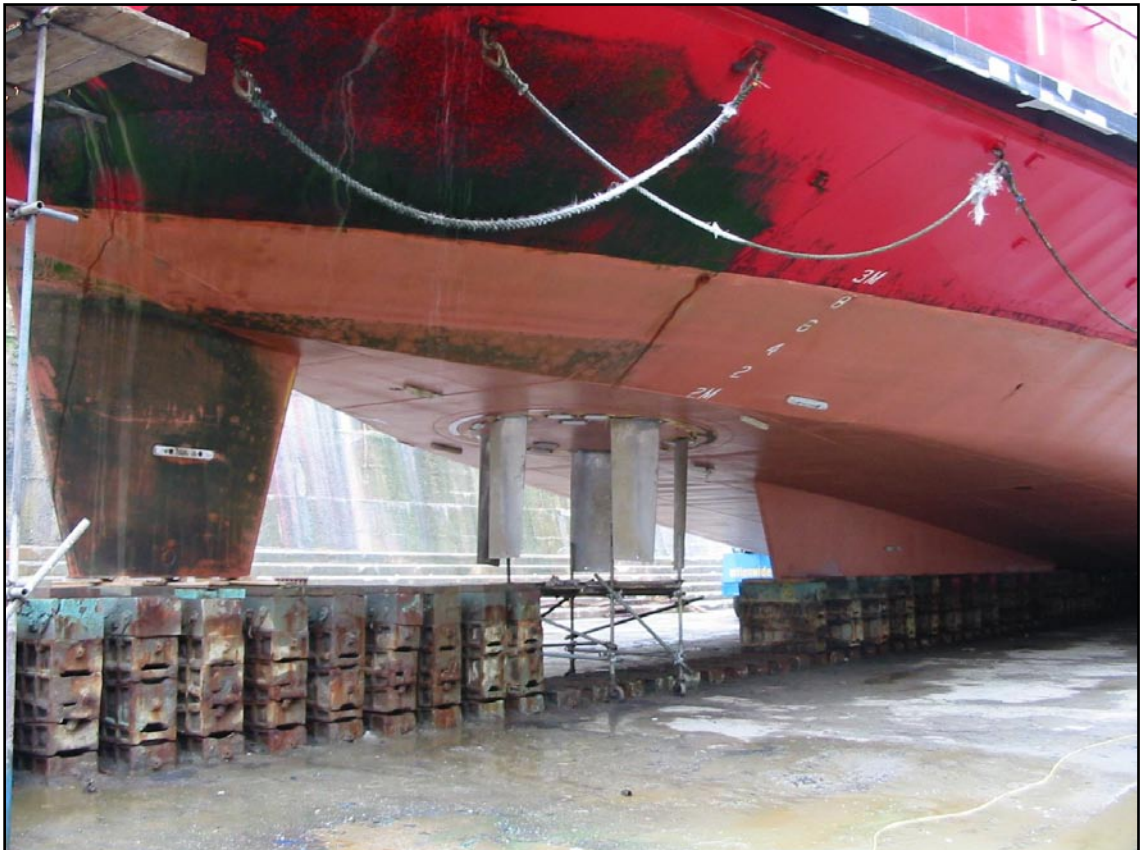
Figure 9

Voith Schneider propulsion unit
