Report on the investigation of
the grounding of
mv Kathrin
Goodwin Sands
Dover Strait
12 February 2006

Marine Accident Investigation Branch
Carlton House
Carlton Place
Southampton
United Kingdom
SO15 2DZ

Report No 24/2006
September 2006

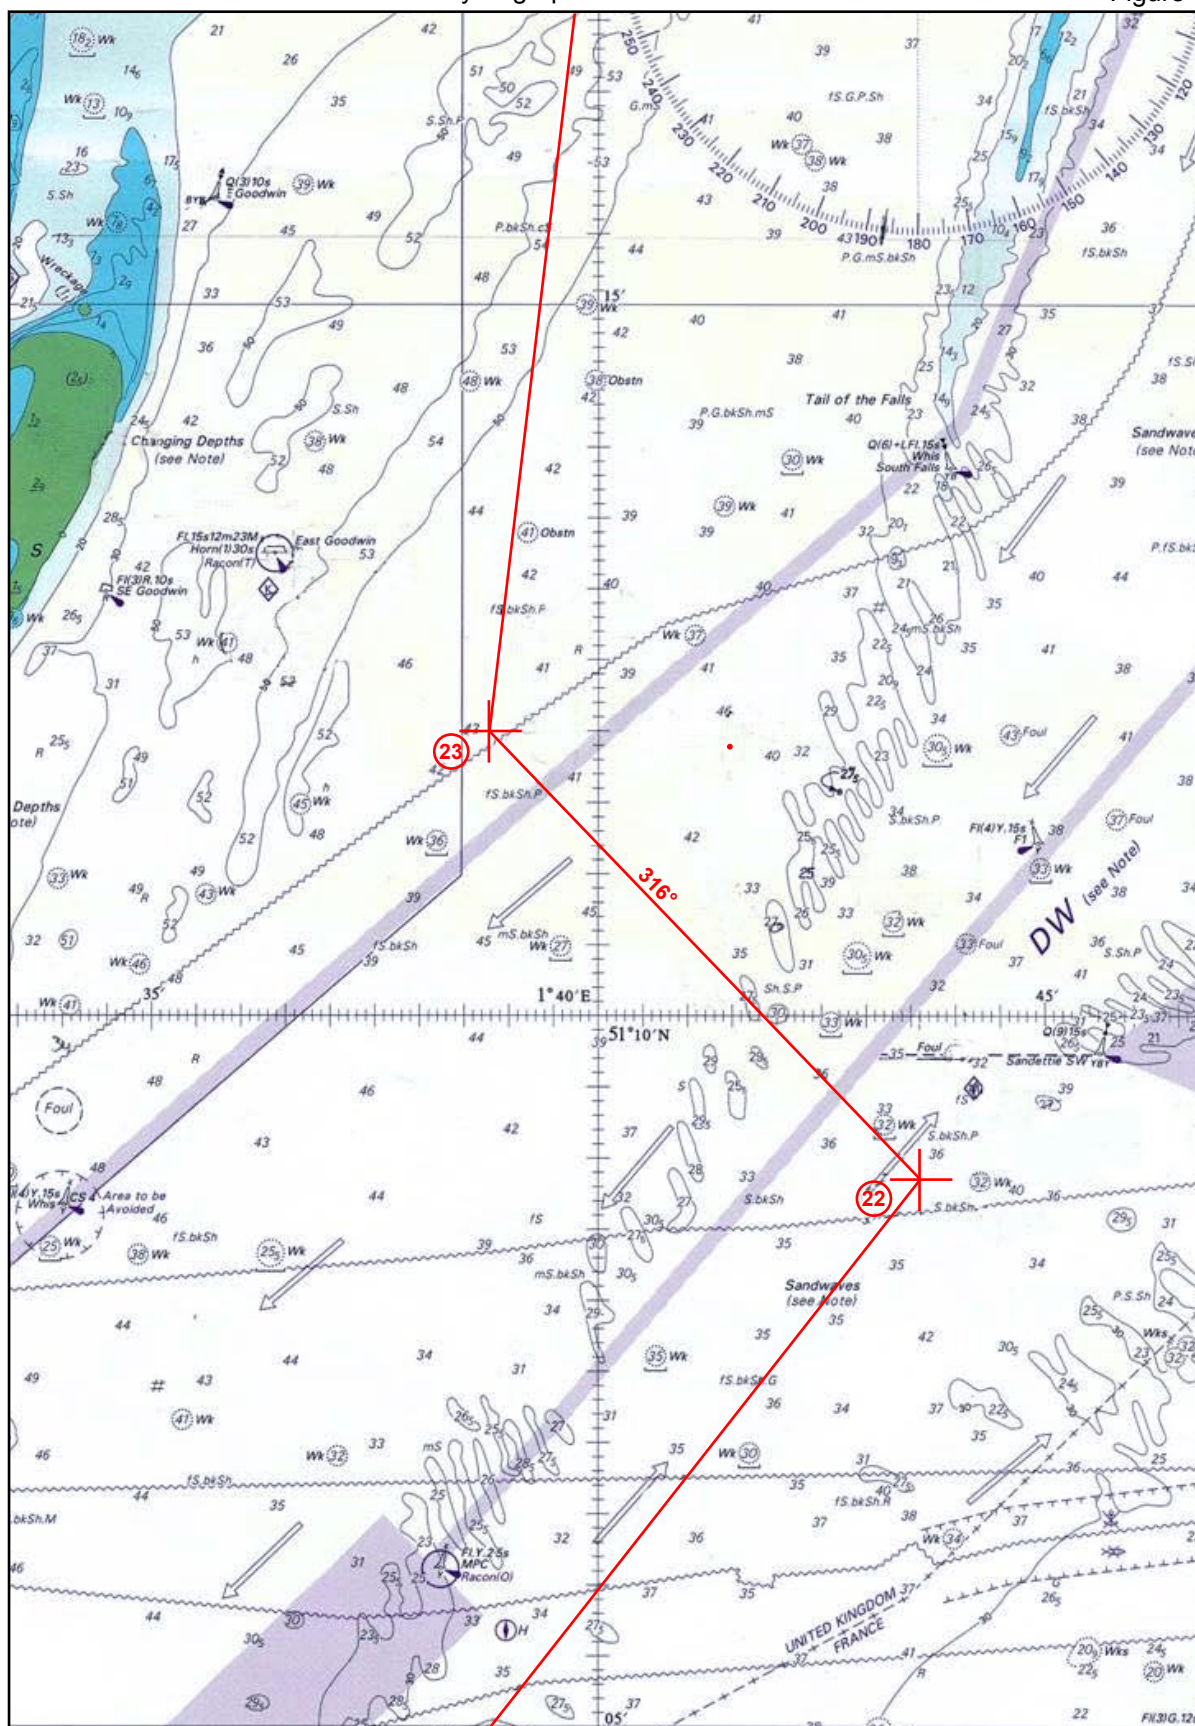
During the visit of MAIB inspectors to *Kathrin* in New Holland, there was no visible damage to the ship, but a red paint streak approximately 2m in length was evident on the vessel's port bow (**Figure 2**). The East Goodwin Lightship (**Figure 3**) was checked by Trinity House, but no damage was evident. *Kathrin* was allowed to sail from New Holland for passage to Warrenpoint, Northern Ireland, after a relief master had joined the vessel, and a condition of Class had been imposed by Lloyd's Register requiring that the underwater portions of the vessel be examined by the end of March 2006.

Figure 12 shows that *Kathrin* passed very close to the East Goodwin Lightship (**Figure 3**), which was painted red. However, although **Figure 2** indicates that the vessel had been in contact with a red object, and there was a deflection in her course made good as she passed the lightship, it cannot be certain that *Kathrin* made contact as no damage could be found during a subsequent inspection of the lightship.

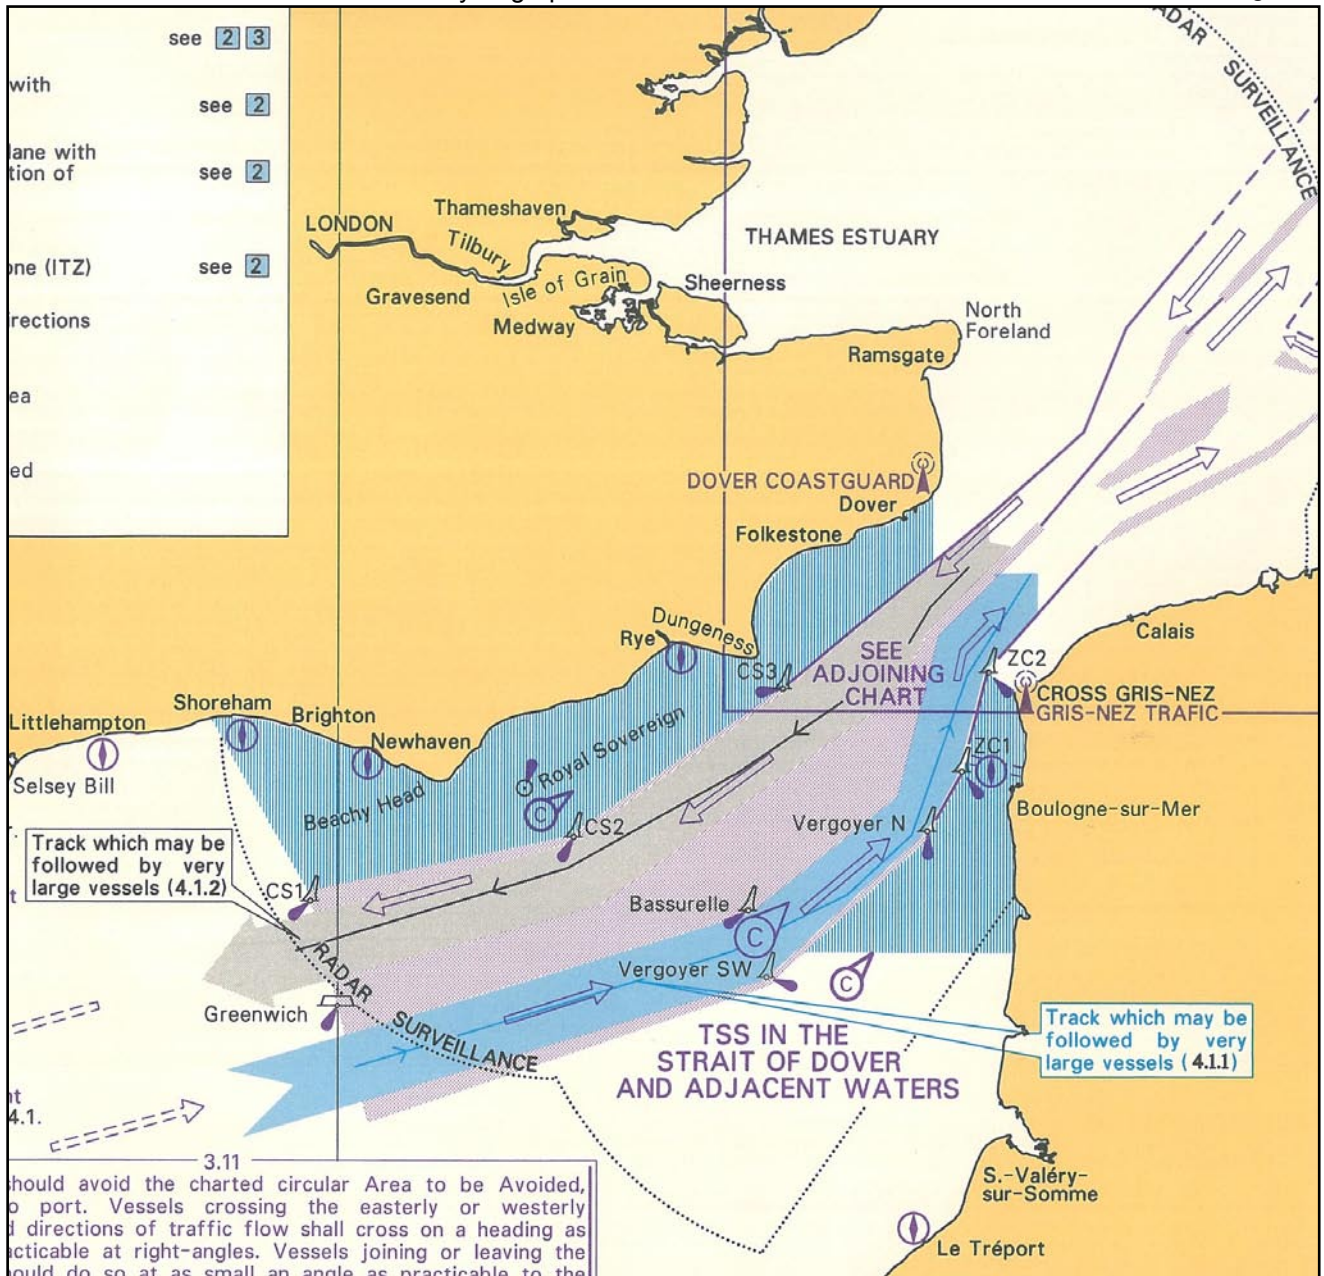
Figure 4

The functions of CNIS are to keep the Dover Strait TSS under observation, to monitor the flow of traffic and to detect and report vessels which contravene the International Regulations for Preventing Collisions at Sea 1972, as amended (COLREGS). A diagram showing the Dover Strait TSS and the limits of CNIS radar coverage is at **Figure 4**.

CNIS - area of coverage

Although the radar recordings show that the grounding occurred within the radar coverage of CNIS, it is likely that the grounding was not detected because the ship was aground for only 15 minutes. Also, because the ship was not entering an inshore traffic zone after she cleared the south west traffic lane at 2212, *Kathrin* was no longer in CNIS' main area of interest (**Figure 4**).

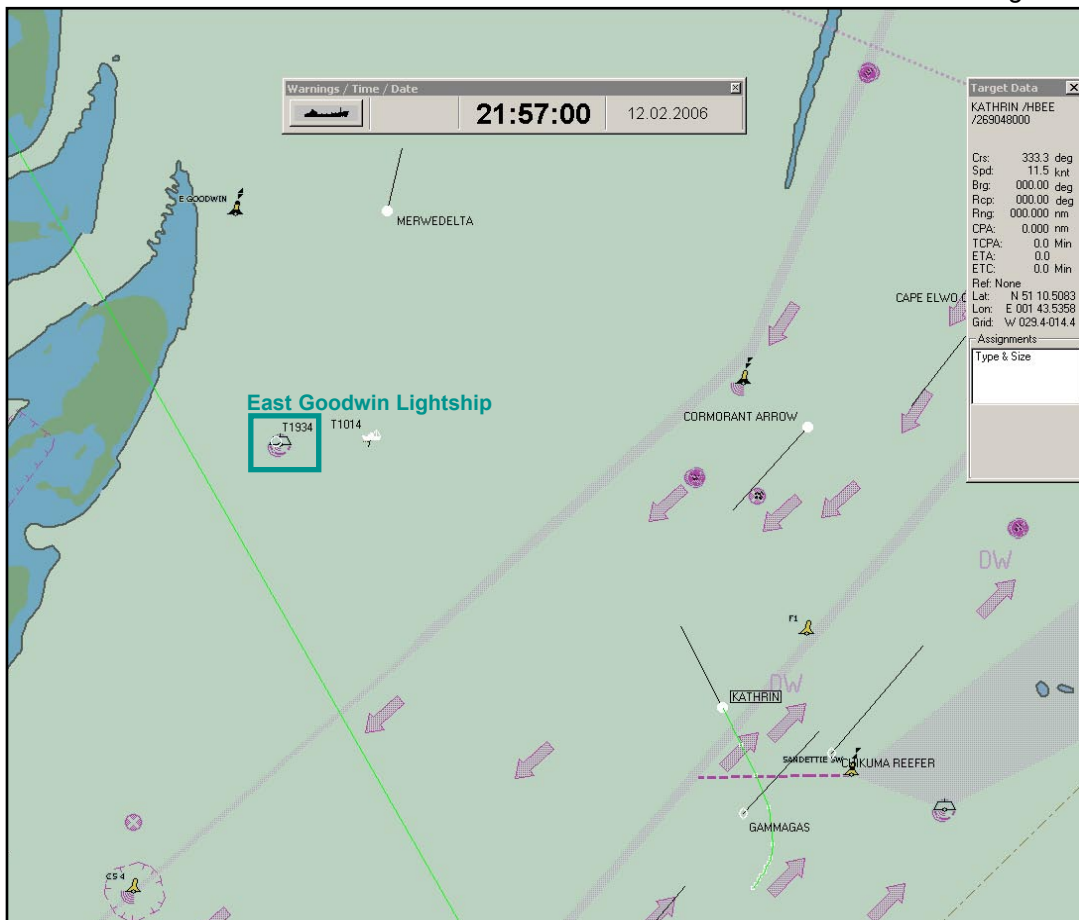
Figure 5

CNIS radar plot 2157:00

Figures 5 to 15 show that the course made good on board *Kathrin* gradually altered from 333° at 2157 (**Figure 5**) to 291° by 2214 (**Figure 11**). They also show that the vessel passed ahead of two vessels, the closest CPA of which was 6 cables on *Cormorant Arrow* (**Figure 8**). Given the slack tidal stream, the gradual change in the ground track is not consistent with the master setting a single course on the autopilot. Course must have been adjusted either via the course set, or by manual steering. As the master also assessed that the closest CPA of any south west bound vessel was 1.5 miles, the accuracy of the master's recollections during this period is questionable.

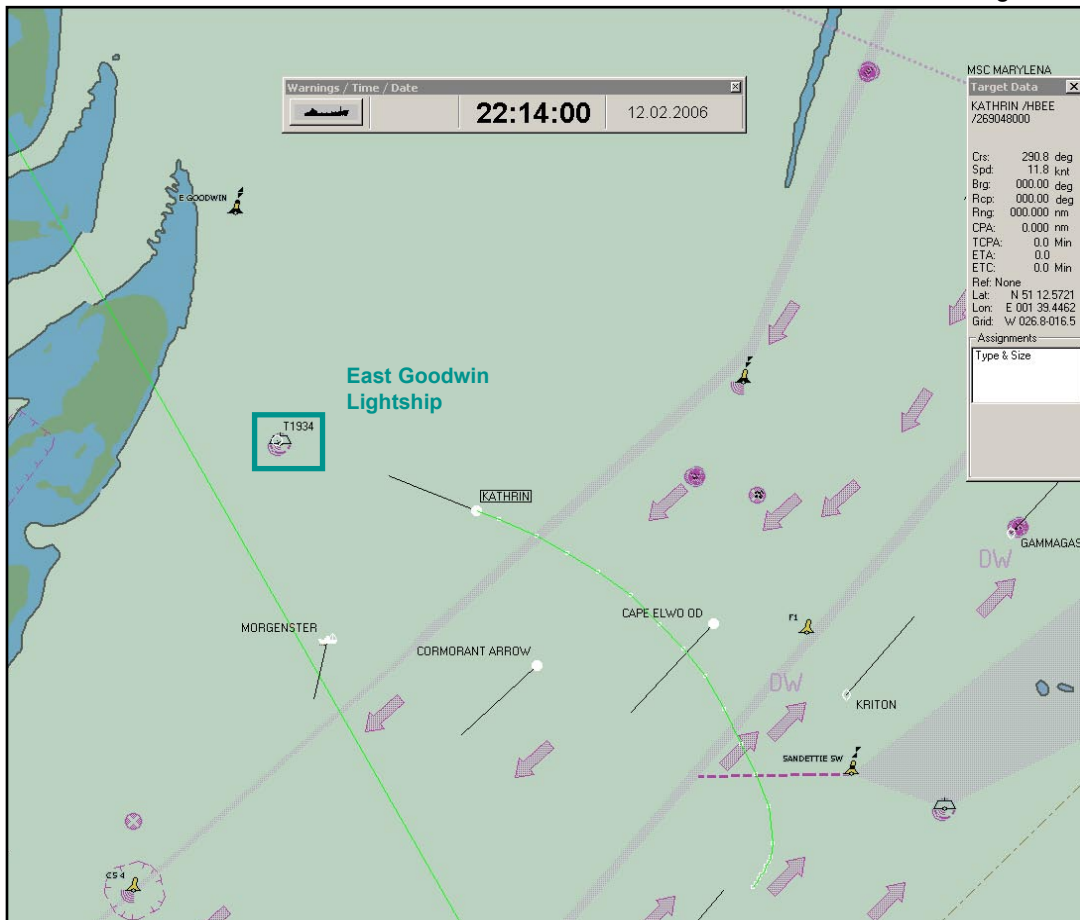
Figure 12

CNIS radar plot 2214:00

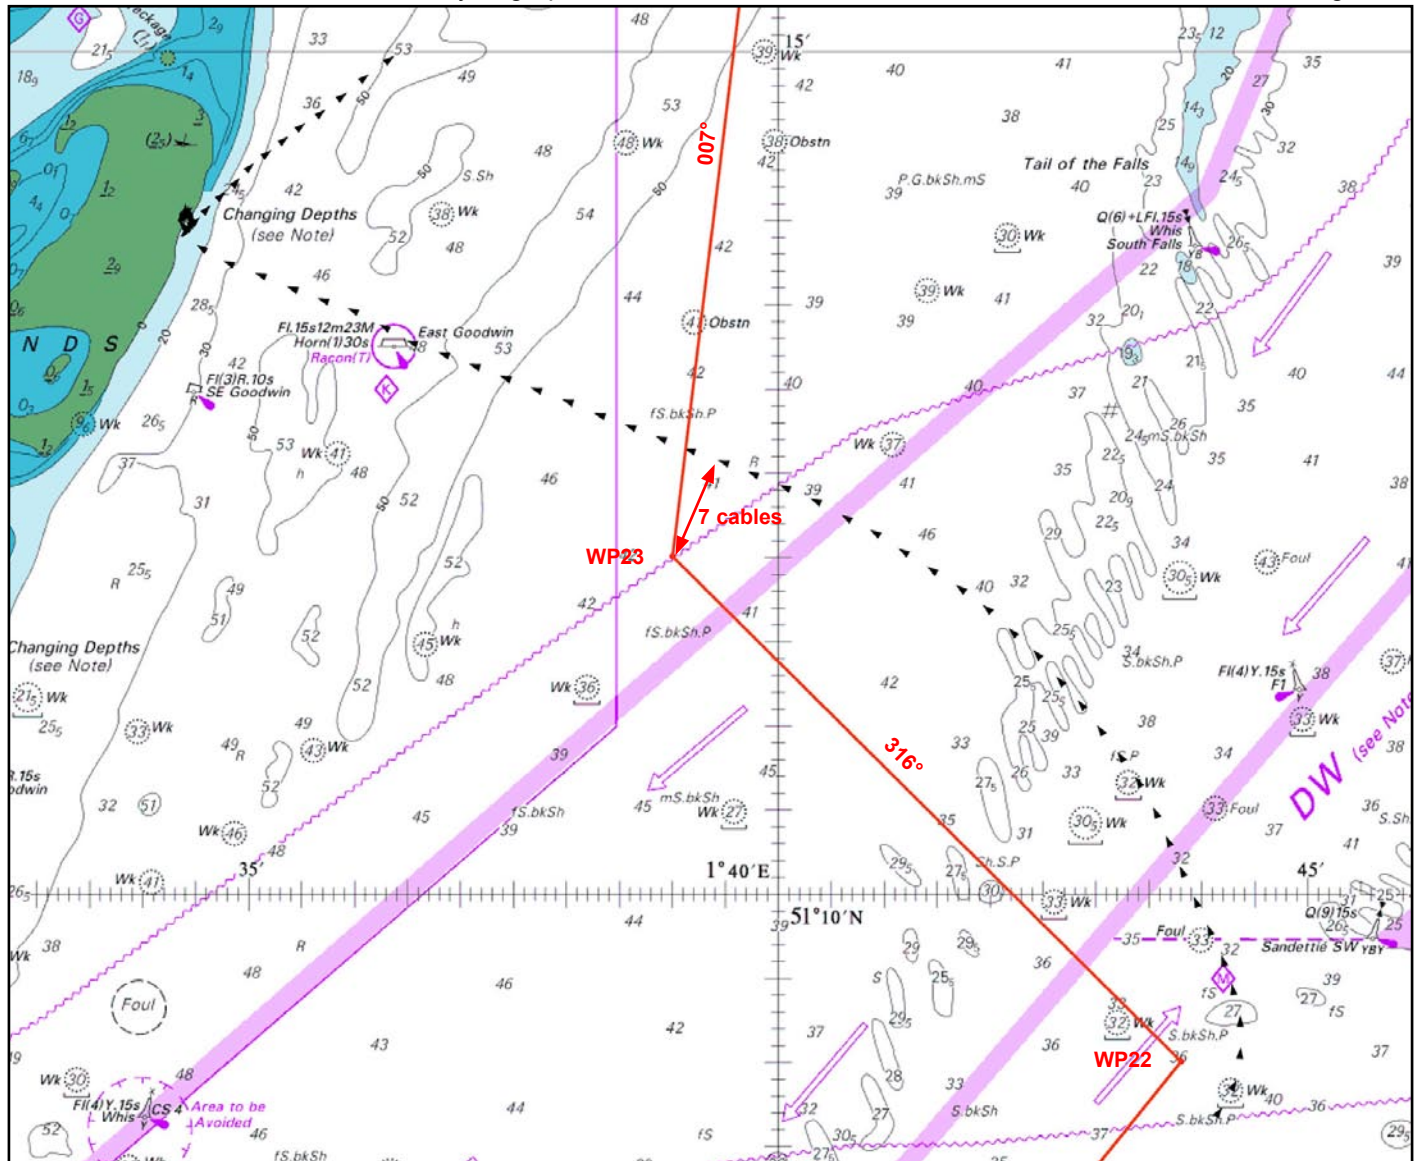
During her passage through the Dover Strait TSS, *Kathrin* was automatically tracked by radar and AIS. This information was recorded, and extracts covering the period between 2147 and 2232 are at **Figures 5 to 14**. A reconstruction of the vessel's radar ground track plotted against her intended track is at **Figure 15**. Close examination of the radar information shows that there was a slight deflection in *Kathrin's* course made good, as she passed the East Goodwin Lightship. CNIS Dover was not aware that the vessel had grounded until informed by the ship manager during the morning of 13 February 2006.

Extract of Chart BA 323 showing ground track
