Report on the investigation of
the loss of cargo containers overboard from

P&O Nedlloyd Genoa

North Atlantic Ocean

Report No 20/2006
August 2006

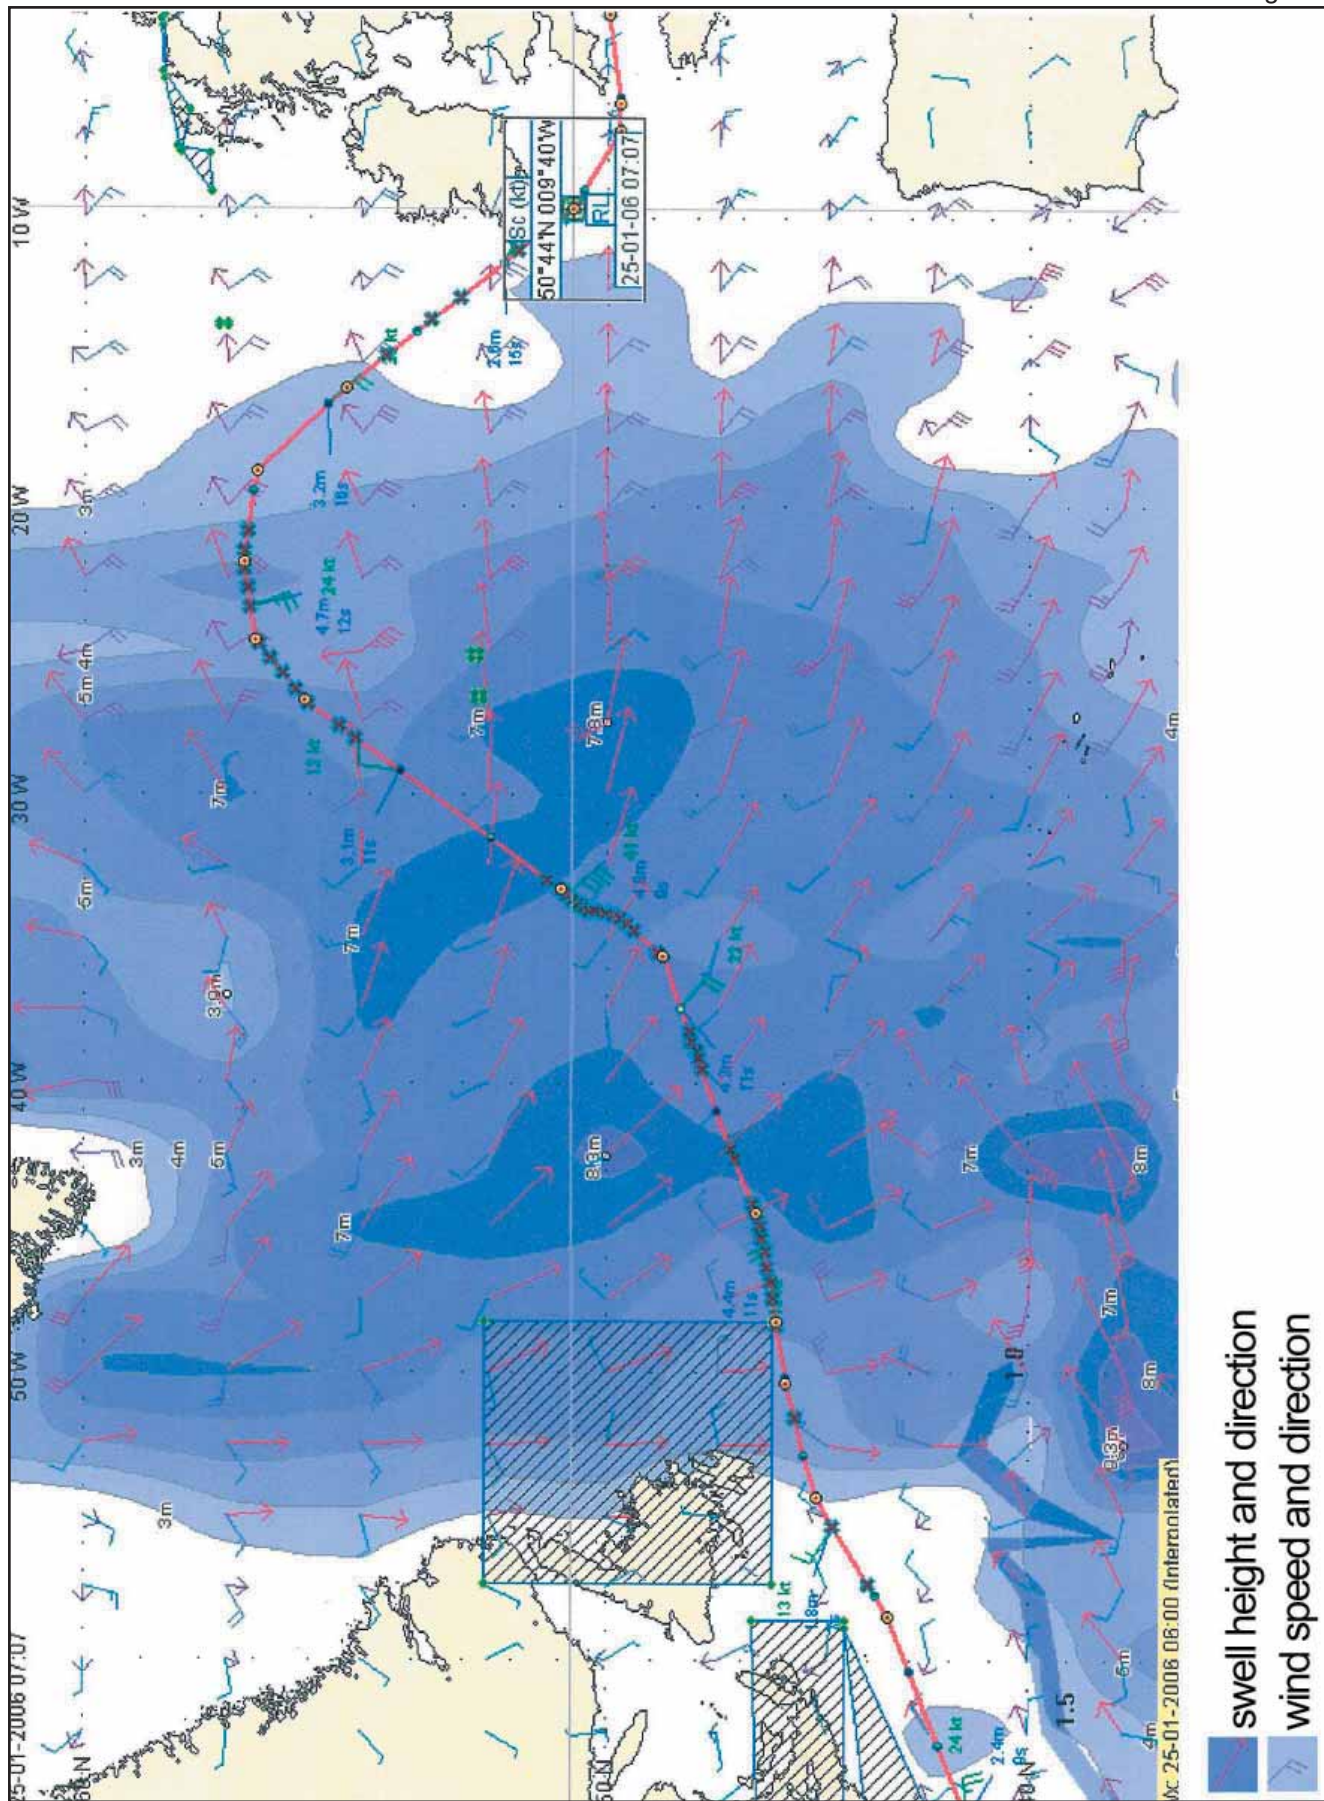
Figure 5

In making the decision whether to take the northern most great circle route or a southerly rhumb line route via the Azores, the master's principal concern was the direction of the prevailing swell. He interpreted that the forecast indicated a predominance of westerly (head-on) swell on the southerly rhumb line route, potentially with wave heights in excess of 9 metres (**Figure 5**).

25 January 2006 - 0707 weather download (wind and swell)

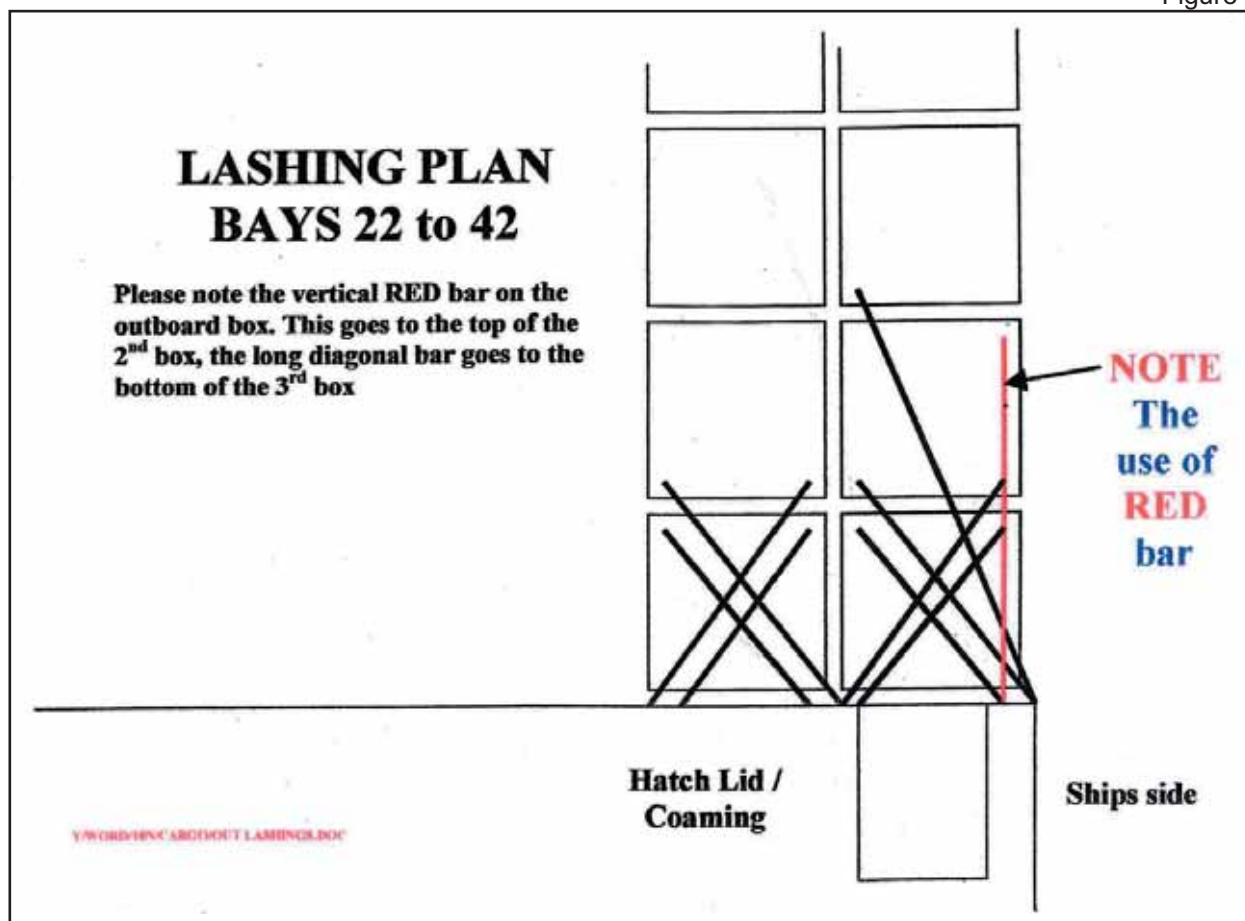
Figure 9

Clear, unambiguous diagrams (**Figure 9**) were posted along the port and starboard walkways, adjacent to the bays, to assist both the ship's crew and the shore stevedores identify the correct lashing configuration.

Lashing diagram displayed adjacent to relevant bays

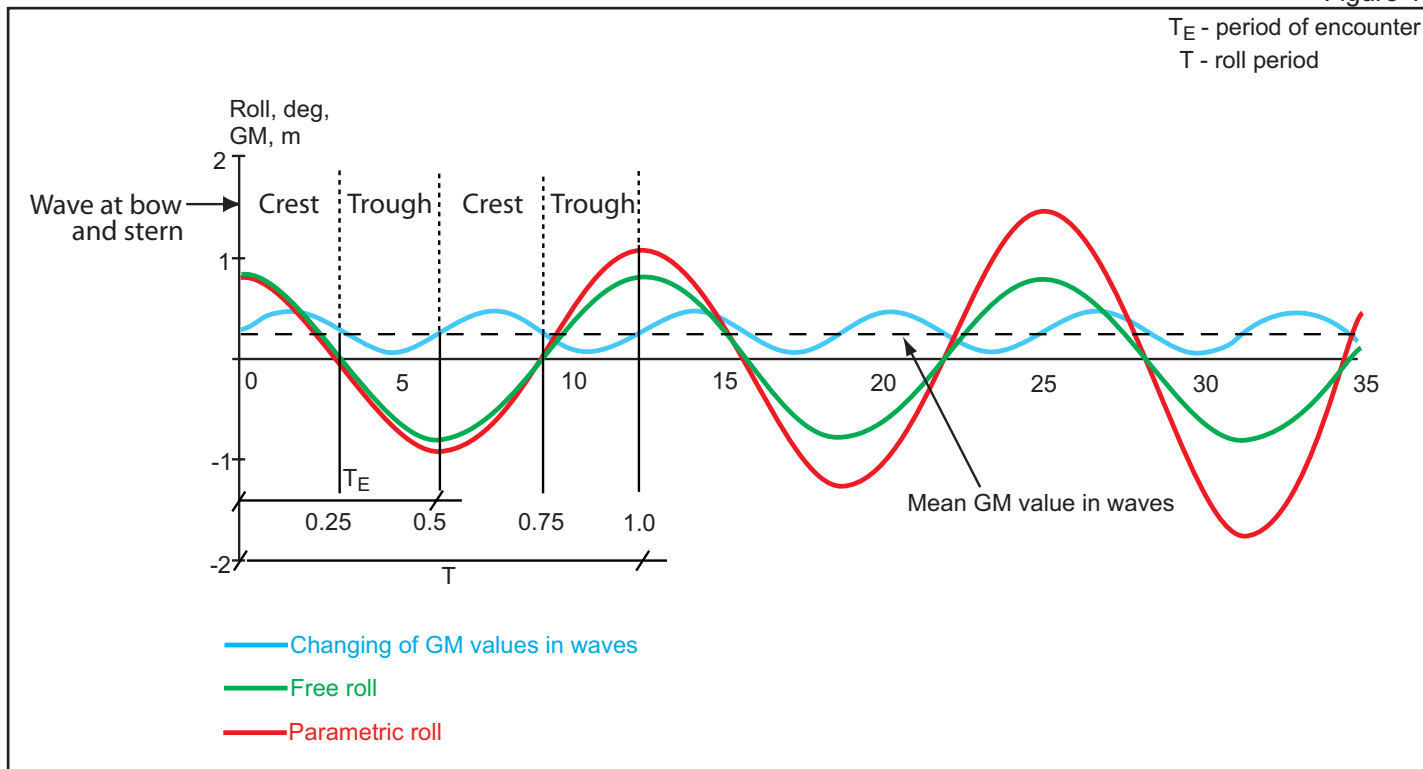
If the encountered wave period is half the ship's natural roll period, a resonant roll motion occurs as the varying GM provides impetus to the rolling action at both extremes of the motion. In these conditions, angles of roll of over 30° can develop within four or five roll cycles.

Development of parametric roll
