Report on the investigation of the grounding of the vessel

CP Valour

in Baia da Praia do Norte, Faial, Azores

**Report No 22/2006
August 2006**

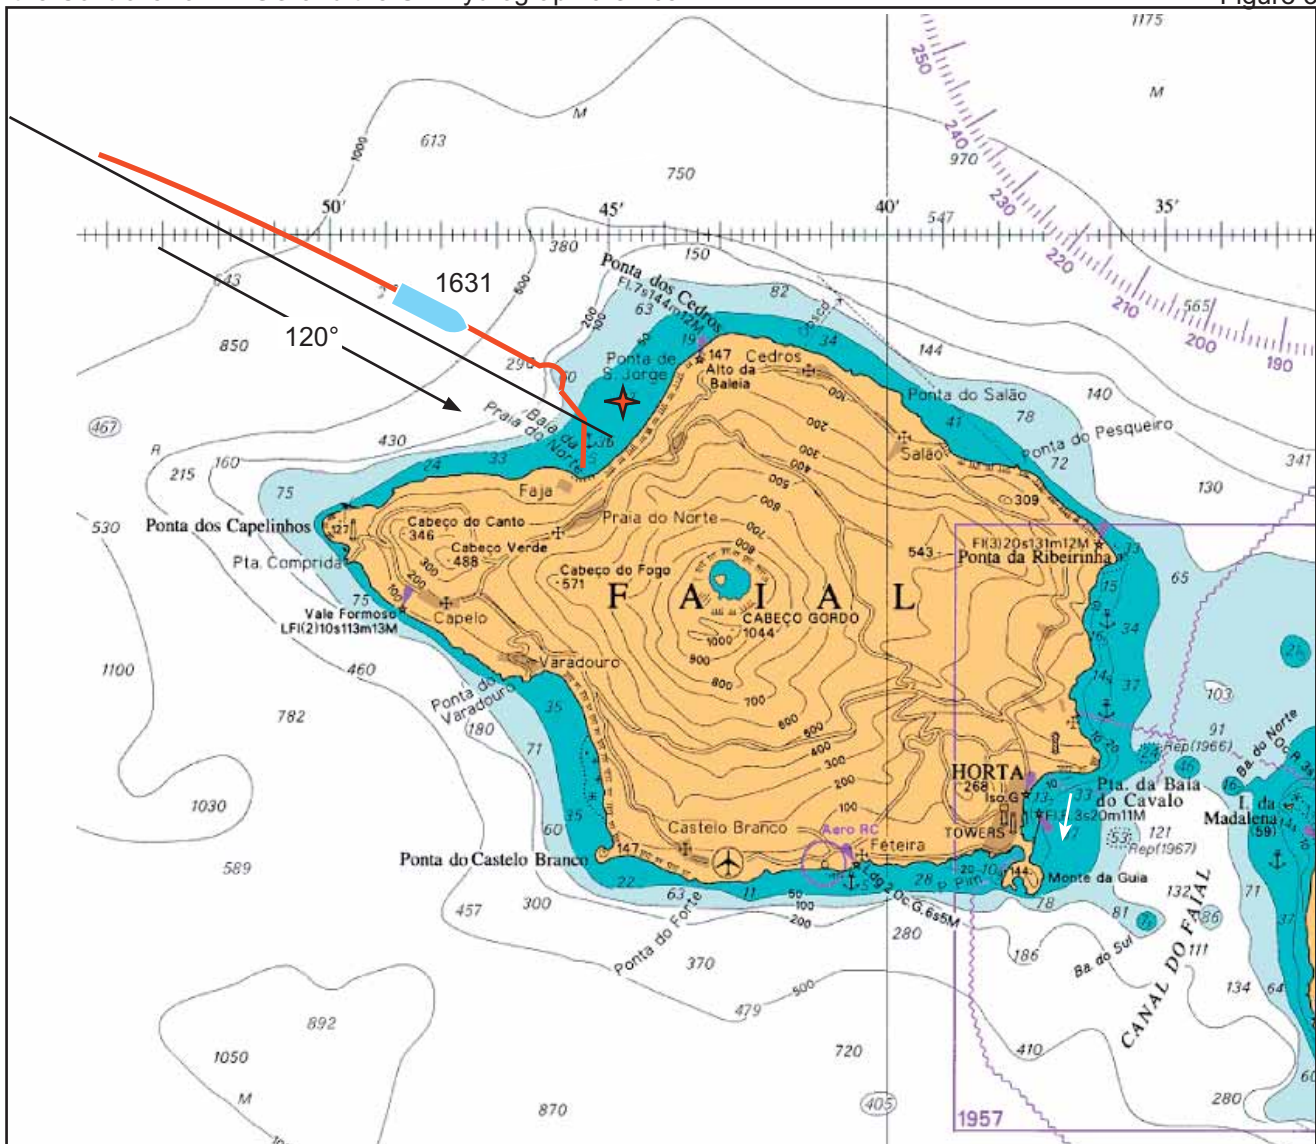
8 cable position

He told the second officer to find the course to steer to the 8 cable anchorage position which he, the second officer, had input into the ECS and to give the helmsman the necessary orders to steer towards it.

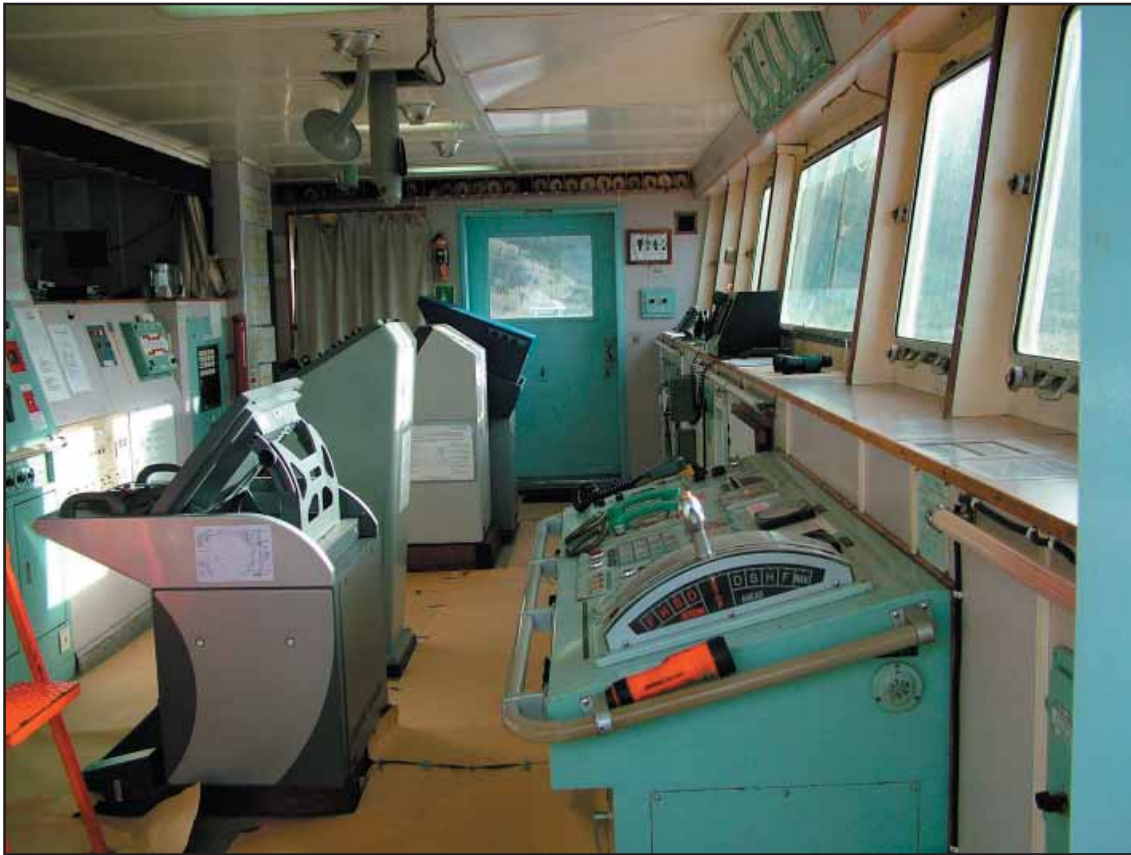
Bridge layout

The echo sounder was a Furuno Mark II, type F-851-S unit, fitted prior to new-building delivery 26 years earlier. The type incorporates a stylus on a rotating loop which burns a trace onto a slow moving reel of impregnated paper. The unit has no remote readout or depth alarm capability. This echo sounder unit was positioned on the chart table, behind and out of sight of anyone in the fore part of the wheelhouse.

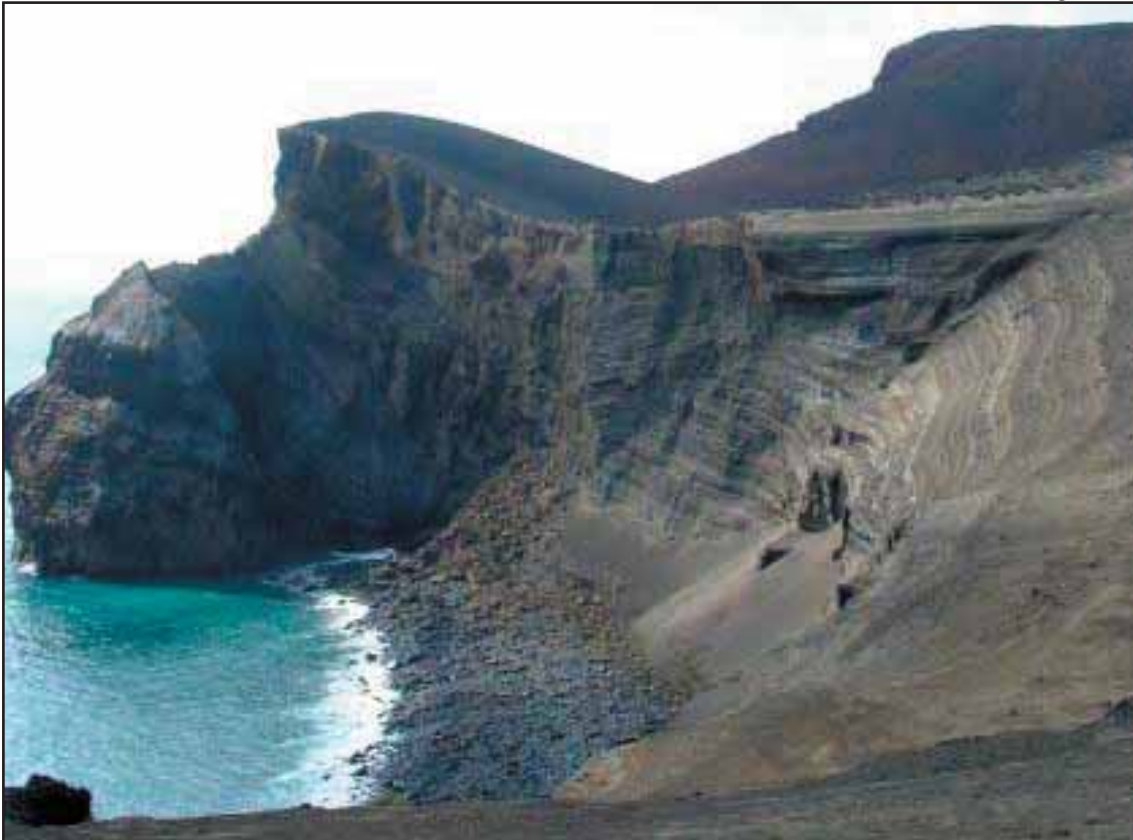
Land added to Faial Island after volcanic eruption in 1957-8
