Report on the investigation of the  
foundering of the fishing vessel

***Blue Sinata***

in Weymouth Bay  
on 8 September 2005  
with the loss of one life

**Report No 7/2006**  
**March 2006**

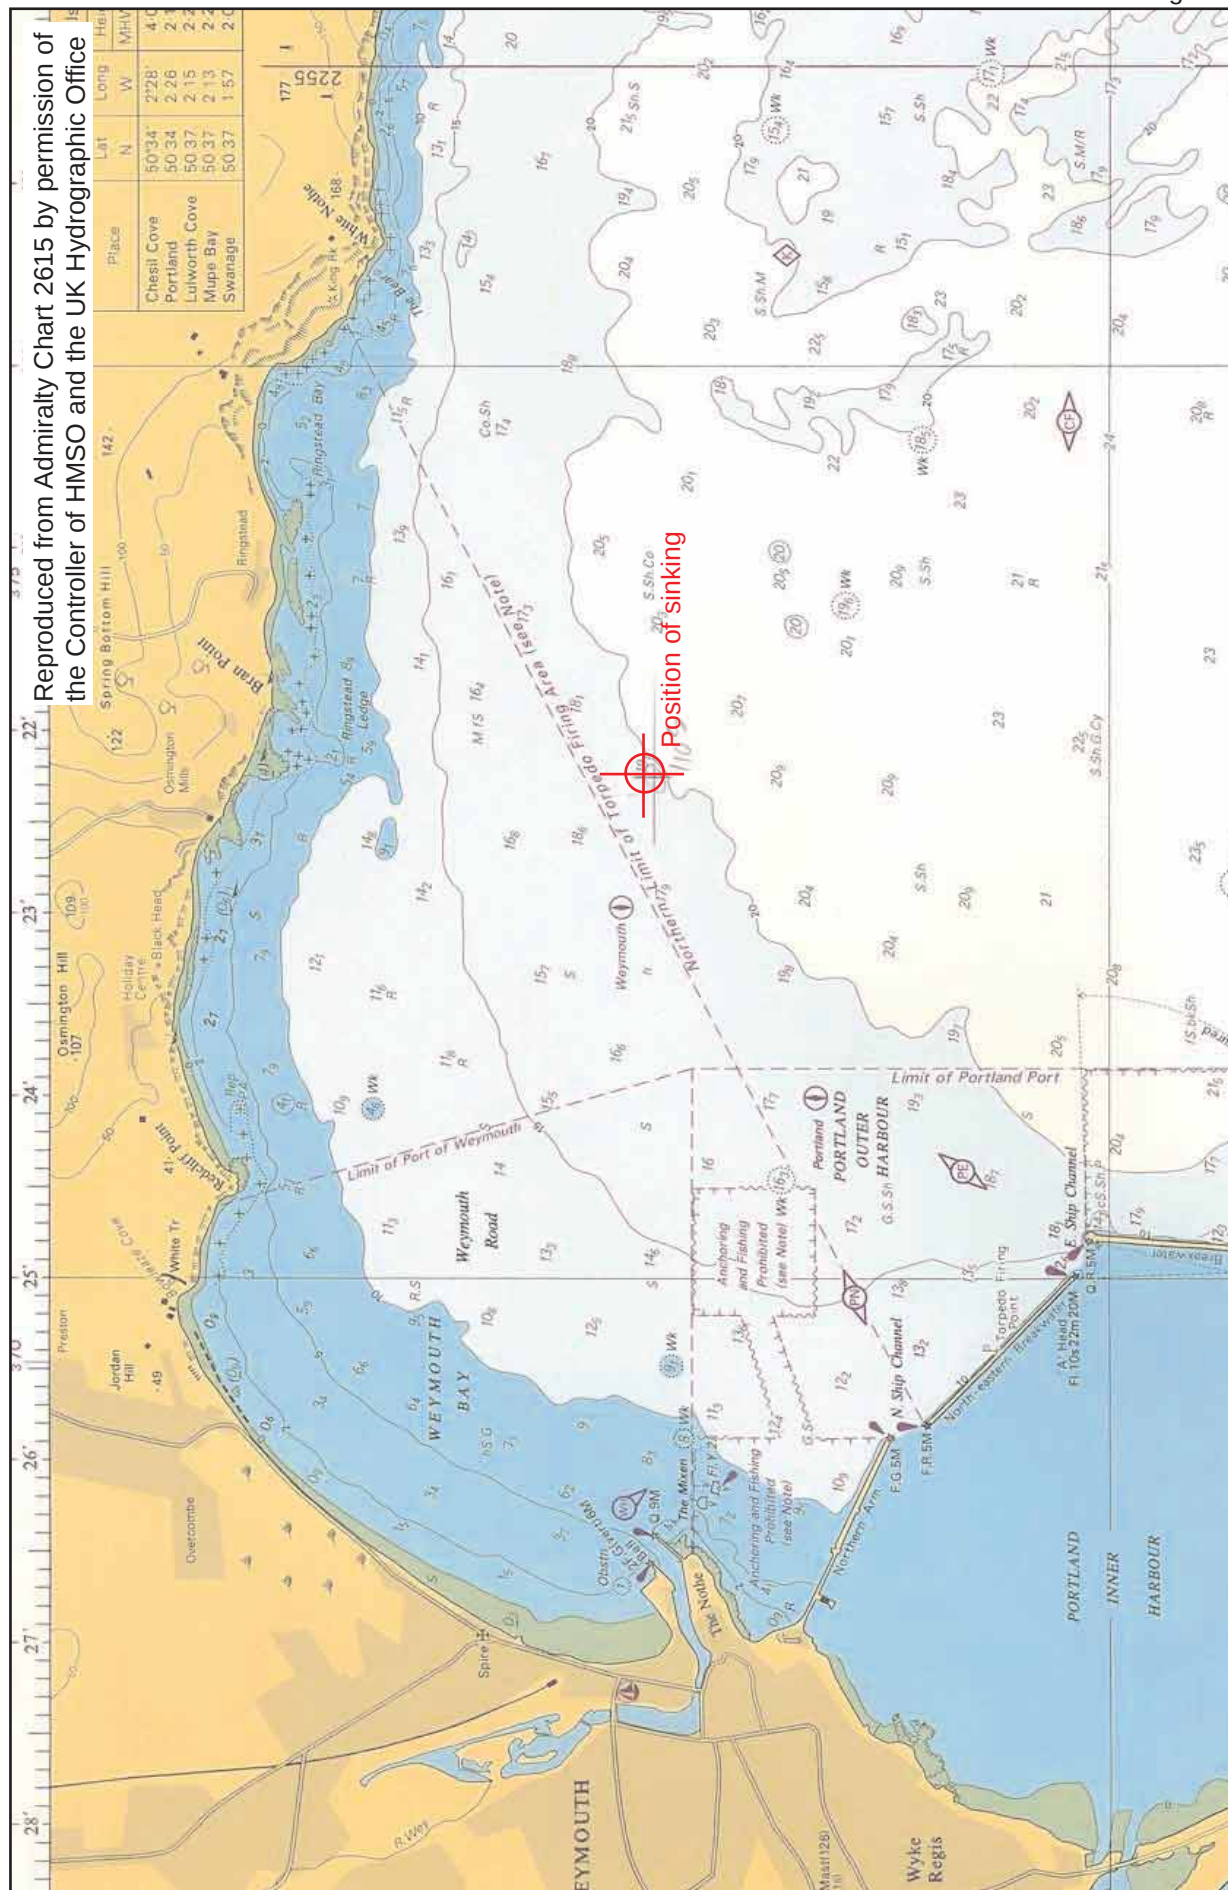
Figure 1

Using diesel oil and surface debris as indicators of position, this diver found and identified the wreck of *Blue Sinata* in 21m of water in position 50° 36.537'N 002° 22.275' W (**Figure 1**). Having found the skipper lodged between the wheelhouse and winch of the vessel, the diver recovered his body to the surface.

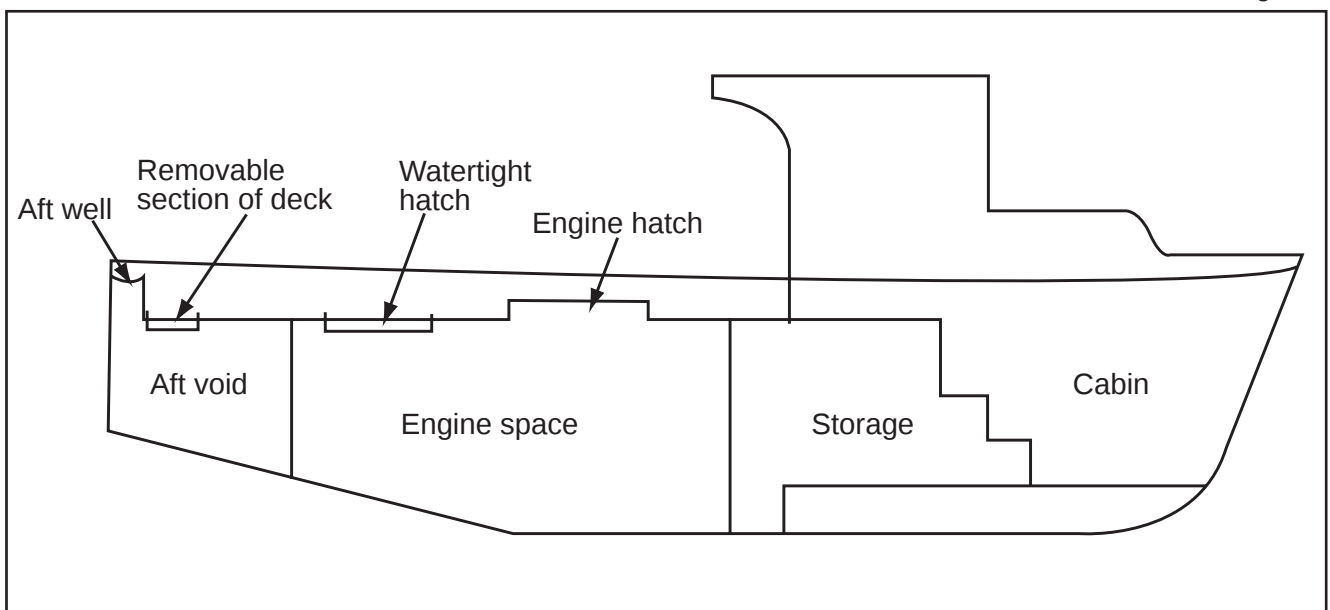
Figure 2

The hull was divided into four significant spaces: forward cabin; under-wheelhouse storage space; engine space and aft void (**Figure 2**).

Adjacent to the transom stern, was an opening in the centre of the deck with a 450mm high coaming. The top of the coaming had a loose GRP cover which had no securing arrangements. The well formed by the coaming led down into the aft void. Immediately forward of the coaming was a rectangular, flush section of the deck that could be lifted for better access to the aft void. This piece of deck had no securing arrangements, but was a close fit in its aperture (**Figure 2**).

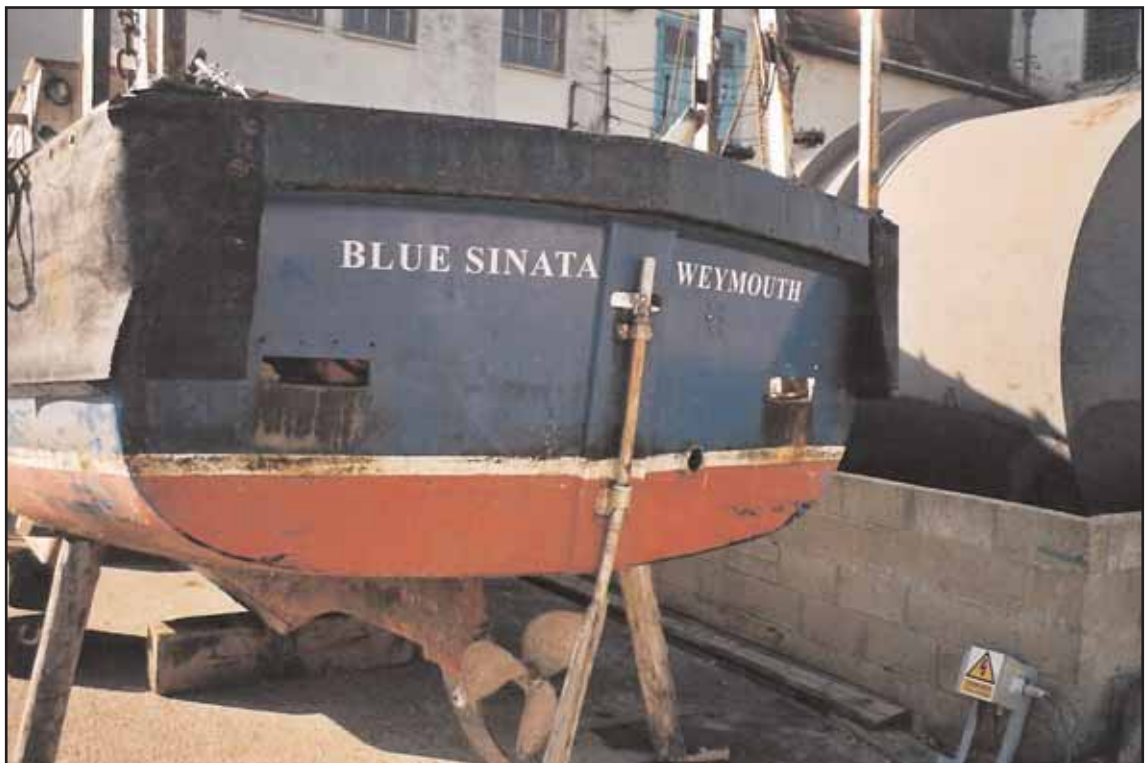
Figure 3

The plywood deck was bonded into the hull around its edges and covered with a layer of GRP. Layers of rubber sheeting covered most of the deck to provide a non-slip working surface. The bulwarks extended 600mm above the deck. Two freeing-ports, each 260mm wide by 55mm high, were cut in the bulwarks at the stern (**Figure 3**).

Stern showing freeing ports

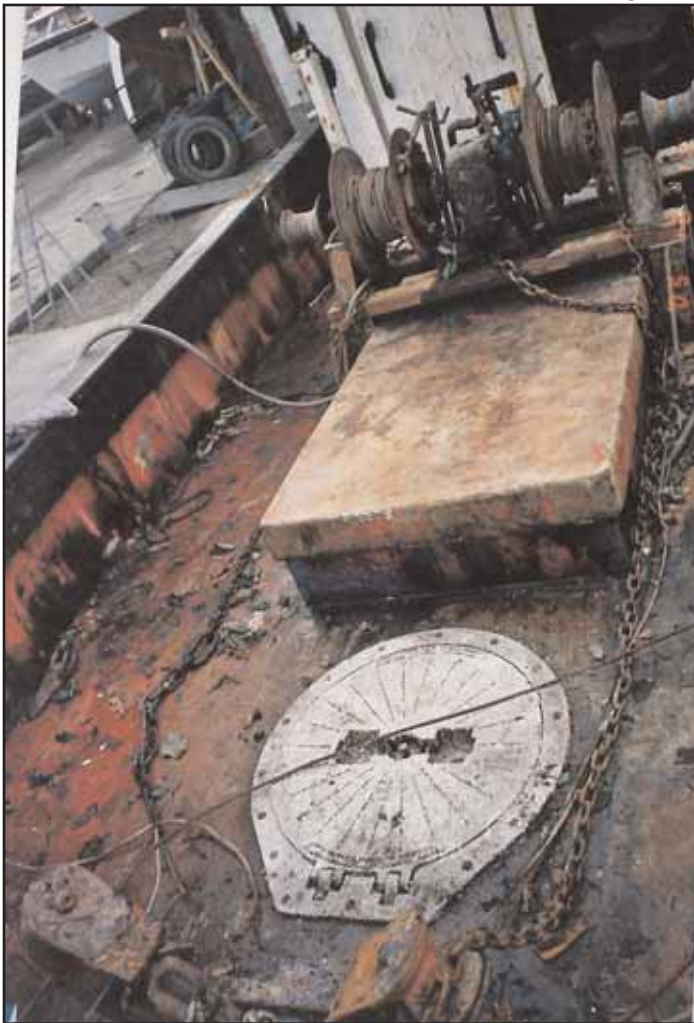
Figure 5

Just aft of the engine hatch was a flush, aluminium, 600mm diameter watertight hatch (**Figure 5**). This hinged at its aft edge and gave access to the space aft of the engine and the vessel's only seawater inlet valves. There was no bulkhead between this area and the engine space.

Circular watertight hatch and engine hatch

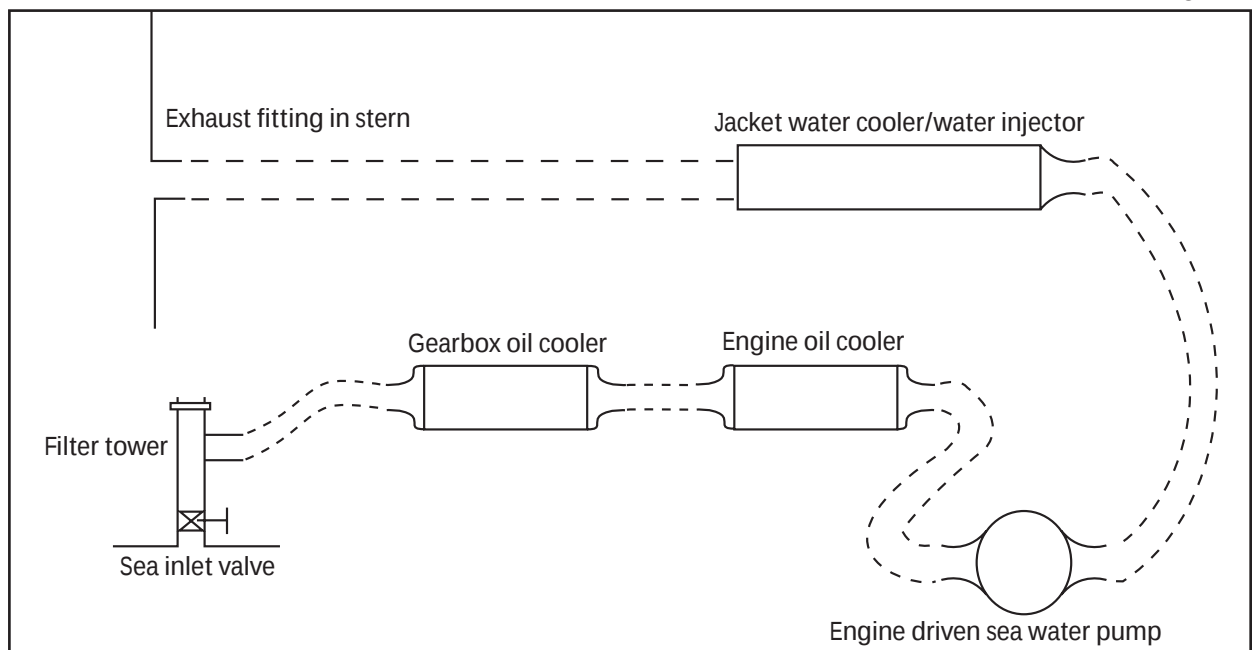
Figure 6

From the seawater inlet valve, below the circular deck hatch, water passed to a gearbox oil cooler mounted over the gearbox. From this cooler, the water then passed to an engine oil cooler on the port side of the engine, before entering the engine-driven seawater pump. The outlet from the pump went to the jacket water cooler, high on the starboard side of the engine, before being injected into the engine's exhaust for cooling and silencing purposes. All seawater pipes between these units were plastic hoses secured with worm drive clips (**Figure 6**).

Engine's sea water and exhaust system

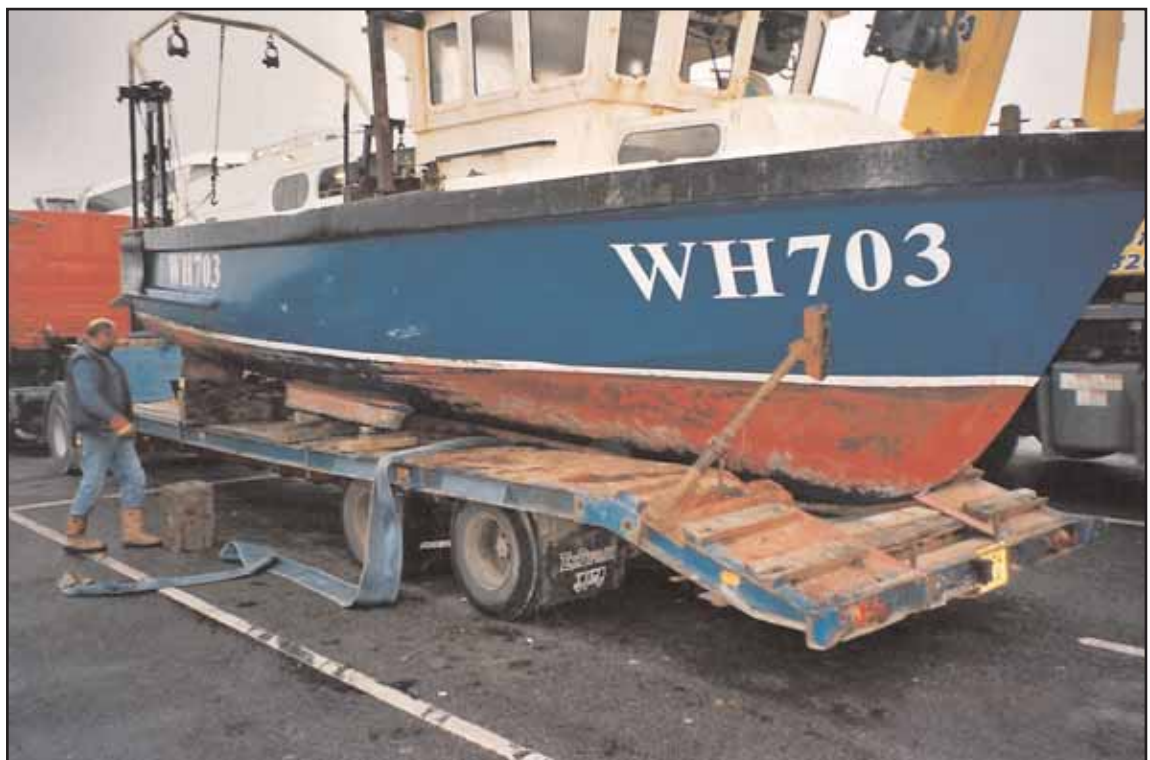
Figure 9

The tow to Weymouth was completed without further event. Following a combined lifting and pumping operation in Weymouth, the wreck was transferred to a low loading transporter by 1720 for the road journey to Southampton (**Figure 9**).

*Blue Sinata* after recovery
