Report on the investigation of
the grounding of UK registered
emergency towing vessel

Anglian Sovereign

near the island of Oxna, in the Shetland Islands

**Report No 16/2006
June 2006**

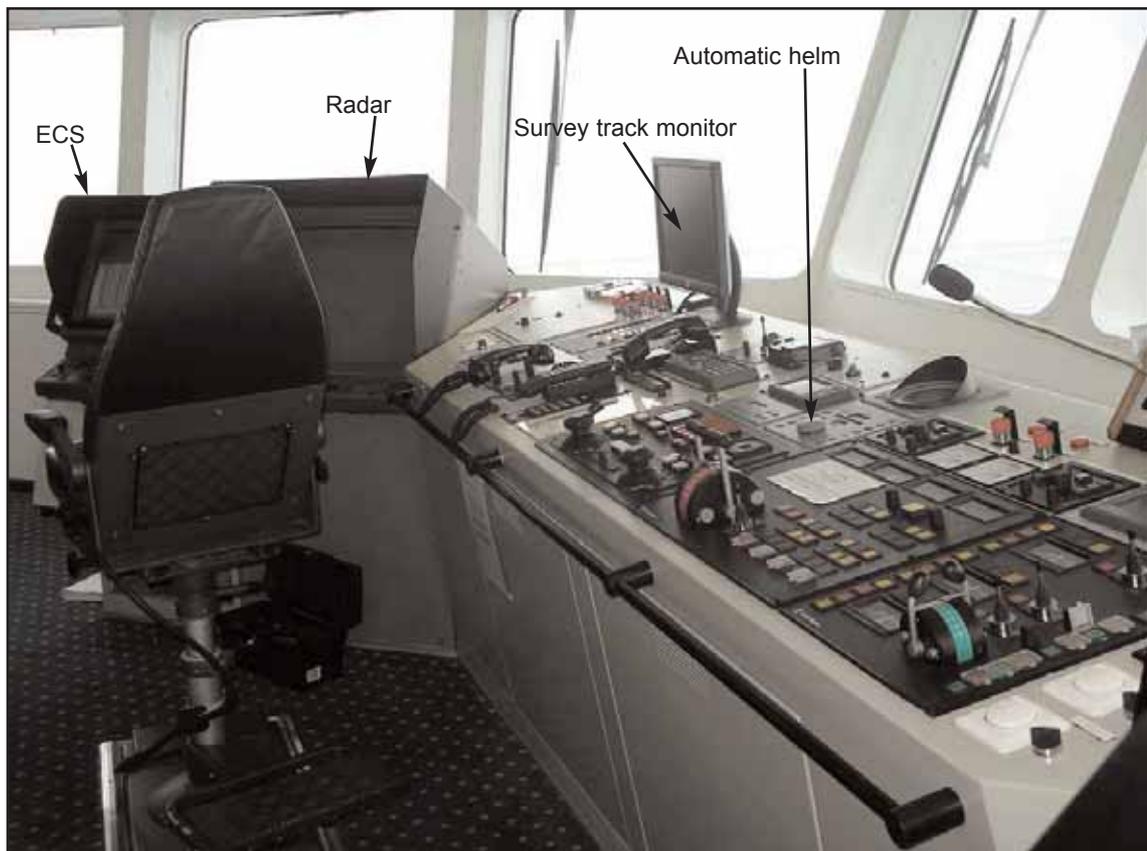
Photograph 2

Anglian Sovereign then began to steam along a number of north and south track lines which were displayed on a monitor mounted on the bridge console, forward of the steering position (**Photograph 2**).

The forward bridge console

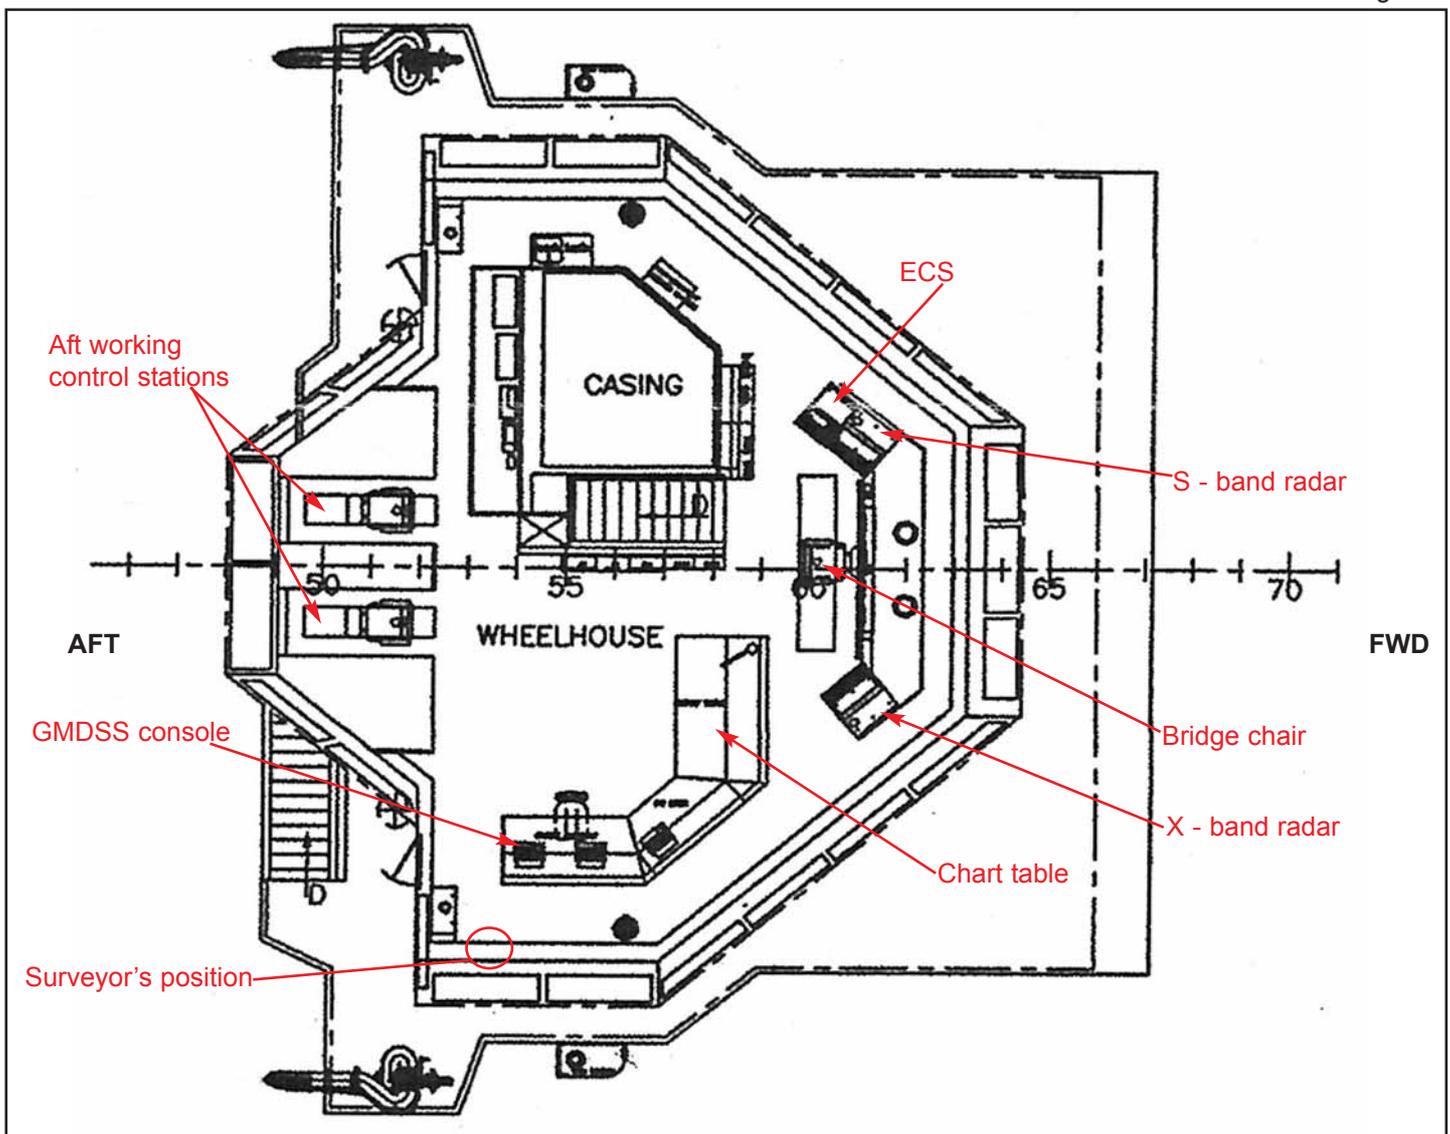
Figure 3

The course set by the master gave a track line to a point just north of the island of Oxna, which was approximately mid-way between the entrances to the North and South Channels for Scalloway harbour. At about 2135, a surveyor from the hydrographic survey team went to the bridge to make a mobile telephone call. The surveyor greeted the master, who was sitting on the bridge chair near the port radar, and the master replied. The surveyor then went to the rear of the bridge and sat on a ledge by the bridge window outboard of the GMDSS console (Figure 3).

Plan of bridge deck

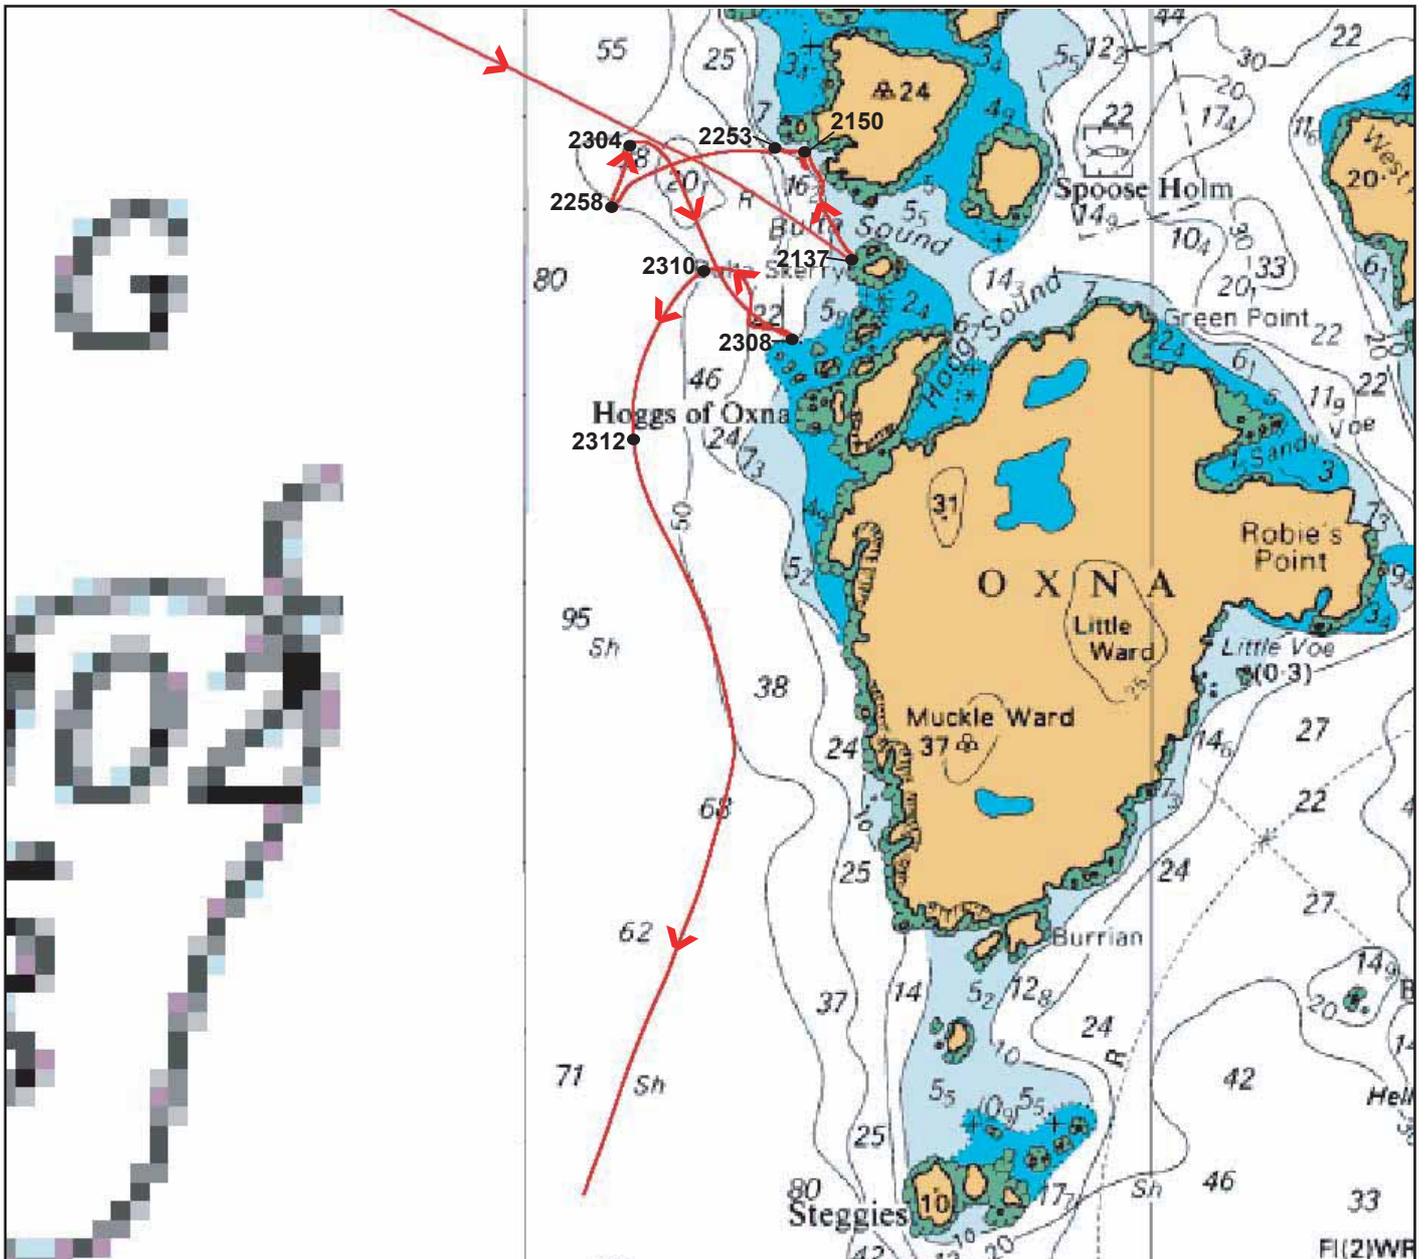
By that time, *Anglian Sovereign* had drifted northwards from the original grounding position on Bulta Skerry, had swung round to starboard, and had come to rest in a cleft in one of the most southern islands of the Cheynies (**Figure 4**). In the resting position, the vessel was facing out towards the open sea, with most of her after working deck area surrounded by rocks and land.

The track of *Anglian Sovereign* between 2137 and 2312

The master of *Anglian Sovereign* used the VHF to inform the master of *Triton*, which by this time was close to his vessel, that he intended to take the vessel through the very narrow passage of the Balta Sound. From data recovered from *Anglian Sovereign*'s Hydrographic survey equipment and recordings of conversations between the master of *Anglian Sovereign* and the bridge team of *Triton*, it became clear that, in attempting to pass through the Balta Sound, the vessel again grounded briefly at 2308 (**see Figure 4**).

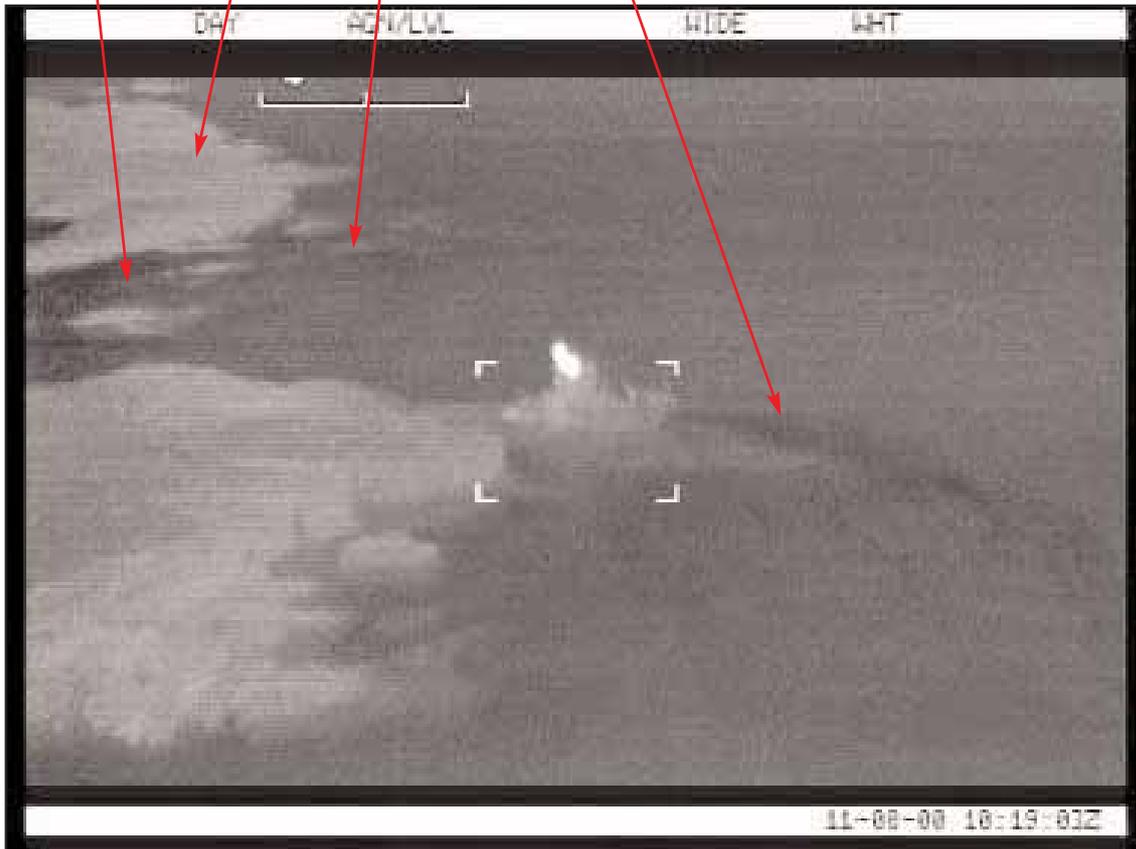
Photograph 3

At 2219, the rescue helicopter arrived on scene (**Photographs 3 and 4**). The crew were lifted off the stricken vessel in pairs, the chief officer being the last one to be evacuated, at 2240 (**Photograph 5**). However, the master remained

An infra-red image from rescue helicopter OC, showing *Anglian Sovereign* in her second grounding position

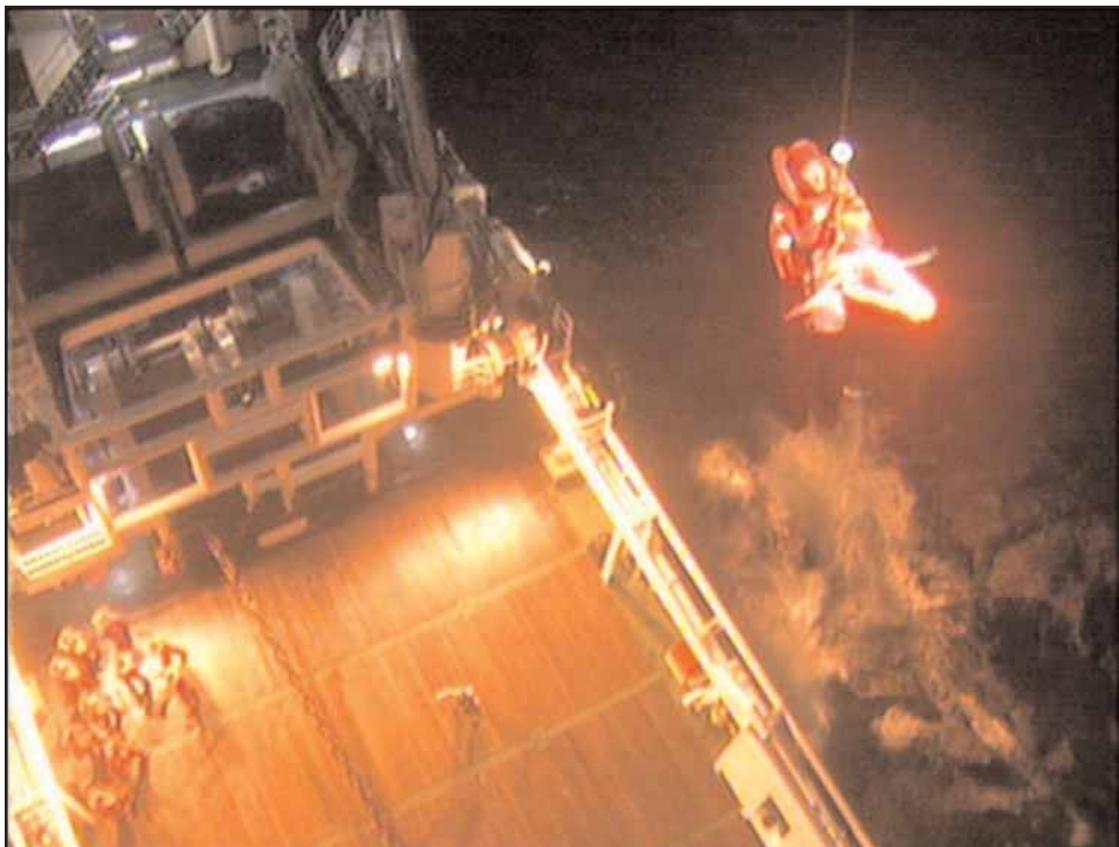
Video still, showing the crew being lifted onto rescue helicopter OC

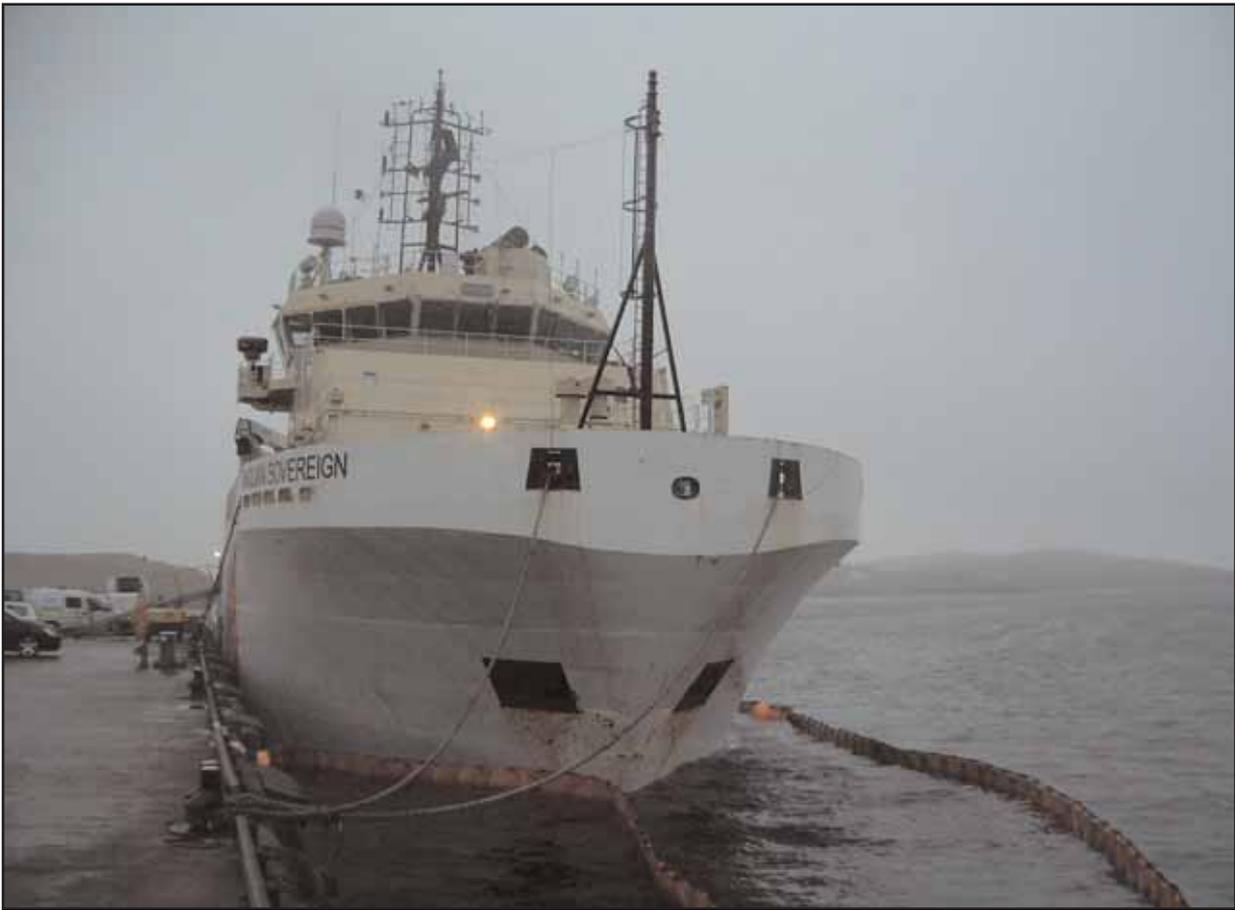
Anglian Sovereign alongside in Scalloway
