Extract from Subsea 7 Shell EPE Pipeline Inspection report

Boreas Consultants Ltd report entitled: Goldeneye Pipelines Assessment of Trawl Gear Incident at KP75.230

# Goldeneye Pipelines Assessment of Trawl Gear Incident at KP75.230

Boreas Report Number BR06022/SUK-56-A/Rev A Issued 15th February 2006

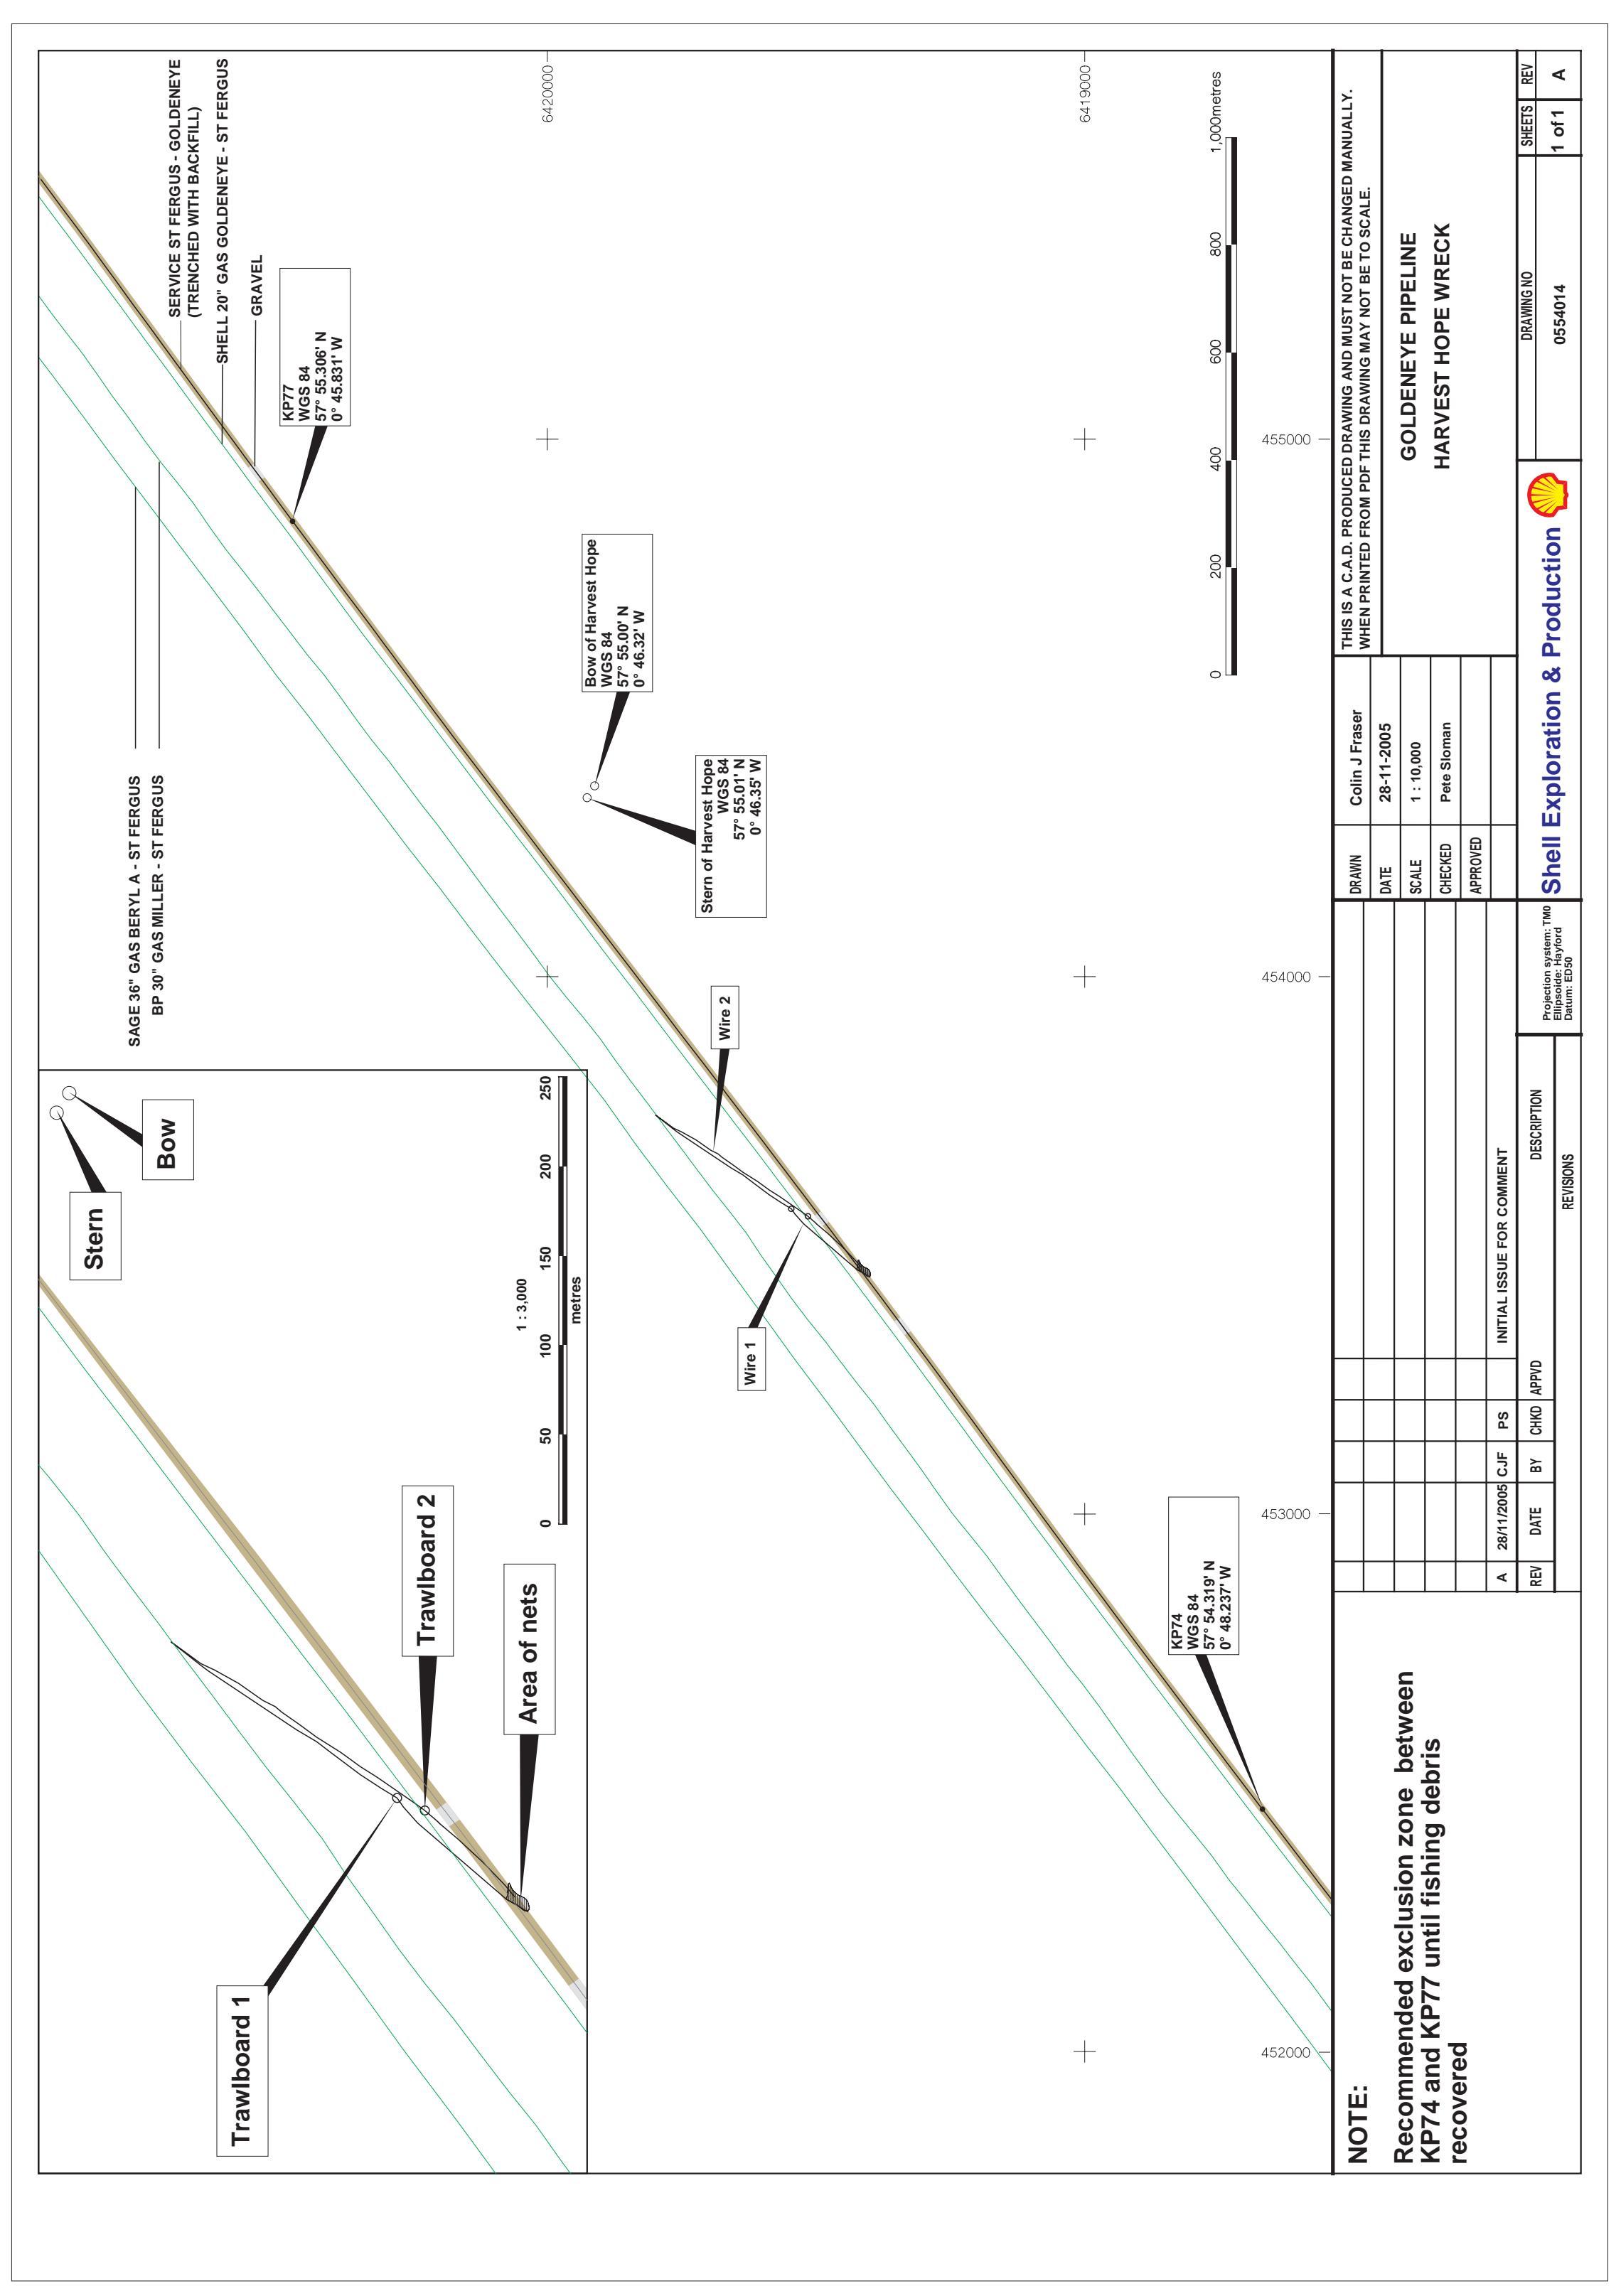
is with any SPOC it is their responsibility to advise other users of the sipeline regarding incidents involving it. However, any call to a SPOC reporting an incident or potential incident to a pipeline should include a request that the SPOC alerts other users of the pipeline. Shell underwater survey plot in area of Harvest Hope wreck

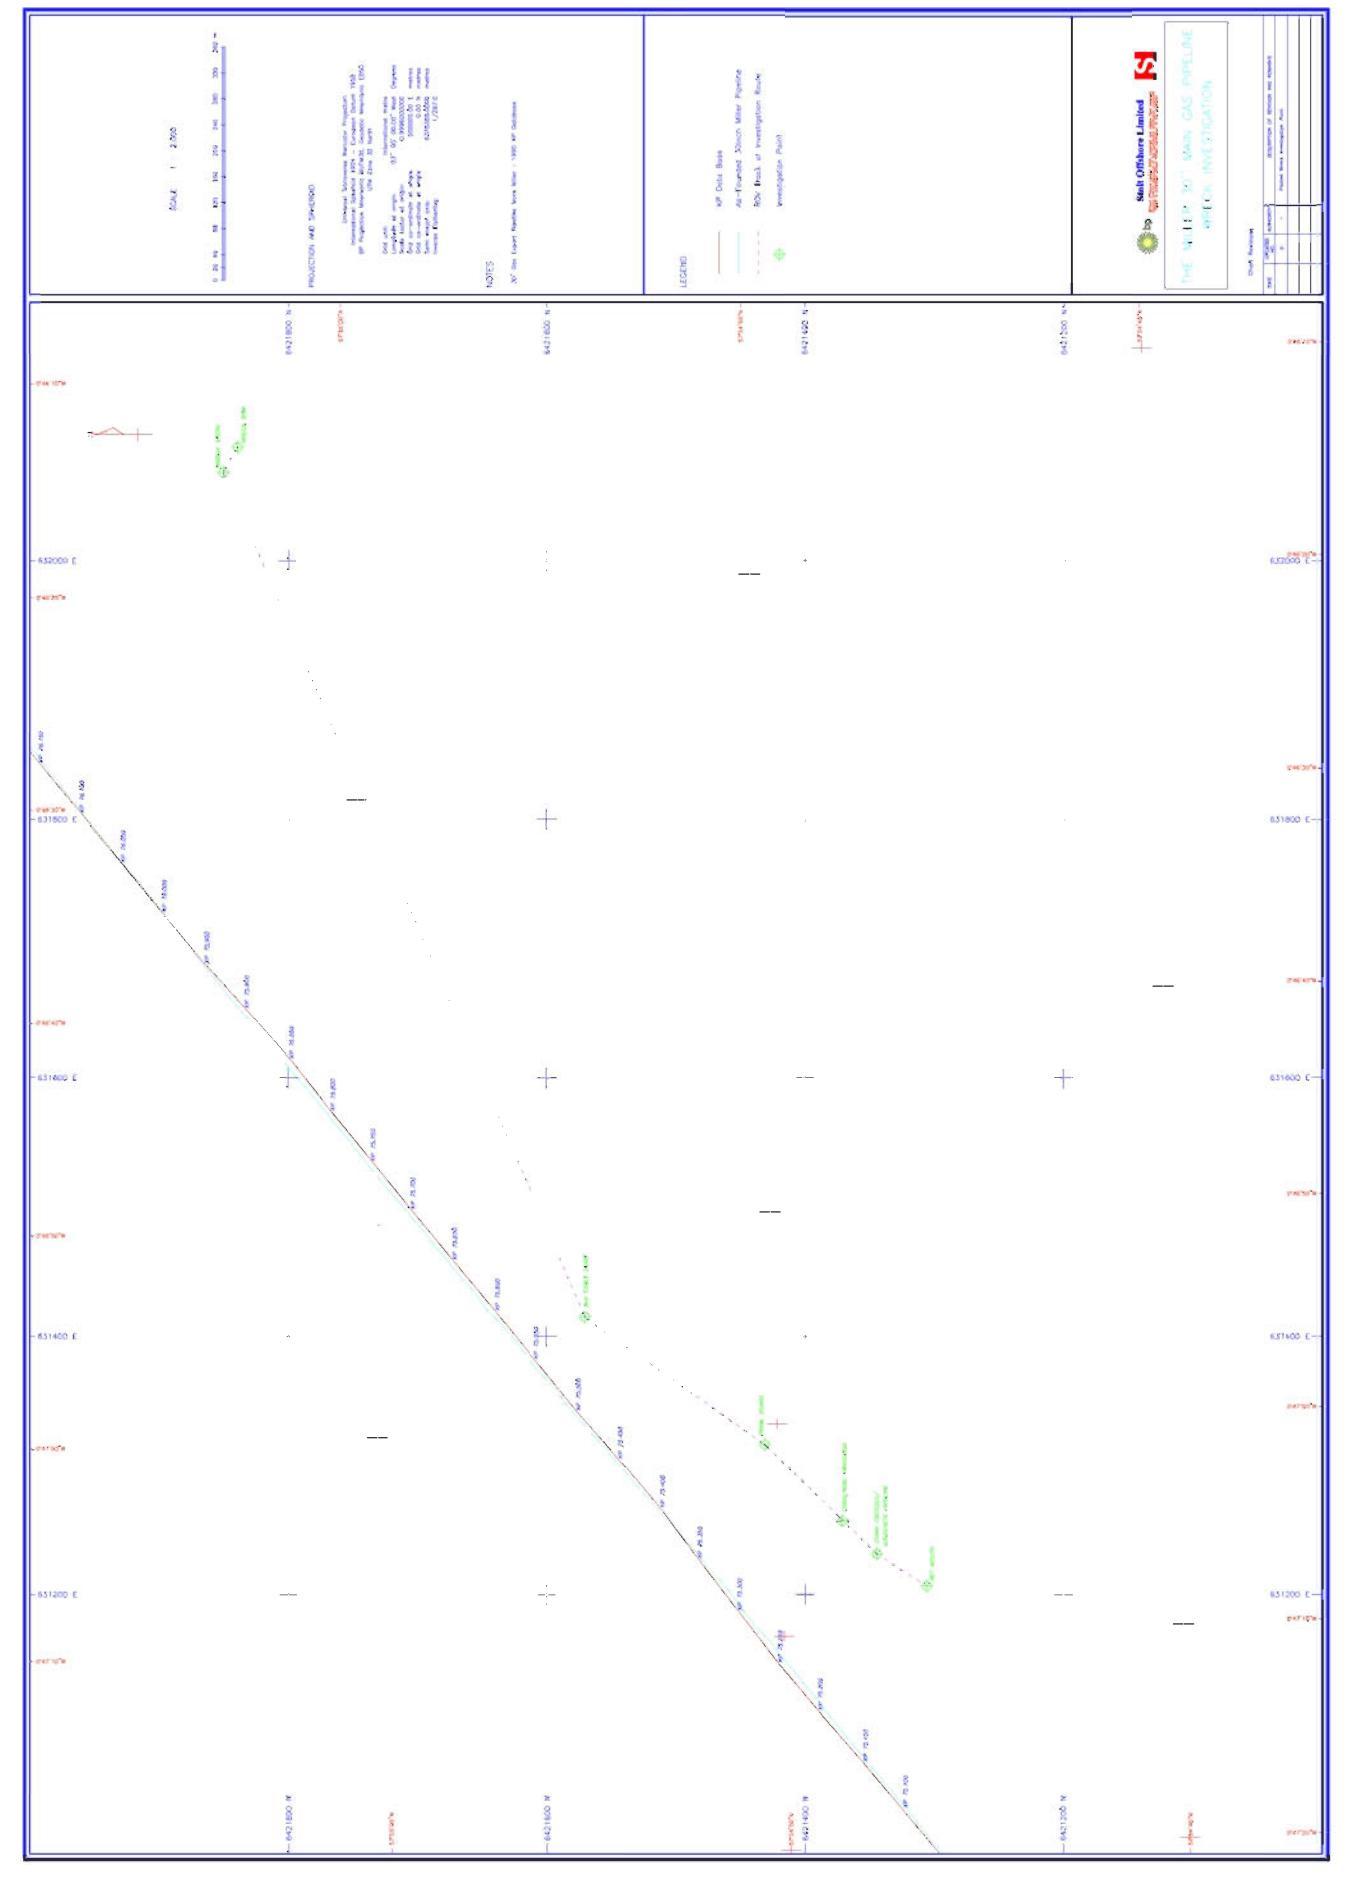
Miller 30" Main Gas Pipeline Wreck Investigation survey plot

The survey identified the debris of the trawl gear and the location of the wreck in the vicinity of the N0209 and N2805 pipelines (See drawing no. ET0261/KSS/05/1254). The trawl gear section was found to be located on and between the N0209 and N2805 pipelines. The trawl gear was not connected to the wreck of the Harvest Hope. The debris includes the net, and associated gear, two tow chains and the port and starboard trawl boards. A summary of the all debris is contained within the events listing below.

No evidence of the net having been caught on any pipeline or seabed feature in the vicinity of the trawl gear debris was observed during the survey. No damage to the pipelines was observed during the survey.
