Report on the investigation of
the hull failure of the rigid inflatable boat

Big Yellow

Porthmeor Beach

**Report No 11/2006
March 2006**

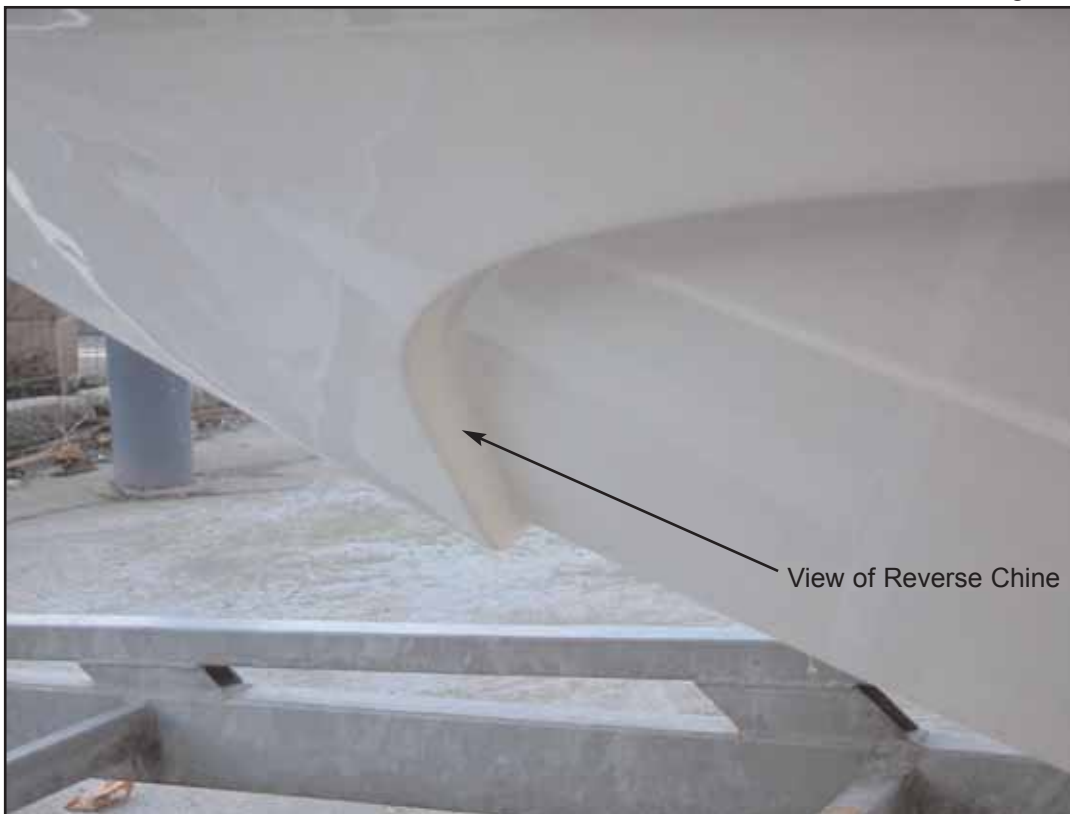
Figure 7

The only major recorded design change to the mould was the introduction of the reverse chine in 1998. The purpose of the reverse chine is to act as an "anti-stuffing" device by accentuating the bow upward lift and, at the same time, deflecting waves (**Figure 7**). This helps to prevent the bow stuffing into the back of a wave, in following sea conditions.

Undamaged reverse chine arrangement

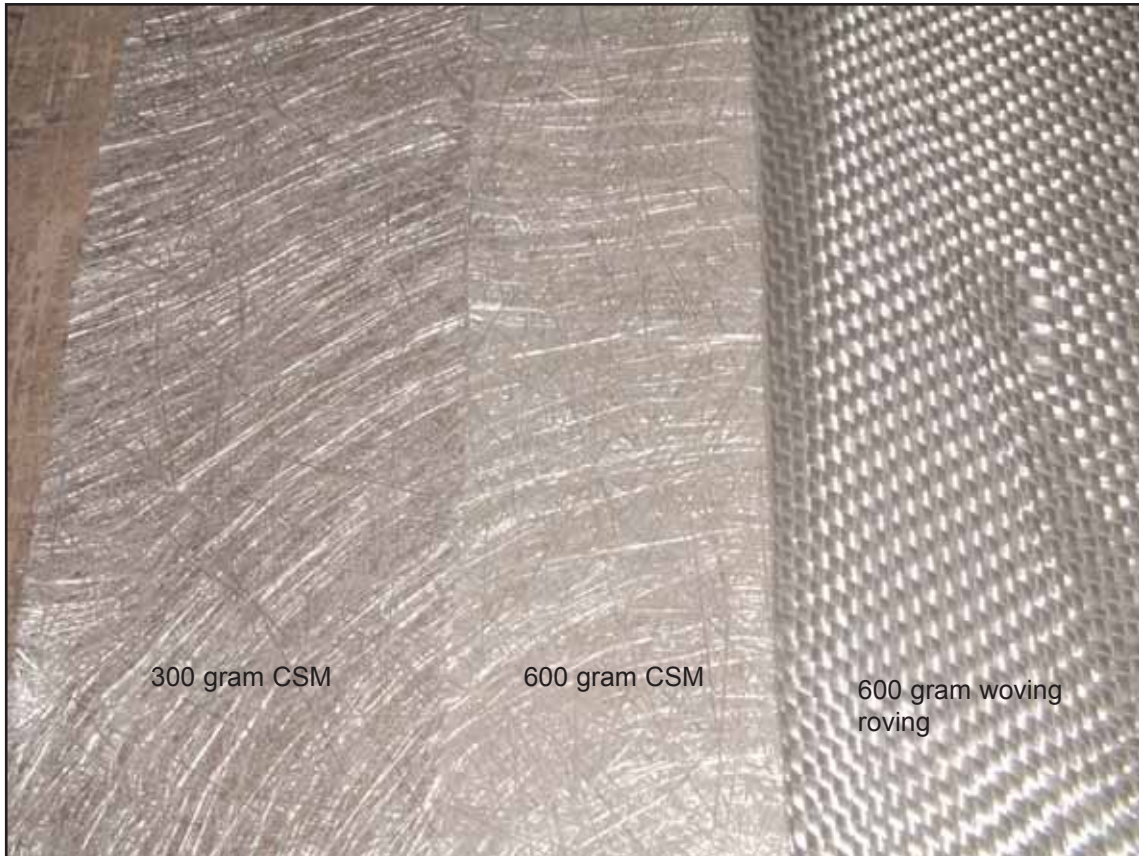
Figure 9

The materials used are shown at **Figure 9**. Between 1 -1.5% catalyst, by volume, is added to the resin and rolled into the GRP materials during the hand laying process.

Materials used for hull lay up

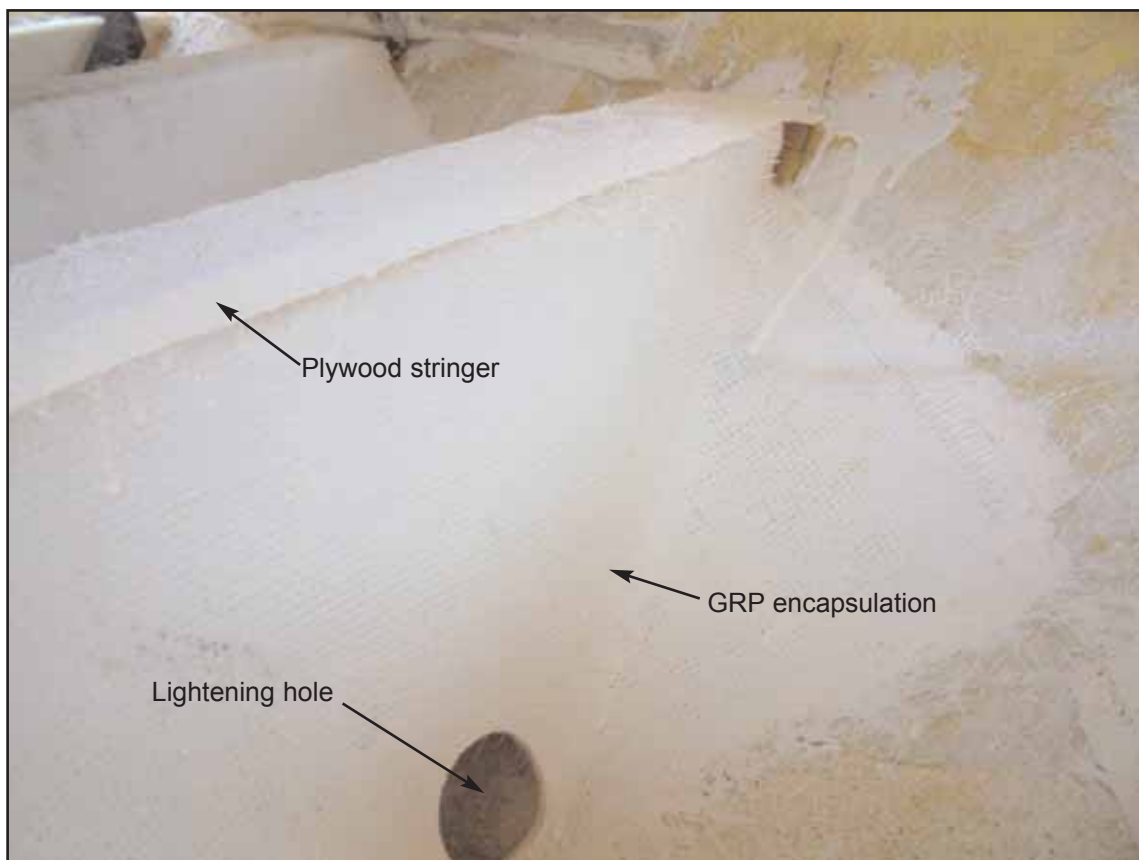
Figure 10

A series of under deck, frame type structures provide a degree of transverse stiffness. The first is located 300mm from the transom, with the remainder spaced at 450mm intervals throughout the length of the hull. The structure's main purpose is to support the plywood deck. The frames comprise an 18mm x 75mm wide marine ply stringer fitted across the hull. These are encapsulated by 2 layers of 600 gram csm and a single layer of woving roving, which are blended to the hull (**Figure 10**). A lightening hole also serves to reduce weight and allows for drainage of the bilge pump suction.

Transverse frame arrangement

There was some transverse stiffening provided by the transverse frame arrangements (see Section 1.8.5). But their effectiveness, in some cases, was compromised by poor bonding of the csm encapsulation to the hull. The 300mm section of the hull, from the deck to the tube flange, was totally unsupported in the transverse direction (**Figure 12**), and would have flexed through the natural tendency of the hull to twist in a seaway.

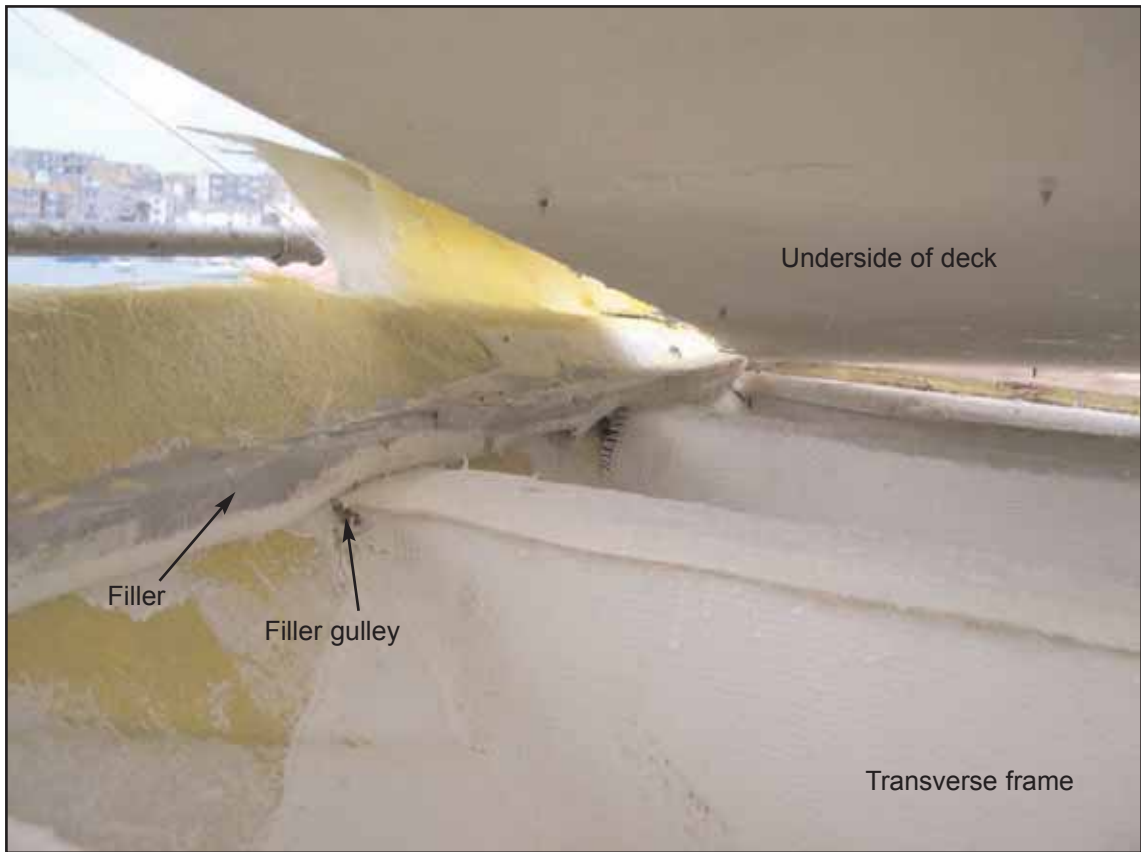
Figure 11

Gaps between the deck edge and hull interface are plugged with a filler compound mixed with resin which is laid into a gulley fitted around the deck edge **Figure 11**. Two layers of 600 gram csm are then laid on top of the deck and are blended into the hull flange. A non slip surface is stippled onto the deck comprising a 50/50 mix of gel and resin, pigment, wax and dried builder's silver sand.

Deck edge/hull interface seal arrangements

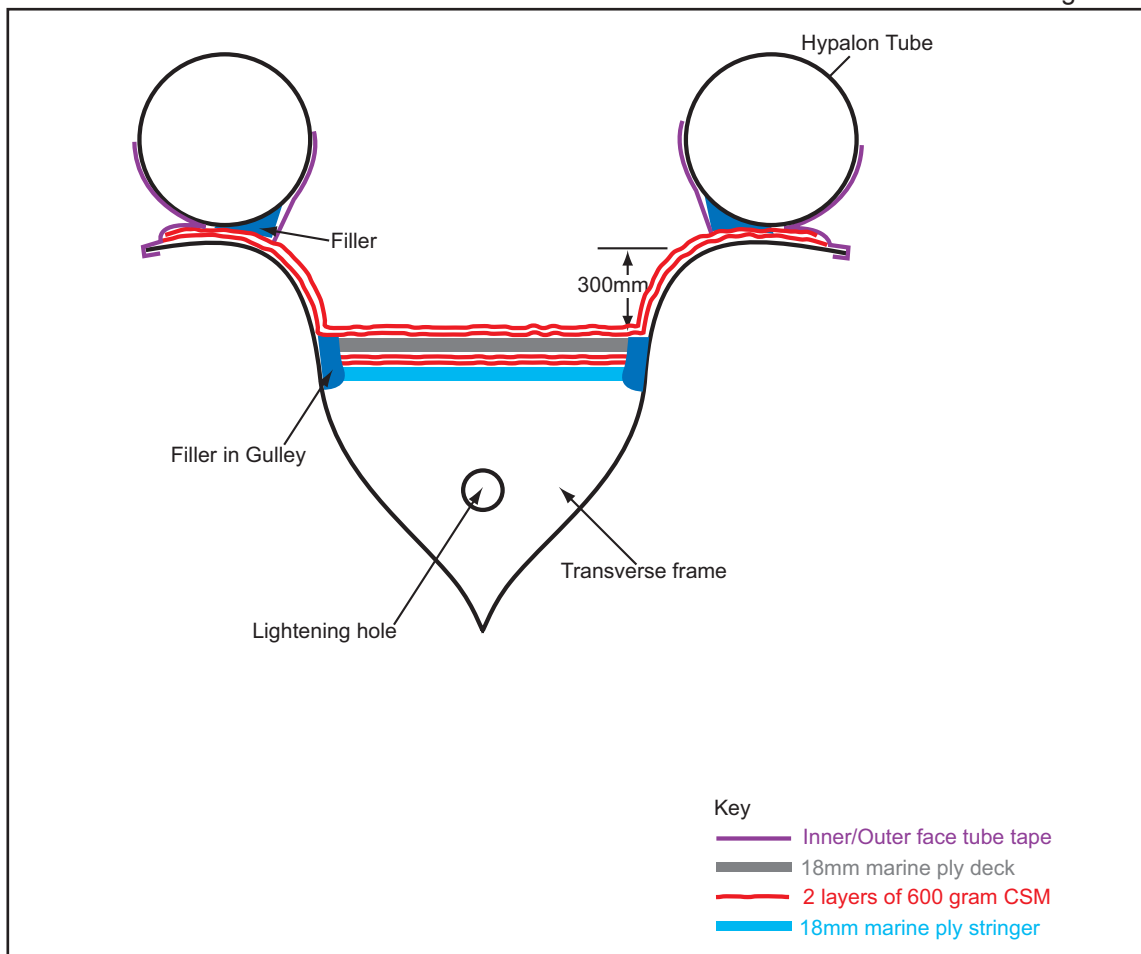
Figure 12

In common with many other RIBs, there are no access points in the deck to allow for under deck hull inspection. The deck and tube configuration is shown at **Figure 12**.

Deck and tube configuration

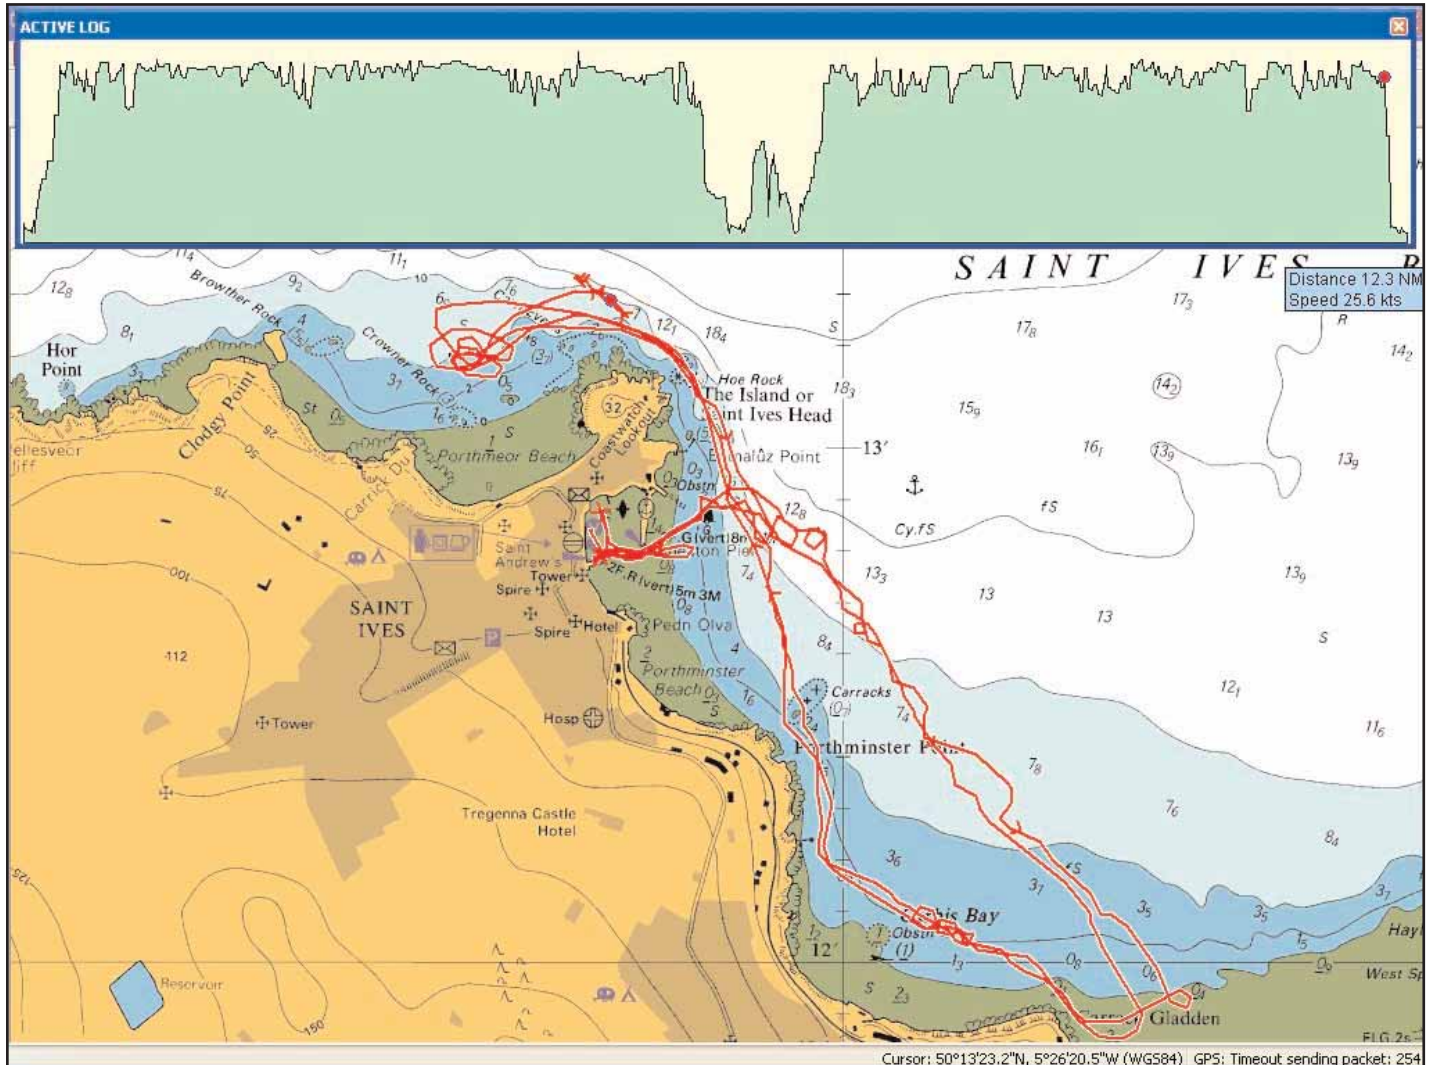
Figure 22

Scrutiny of the GPS data confirmed the boat's speed was consistent with the trip made earlier on the day of the accident. The RIB's tracks and associated speed profile for 26 August is at **Figure 22**. There was nothing to suggest that the accident trip circumstances were unusual to those previously experienced.

Big Yellow was being used well within the appropriate operational limits set out in the MCA's Yellow Code. However, it is apparent that, due to the lack of any handling, environmental or loading extreme circumstances, the boat's structure was unable to withstand the normal in service forces, and was therefore unsuitable for its intended role.

Chart of St Ives Bay with RIB speed profile for 26 August 2005

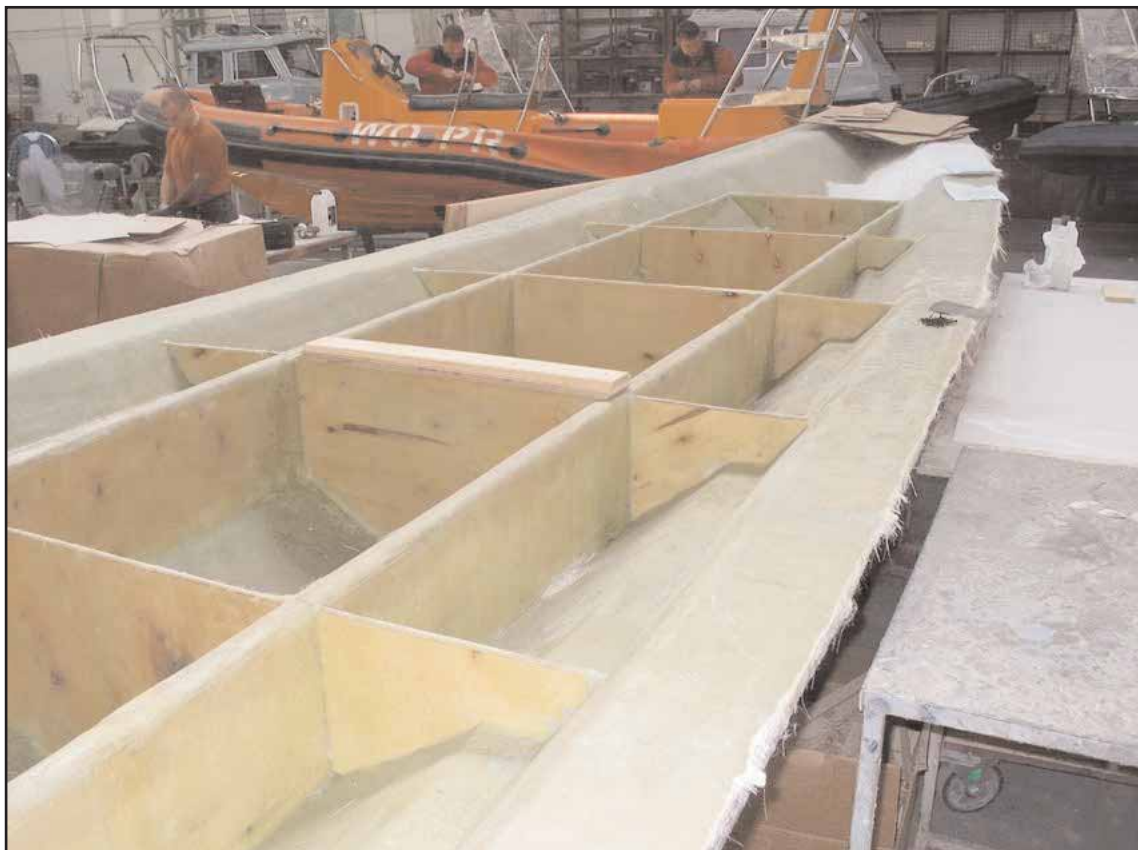
Figure 24

Under deck structural stiffening - Parker RIBs 900RS
