Report on the investigation of  
the engine failure of  
***Savannah Express***  
and her subsequent contact with a  
linkspan at Southampton Docks  
19 July 2005

Marine Accident Investigation Branch  
Carlton House  
Carlton Place  
Southampton  
United Kingdom  
SO15 2DZ

**Report No 8/2006**  
**March 2006**

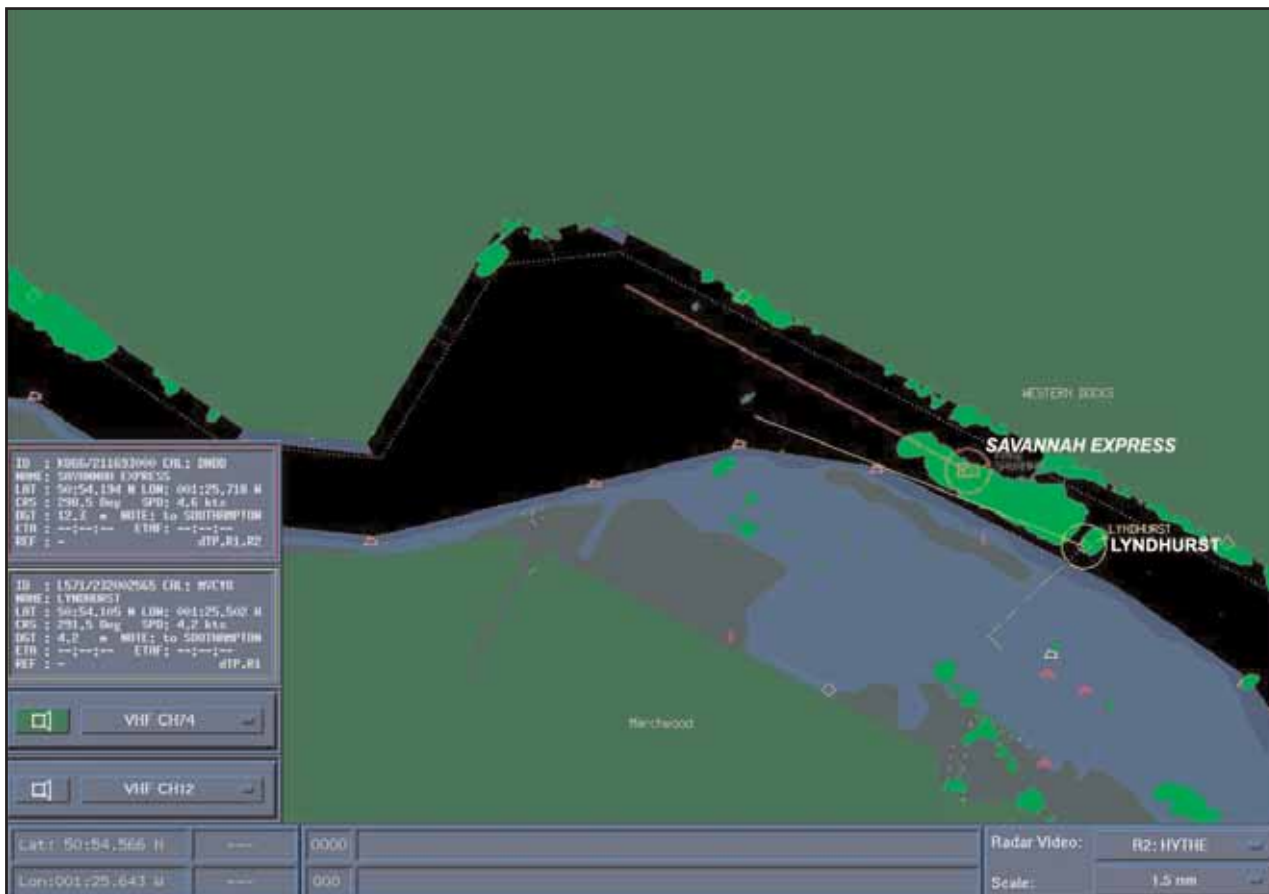
Figure 5

At 1136 the engine was set to dead slow astern. The engine briefly responded to the astern command and, although it reached 46 rpm, it failed to run and it stopped after about 18 seconds **(Figure 5)**. Further hydraulic low pressure alarms and ECU – A and B 'tacho failure' alarms occurred in the engine control room (ECR). Several attempts to re-start the engine in astern were made from the bridge wing before control was transferred to Bridge Control, and then to the ECR.

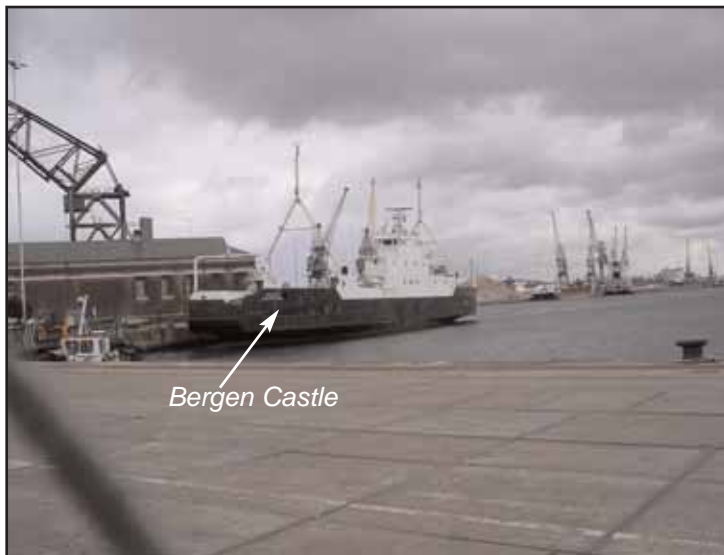
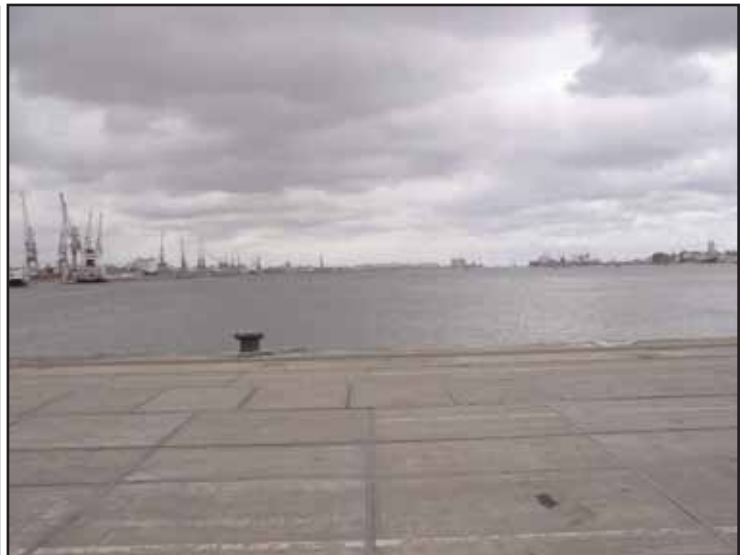
Figure 10a

The weather on the morning of the incident was fine and clear with a moderate westerly wind of 10 to 15 knots, gusting to 18 knots. Visibility was good and there were only low wind waves in the sheltered Upper Swinging Ground (**Figures 10a and b**).

Panorama of Upper Swinging Ground including *Bergen Castle*

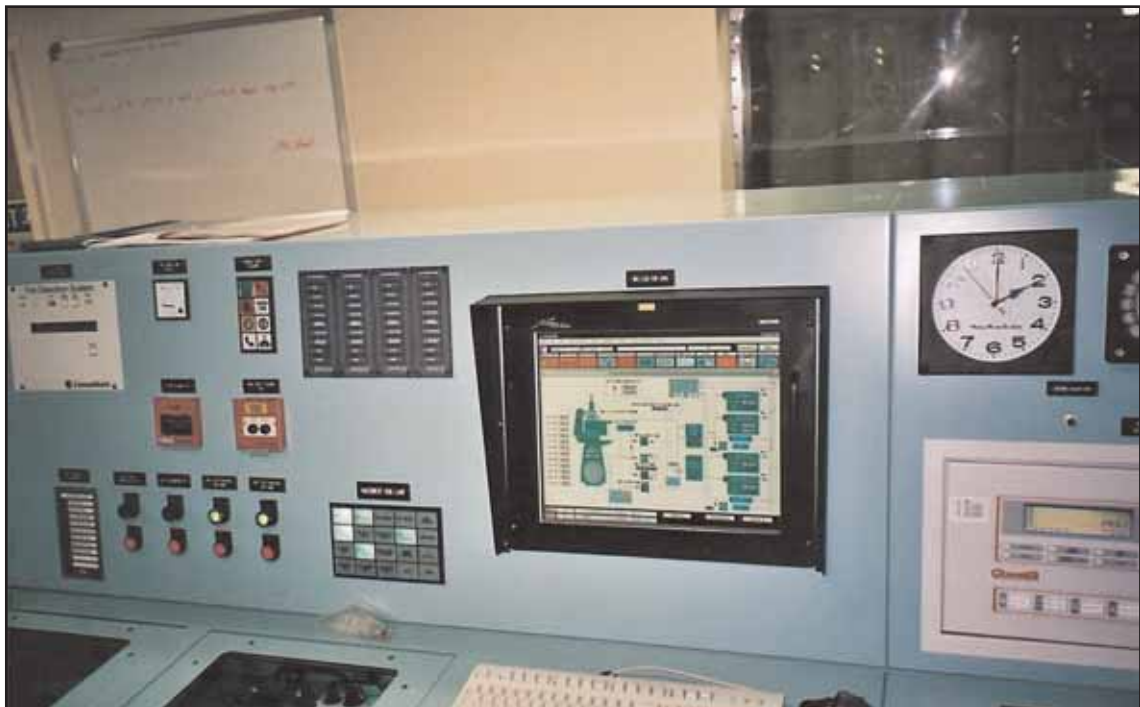
Figure 14

Each engine driven pump unit has a hydraulic pressure sensor, or transmitter, situated on the suction side of the pump. These protect the pumps in case of loss of oil supply, via alarm indication on the Main Operating Panel (**Figure 14**) and, if all four sensors indicate loss of oil pressure, initiate an engine shutdown.

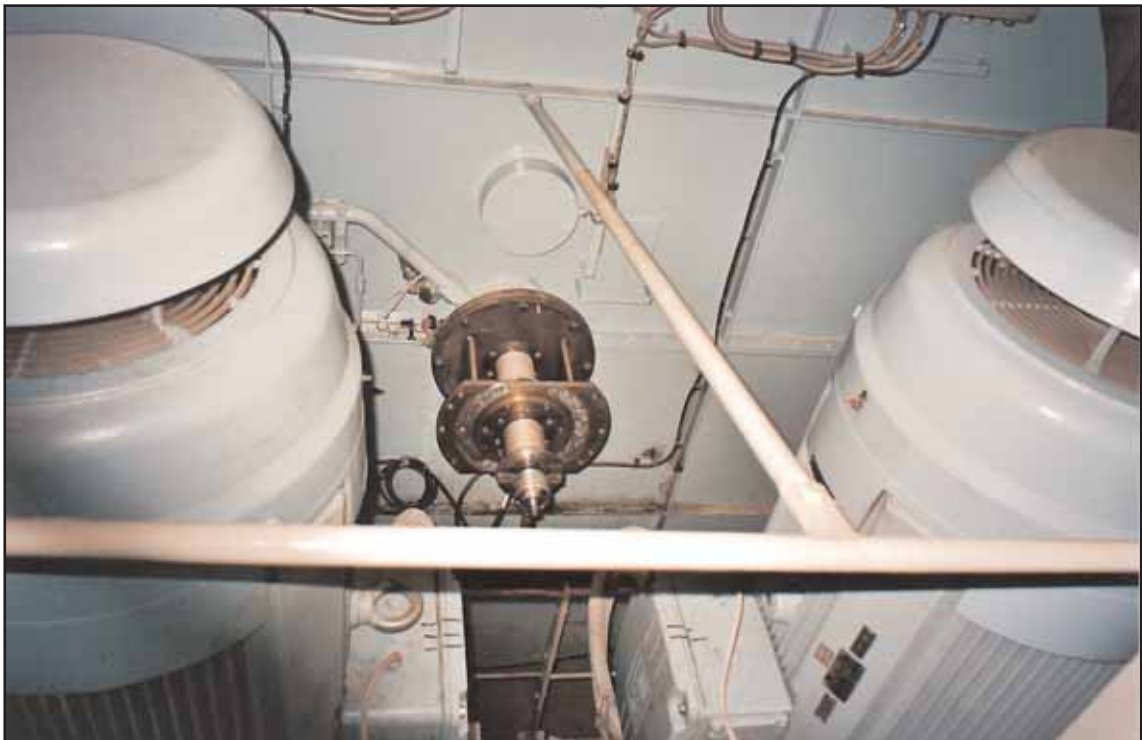
Figure 15

The tacho system uses two self-contained angle encoders, mounted externally, at the forward end of the crankshaft to measure rotational speed and crankshaft position. They are connected axially, and operate within bellows to protect the encoders against vibration and any slight misalignment. The bellows are protected by a steel enclosure (**Figure 15**).

The two encoders measure crankshaft position from the 0° position and the 45° position respectively. A single reference sensor at the flywheel provides a signal to ECU-A of the top dead centre (TDC) position of number one piston. This provides crankshaft position redundancy in case of failure or shaft slippage of either of the encoders.
