Report on the investigation of
the collision between
Carrie Kate and ***Kets***
resulting in one fatality
near Castle Point, St Mawes, Cornwall
16 July 2005

Marine Accident Investigation Branch
Carlton House
Carlton Place
Southampton
United Kingdom
SO15 2DZ

Report No 6/2006
February 2006

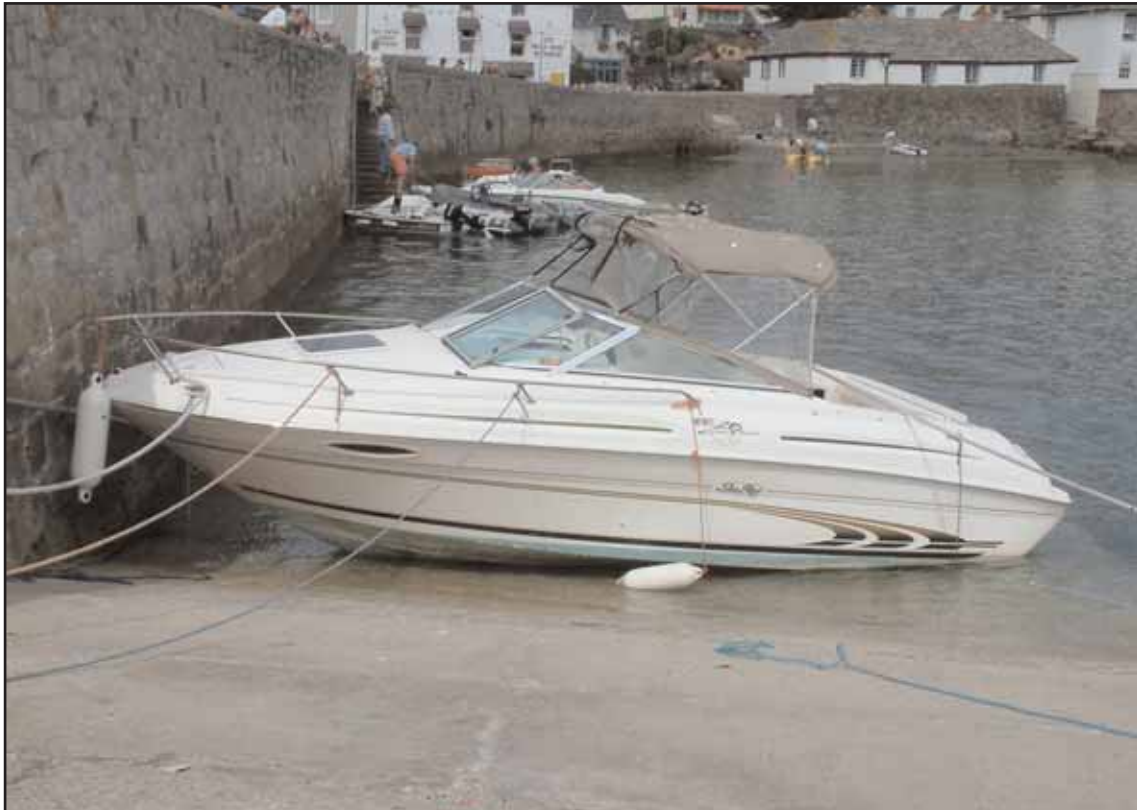
Figure 1

Carrie Kate

The helmsman of *Carrie Kate* on the day of the accident was an employee of the vessel's owner. The helmsman had been asked by his employer to house-sit while he was out of the country, and had been allowed the use of the employer's speedboat, *Carrie Kate* (**Figure 1**), which was moored at the bottom of his garden, on the Truro River.

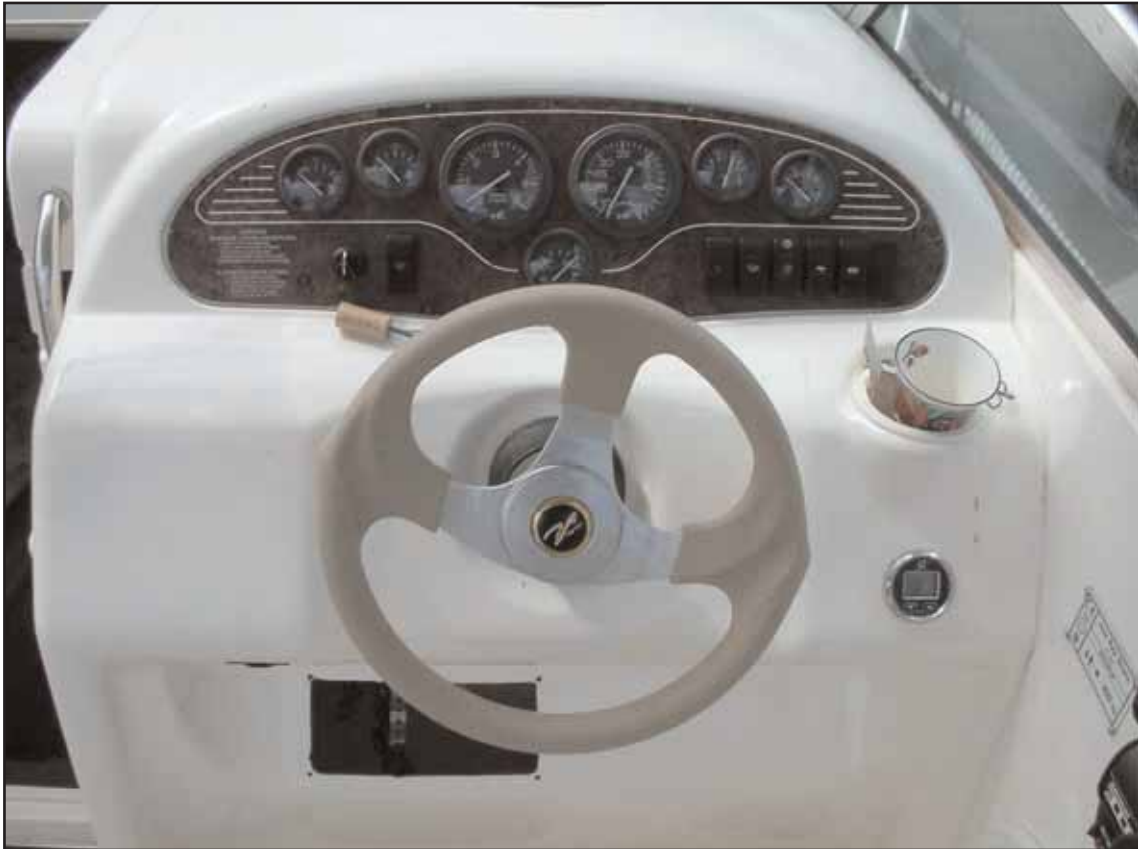
Figure 6

The helm position was on the starboard side, with the basic controls and instruments as shown **(Figure 6)**. The throttle was mounted on the starboard side next to the seat. The instruments included a log, calibrated in mph, echo sounder, and engine oil and temperature gauges. The electrical switches controlled the horn, bilge pump, bathing platform shower and navigation lights. The navigation lights consisted of a combined red and green sidelight unit on the bow **(Figure 7)**, and an all-round white light on top of a 1.95m metal pole, which could be slotted into a socket on the starboard aft bulwark when required **(Figure 8)**. *Carrie Kate's* all-round white light and pole were reported as having been broken, and were not onboard at the time of the accident.

Carrie Kate's helm position

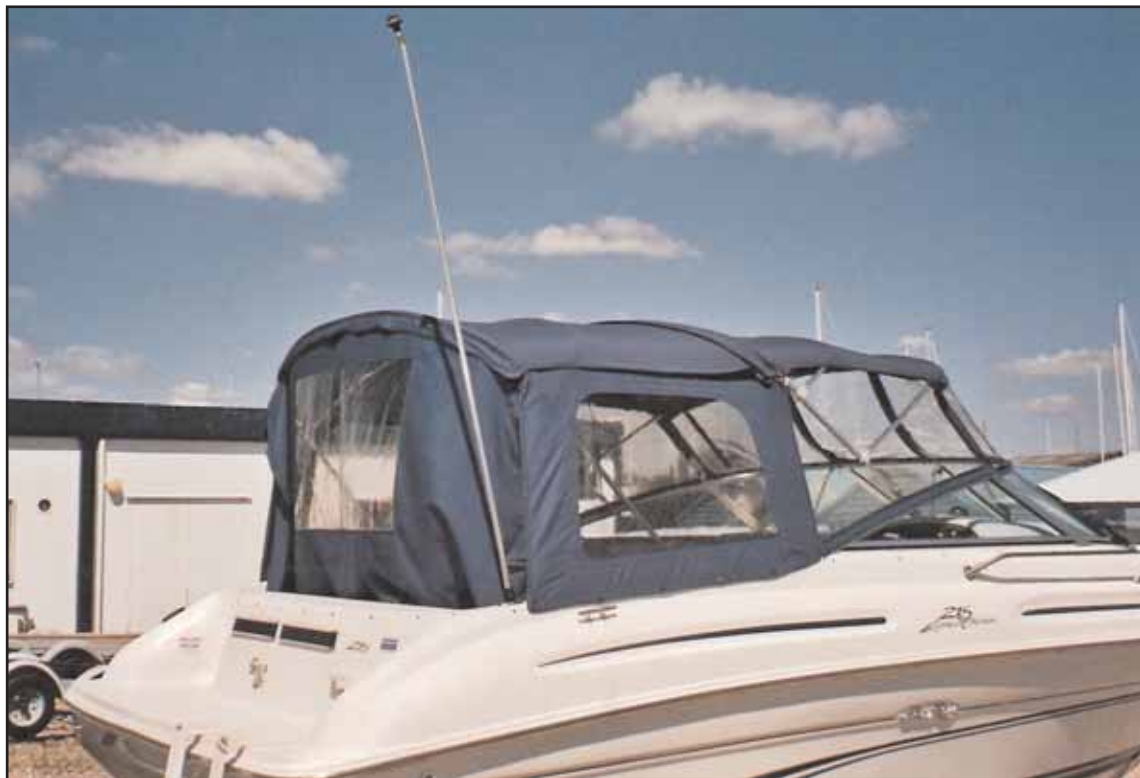
Figure 8b

All round white light shown in position on another similar vessel
