Report on the investigation of
the capsize of the sailing dinghy

Mollyanna

With two fatalities off Puffin Island, North Wales

Report No 9/2006
March 2006

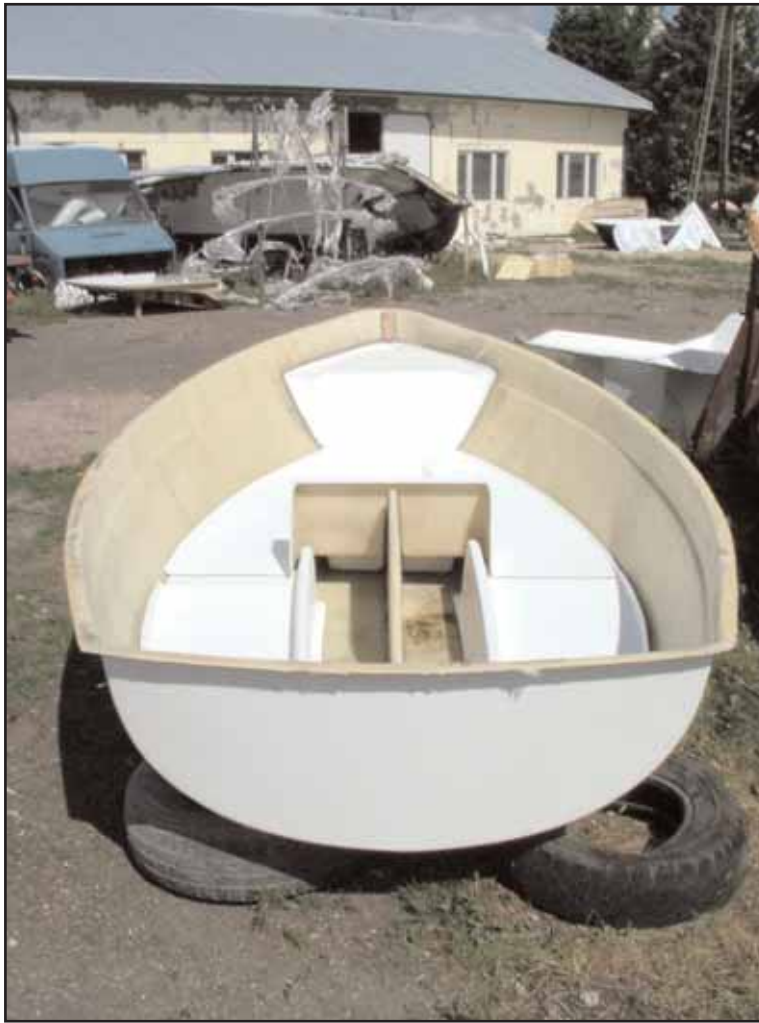
Figure 7

The boat is made from GRP; the hull is made from a single mould, but its inner mouldings including the deck and superstructure comprise several modules, which are attached separately to the hull (**Figures 7 and 8**). The void spaces between the inner-mouldings and the hull, which are not airtight, contain polystyrene, which is cut to fit. The cockpit is self-draining, but the cabin has no drain, or any pumping arrangements. The dinghy is fitted with a pivoted metal centre plate, which can be raised and lowered using a rope pennant in the cockpit. The centre plate can be secured in its raised, but not in its lowered position. The rudder is detachable and is fitted with an "up-line" for raising in shallow water, but is not fitted with a "down-line" to ensure it stays in the down position when in use. Jamming cleats are provided for the jib and genoa sail sheets, but not for the mainsheet. The boat is supplied with three sails: a mainsail, a jib and a genoa. The main sail area is 5.41m², the jib 2.86m², and the genoa 4.4m². It is estimated that the boat makes about 4 knots headway under full sail.

BEZ 2 - modular construction

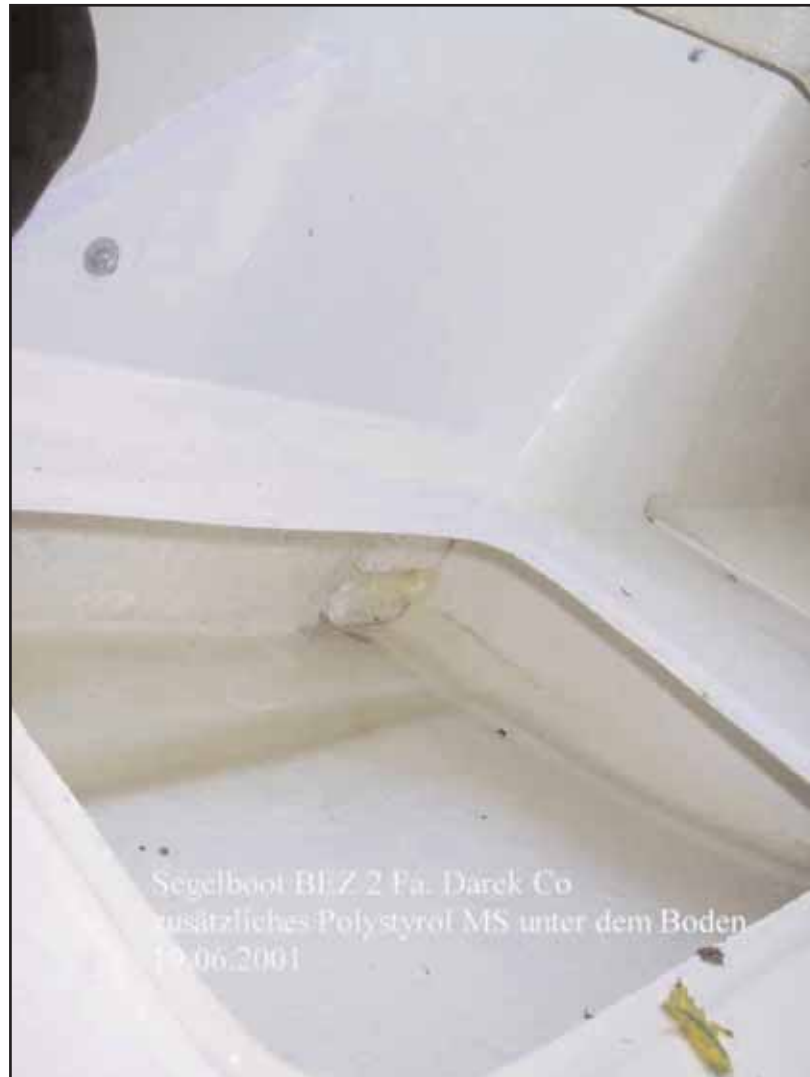
Figure 9

It is not known if, or how, the requirement for the additional flotation required by the test results was passed to Poliglass, but following the tests in June 2001, additional polystyrene was fitted between the boat's deck and outer hull, notably in two storage areas with removable covers on either side of the cabin deck (**Figure 9**) as indicated at **Annex A**. These areas were sealed after 2001.

Under-deck storage
