Report on the investigation of the capsizing  
and loss of the 9.8m stern trawler

***Bounty***

4 miles off Berry Head, South Devon  
on 23 May 2005

**Report No 2/2006  
February 2006**

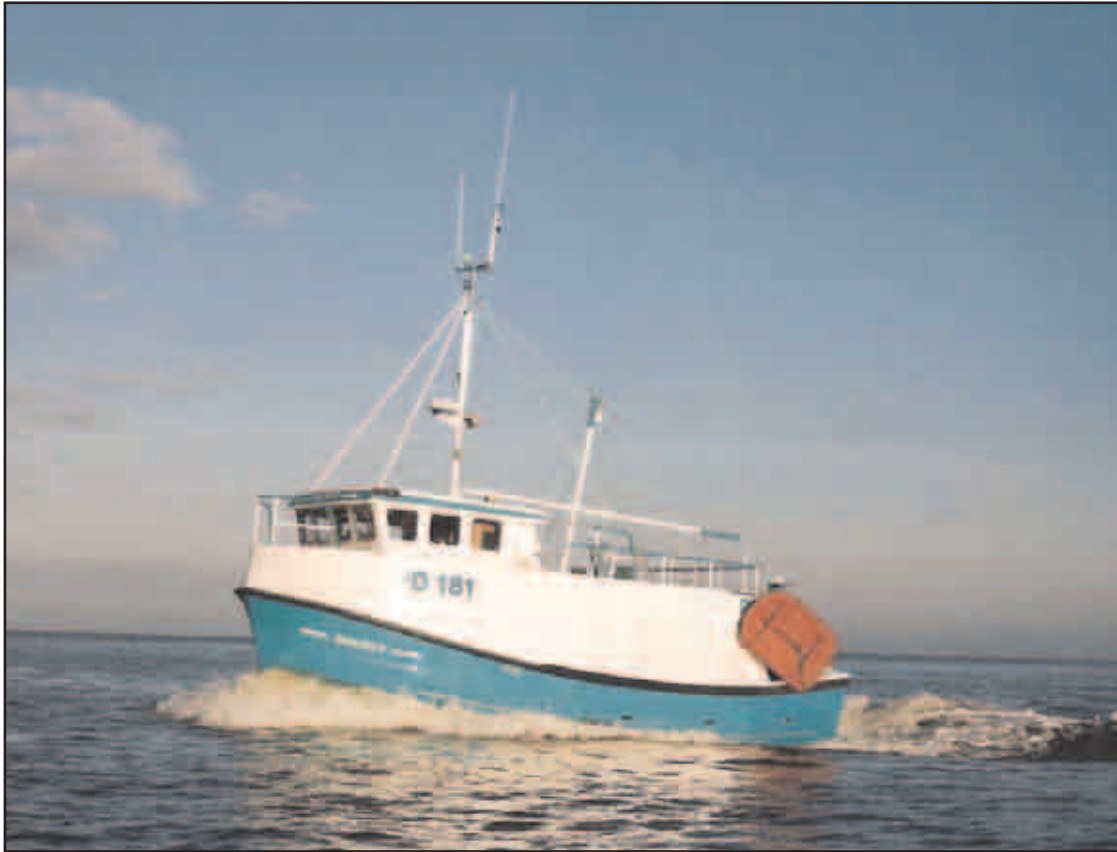
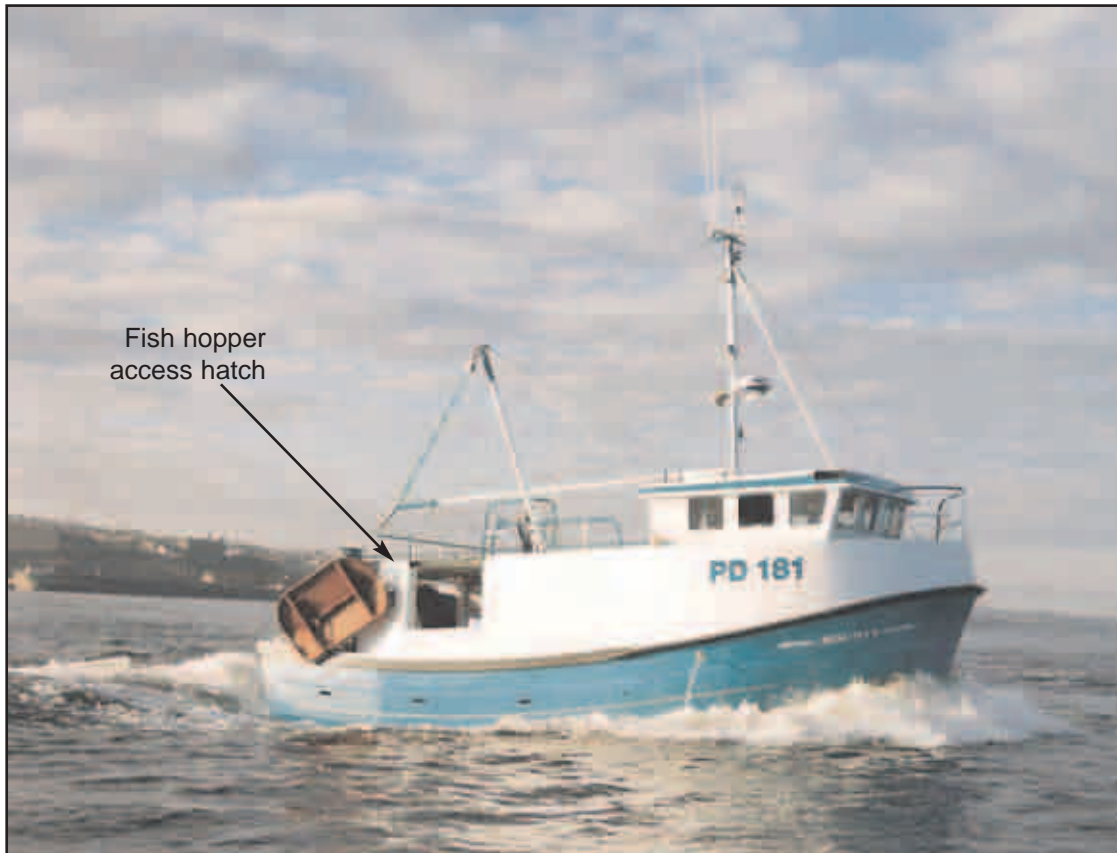
Figure 1

Photographs of *Bounty* are shown in **(Figures 1 & 2)**.

*Bounty* (**Figures 1 & 2**) had a wheelhouse forward and a working deck aft. An aluminium shelter was attached to the wheelhouse and extended aft to the two net drums; it covered most of the working deck. Access to the wheelhouse was through a doorway above a raised step from the working deck on the port side.

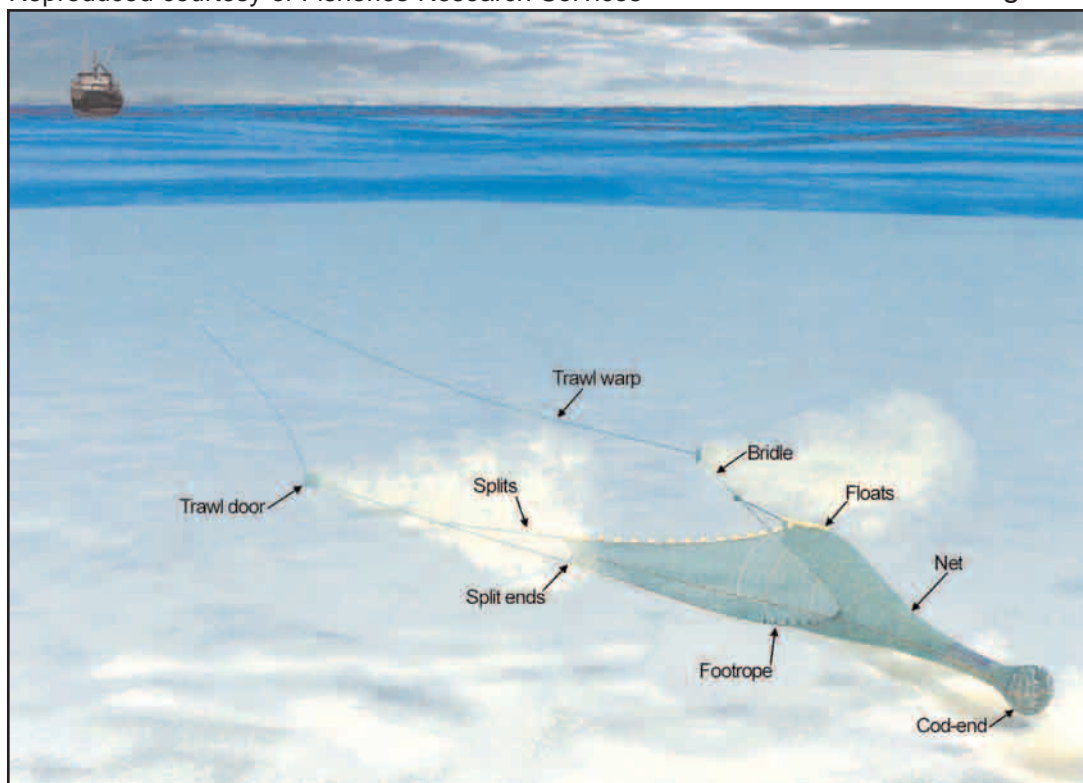
Figure 3

The skipper set the engine control to dead slow ahead and engaged the autopilot to keep the vessel steering in the same direction as she had been towing. He then went into the shelter and operated the hydraulic winch to heave back and bring the trawl warps (**Figure 3**) on board. The trawl doors were then stowed, and the trawl winch was used to start hauling the bridles. The trawl winch was braked when some of the bridle had been wound in, and then, with the crewman standing aft of the net drums, the skipper returned to the wheelhouse. He used a burst of ahead power, about 1500rpm, in an attempt to pull free from the fastener. *Bounty* was effectively anchored to the seabed with

Becoming snagged on an underwater obstruction occurs regularly when bottom trawling. The lower edge of the mouth of the trawl is kept on, or near the seabed by a weighted footrope (**Figure 3**), and a relatively slow towing speed is used. Heavy rubber discs or rock hoppers incorporated into the footrope are used when trawling over a rough seabed, and these were fitted to the nets on *Bounty*. The frequency of snagging will depend on the type of seabed, topography of seabed, trawl design, rigging, vigilance, knowledge of the skipper and the weight of the gear.

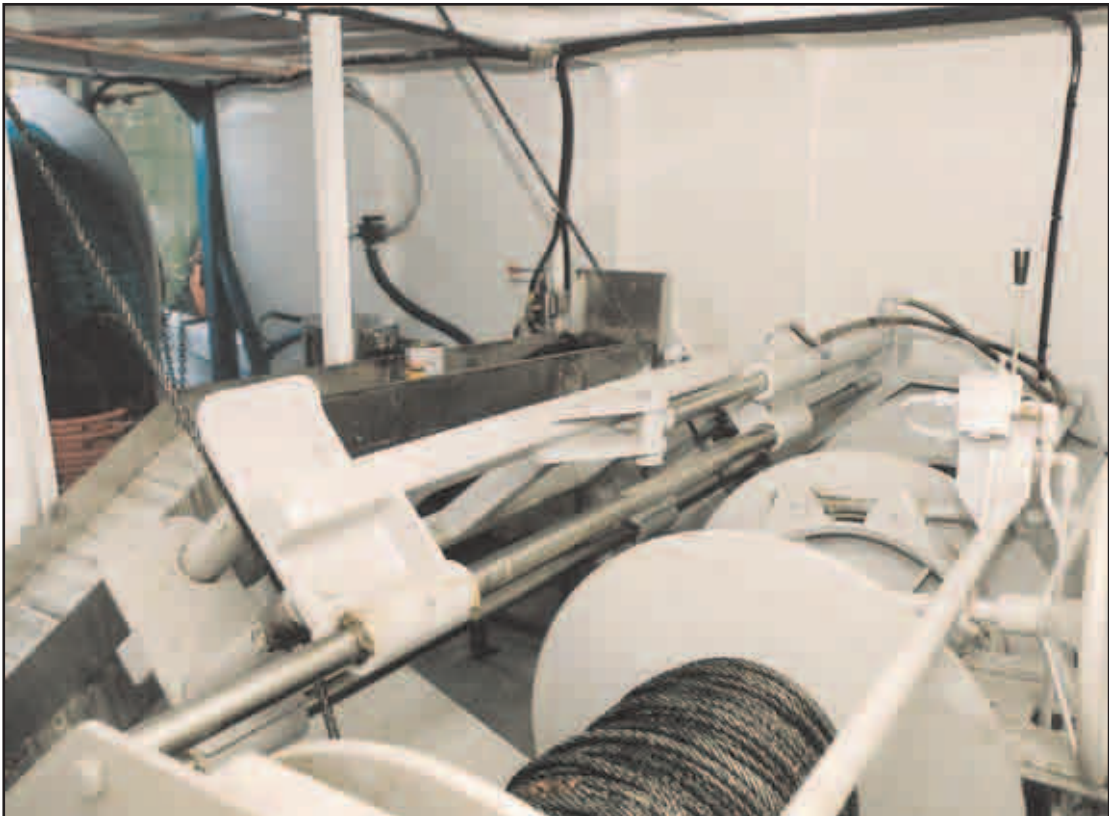
Trawl winch

- Hanging blocks were suspended from gallows at the aft end (**Figure 4**). The warps/bridles/splits (**Figure 3**) were led over the hanging blocks and then down through the shelter top via two pulleys to the trawl winch (**Figure 5**).
- Two split net drums, each with a core pull of 2.1 tonnes, and a weight of 780kg; direct drive low speed/high torque motor without clutch or brake. The nets were wound onto the net drums, after being detached at the split ends, they were hauled over a roller attached to the top of the transom bulwark (**Figure 4**).

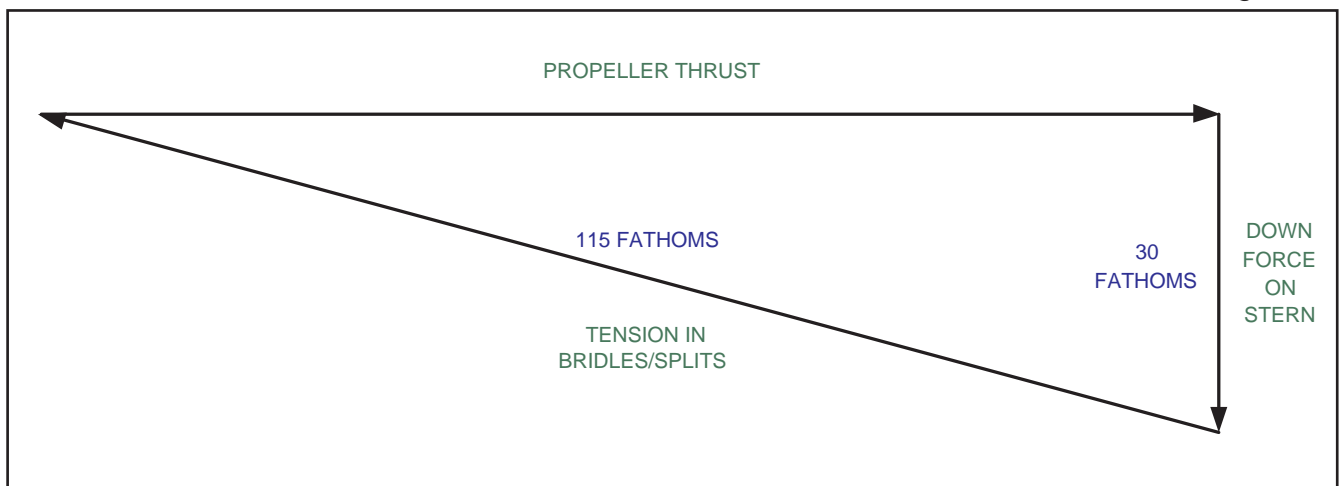
Figure 10

The skipper then used a substantial burst of engine power to try to break free. The 1500rpm that was used was similar to the power applied when cruising at a speed of 8.5 knots. The thrust from the propeller would have been balanced by the tension in the bridle wires and the buoyancy of the stern, as shown in the force diagram (**Figure 10**). The use of engine power forced the stern down, and assisted in allowing the wave to come aboard.

At the time of the accident, it was the first time that the skipper had come hard fast on *Bounty* with significant waves approaching the stern. *Bounty's* inadequate freeboard meant that she did not have sufficient buoyancy to ride over the approaching waves when her stern was held by the fastener.
