Report on the investigation of
the collision between
Lykes Voyager
and ***Washington Senator***

Taiwan Strait

8 April 2005

Report No 4/2006
February 2006

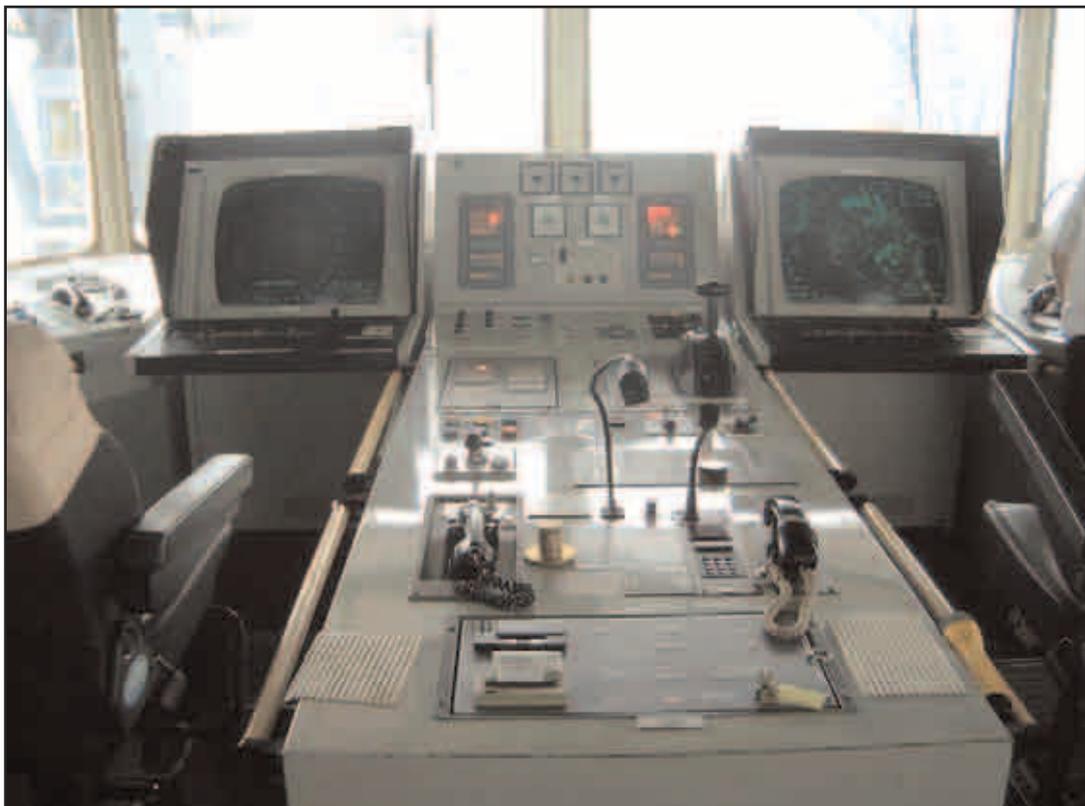
Figure 1

Photograph of the command console on the bridge of *Lykes Voyager*

Lykes Voyager was fitted with two radar displays, one on the port and the other on the starboard side of the command console (**Figure 1**). Both radars were switched on. The starboard display was operating in true motion, fixed origin, and the port display was operating in relative motion. The starboard display was an ARPA display, and was offset to the south west. This display was predominantly set to the 6 mile range scale, which gave a range ahead of about 9nm. The range scale was occasionally adjusted to the 3nm or 12nm scales. The third officer was not familiar with the operation of this model of ARPA display fitted, but felt she had sufficient knowledge to be comfortable when on watch.

Two VHF radios were available on the bridge, sited either side of the command console (**Figure 1**). The port radio was set to channel 16, and the starboard radio was set to channel 88 for communication with the chief officer when working on deck.

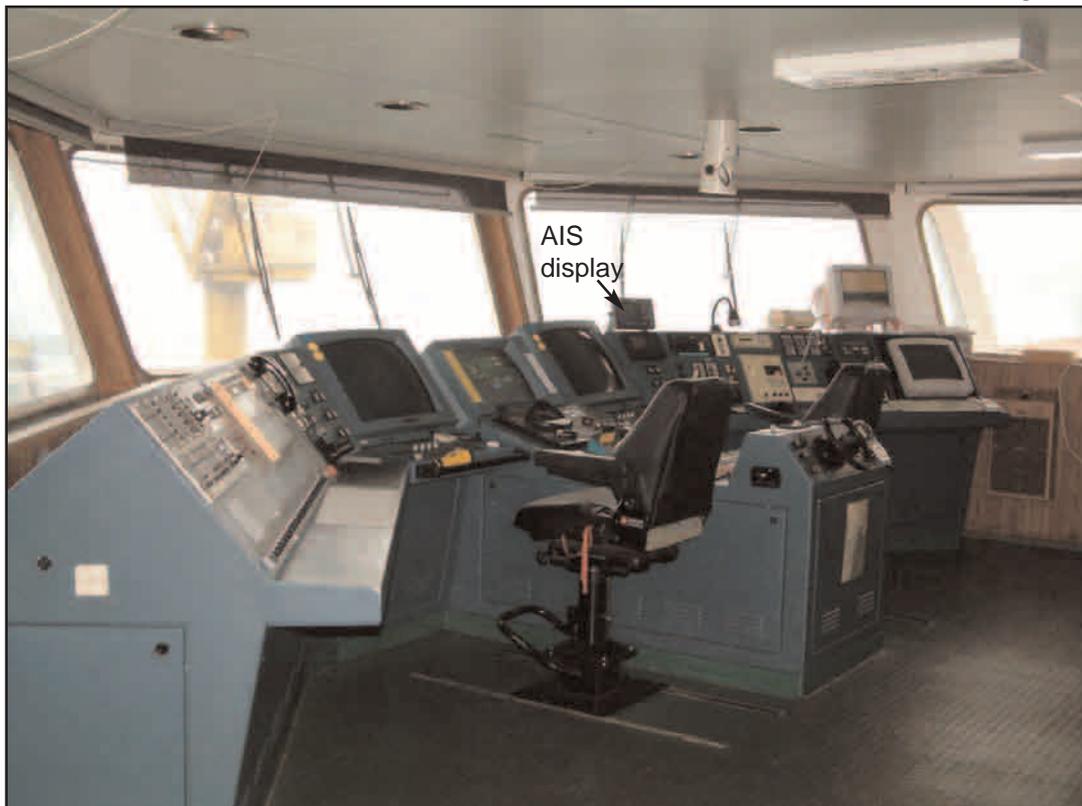
The master arrived on the bridge at about 0905. He initially sat at the port ARPA radar display, and the third officer sat at the starboard ARPA radar display (**Figure 3**). Visibility then reduced to less than 200m. The ship was slowly overtaking a radar target on her port bow, which was on a similar, or only a slightly diverging, course to *Washington Senator*. Its CPA by ARPA was about 9 cables within the next 10 and 12 minutes. Before the master's arrival, the AB lookout had heard a single fog signal on the port side, which had been associated with this target. The third officer saw from the AIS display that this ship was bound for Singapore; he did not note her name.

Photograph of the bridge on *Washington Senator*

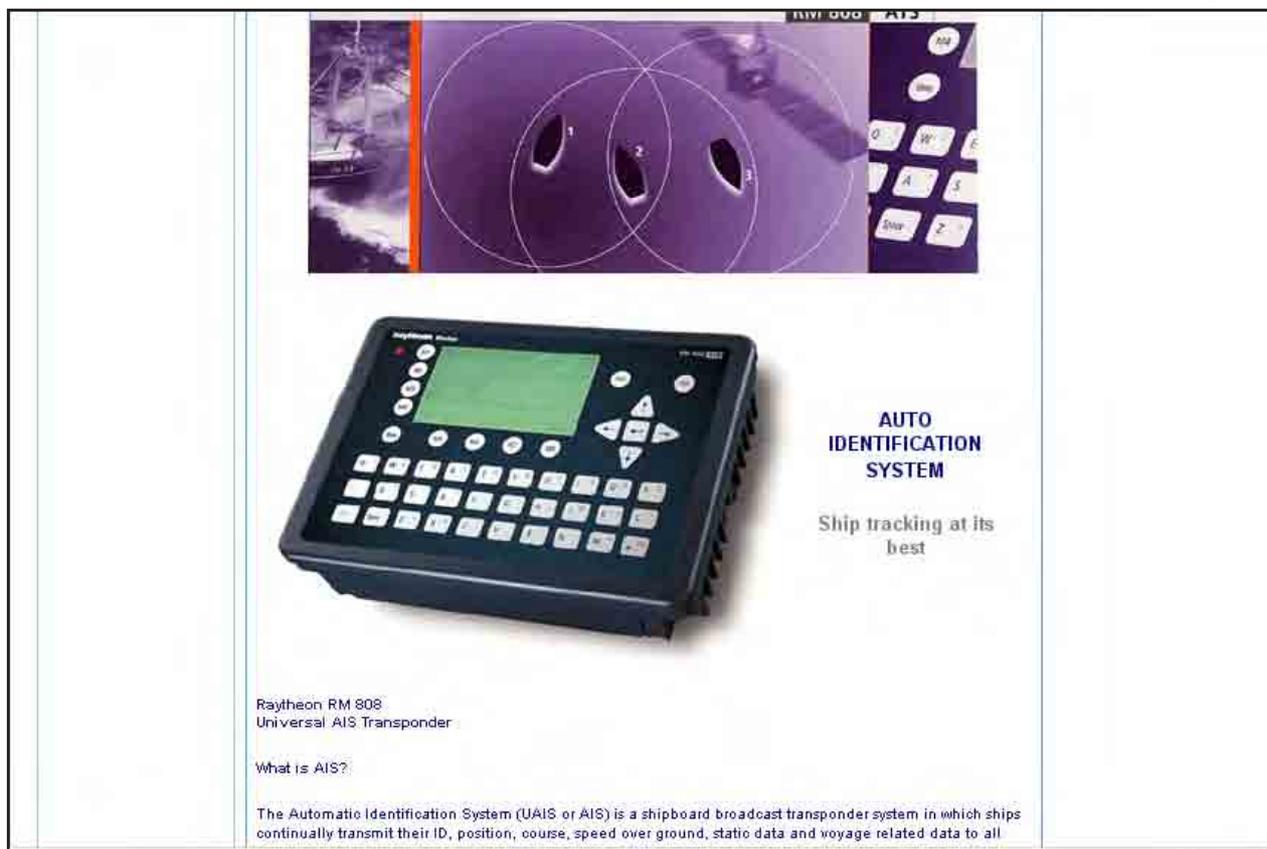
The ship was fitted with a Raytheon RM 108 AIS display (**Figure 5**), sited adjacent to the ARPA display. This was a minimum keyboard display, which showed AIS information as text only. The third officer did not obtain any information from the display regarding the other vessels in the vicinity during the period before the collision, and the transmitted status of the vessel was not amended to 'not under command' after the collision.

Photograph of type of AIS used on board *Lykes Voyager*

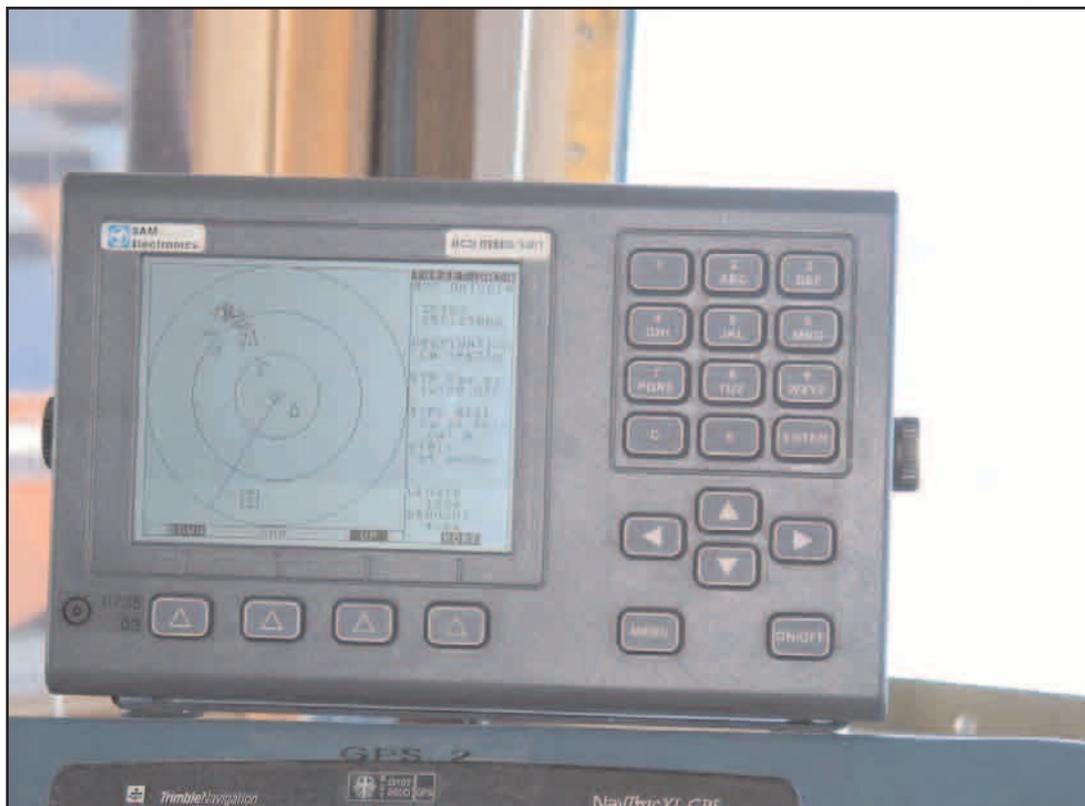
The ship was fitted with a Sam Electronics DEBEG 3401 AIS, which has a graphical display (**Figures 3 and 6**). A VHF radio was sited on either side of the command console, both of which were set to channel 16.

Photograph of the AIS on board *Washington Senator*
