Report on the investigation of the Brenscombe Outdoor Centre canoe swamping accident in Poole Harbour, Dorset on

6 April 2005

Marine Accident Investigation Branch Carlton House Carlton Place Southampton United Kingdom SO15 2DZ

> Report No 22/2005 December 2005

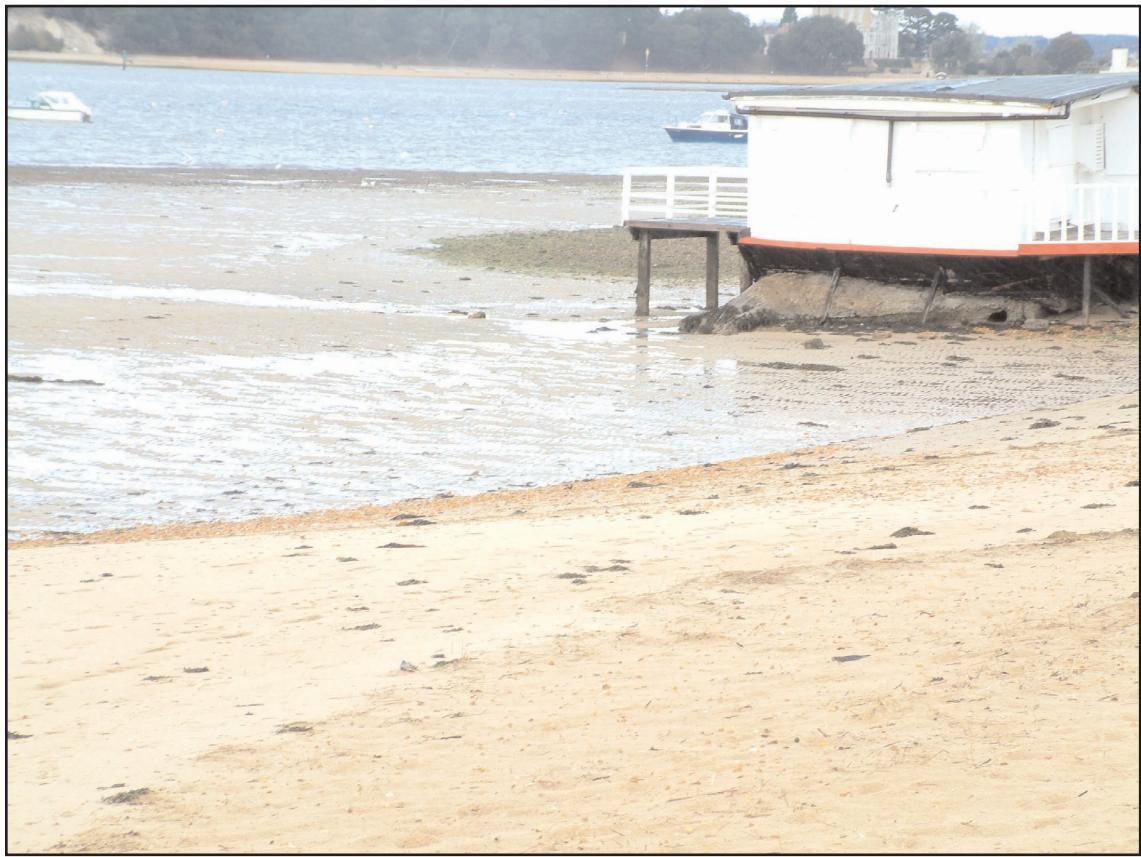
Figure 2

The exercise start point at Bramble Bush Bay is mainly gently shelving sand **(Figure 2)**. The bay is shallow and offers plenty of shelter. However, once past Jerry's Point, the lee of the land is lost and there is a risk of craft being blown by a south/south-westerly wind into the deep water channel known as the South Deep. Lee protection is gained once more after passing Goathorn Point leading onto the final leg to Cleavel Point.

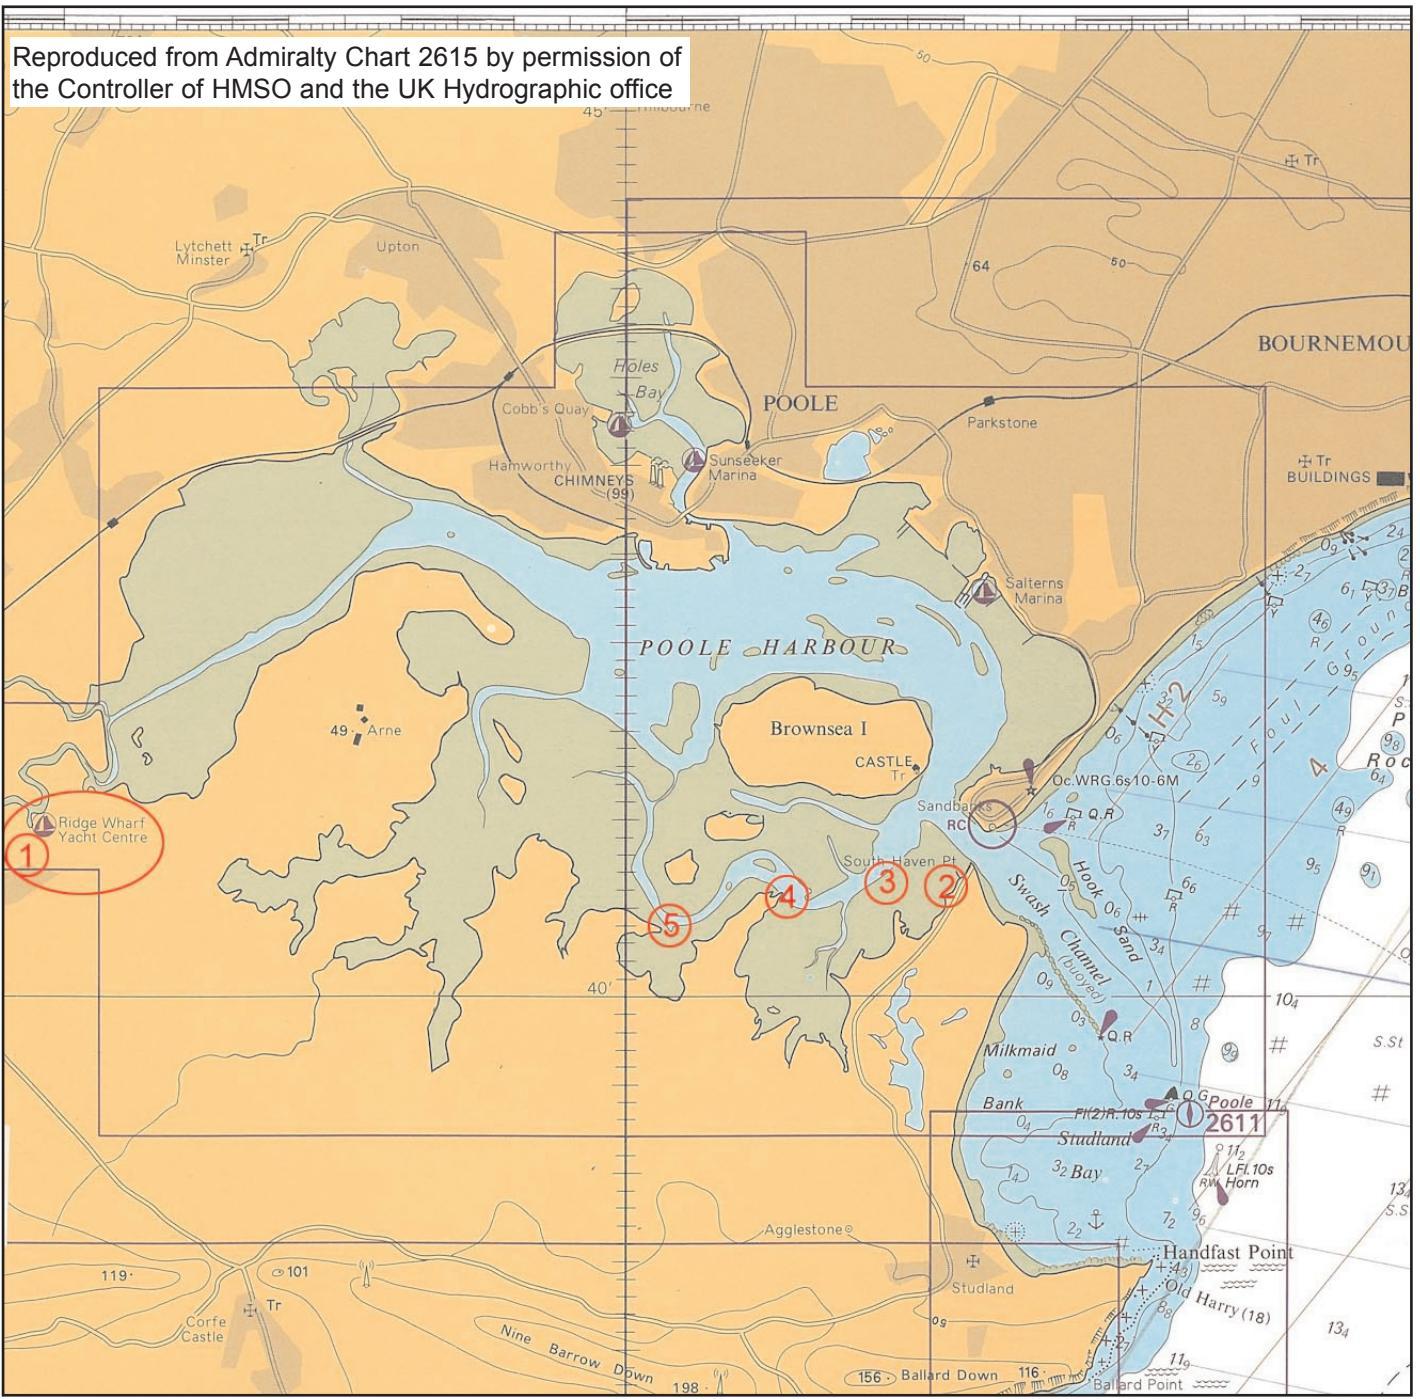
# Figure 3

- 1 Ridge Wharf location of BOC's RIB
- 2 Bramblebush Bay (launching point)
- 3 Jerry's Point
- 4 Goathorn Point
- 5 Cleaval Point

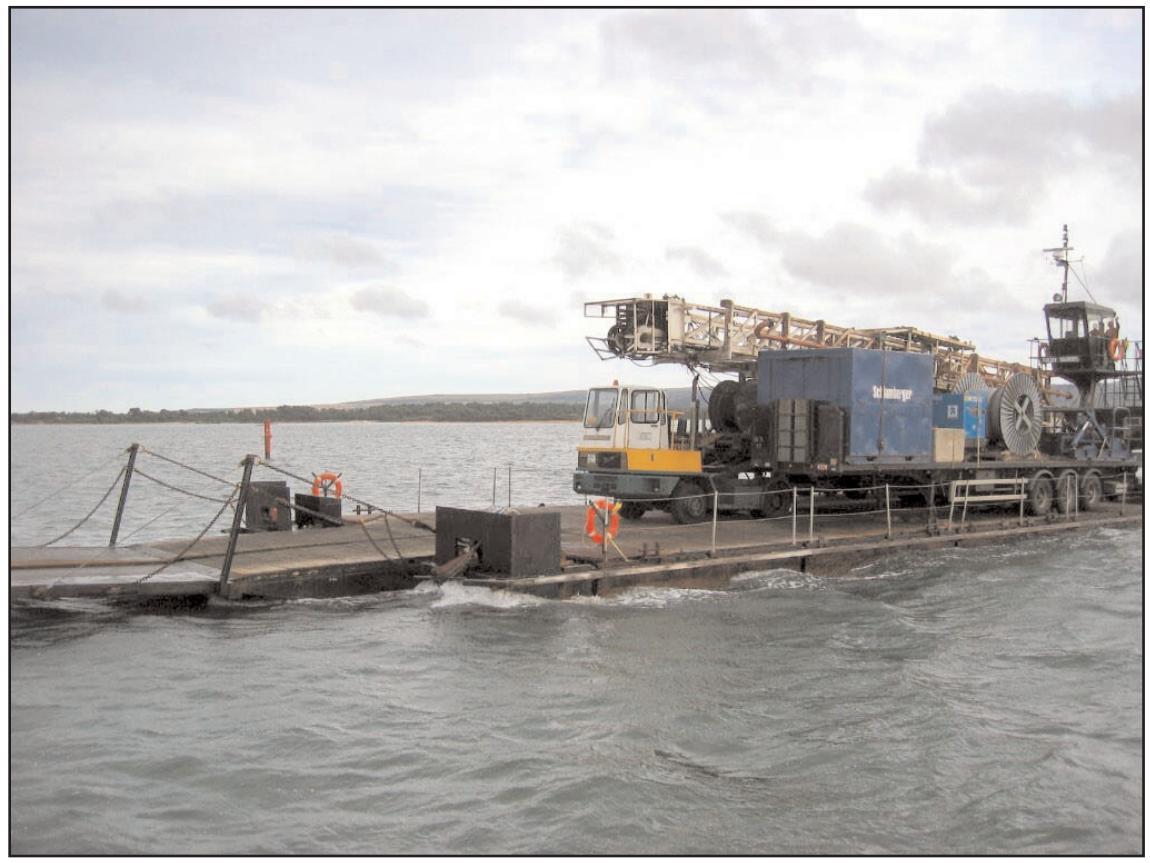
Supply vessel Furzey Squirrel

whole team to get into the safety boat to warm them up and to aid transfer to *Furzey Squirrel.* In doing so, he far exceeded the boat's 4-man capacity. Overloaded and shipping water, the safety boat capsized, plunging the team members, their personal kit, instructors and mobile telephone into the water.
