Report on the investigation of
two people being thrown from a
high-speed rigid inflatable boat
with the loss of their lives
in Milarrochy Bay, Loch Lomond, UK
on 13 March 2005

**Report No 24/2005
December 2005**

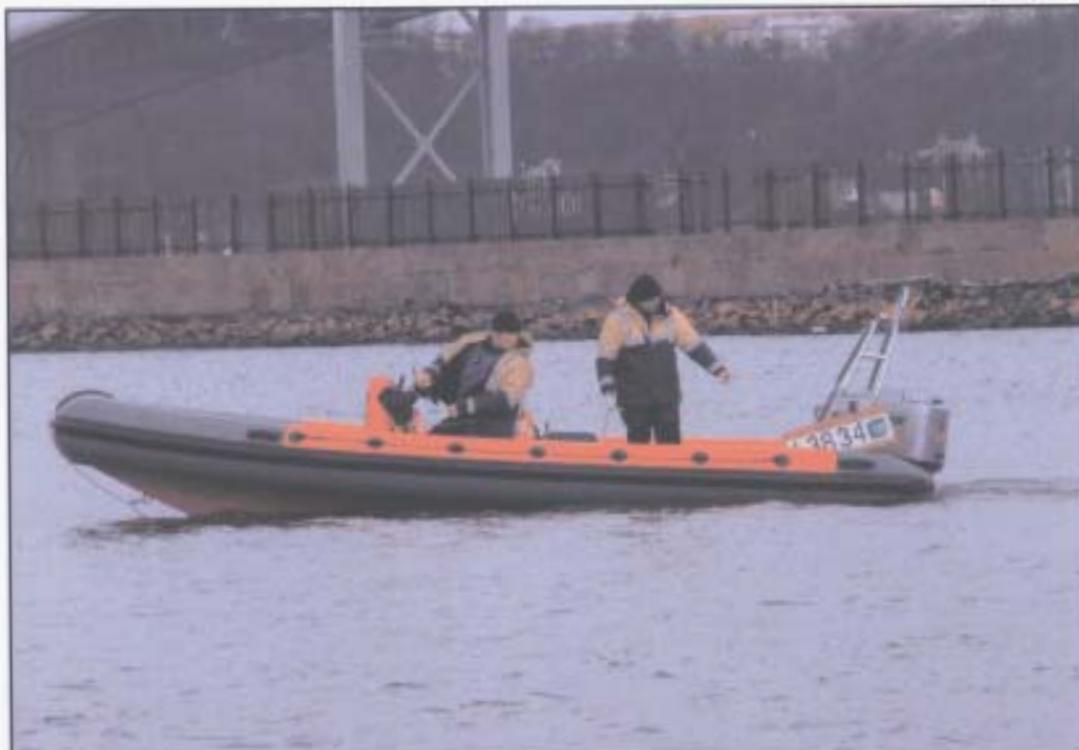
Police officers from Central Scotland's Underwater Search Unit testing the RIB in the Firth of Forth

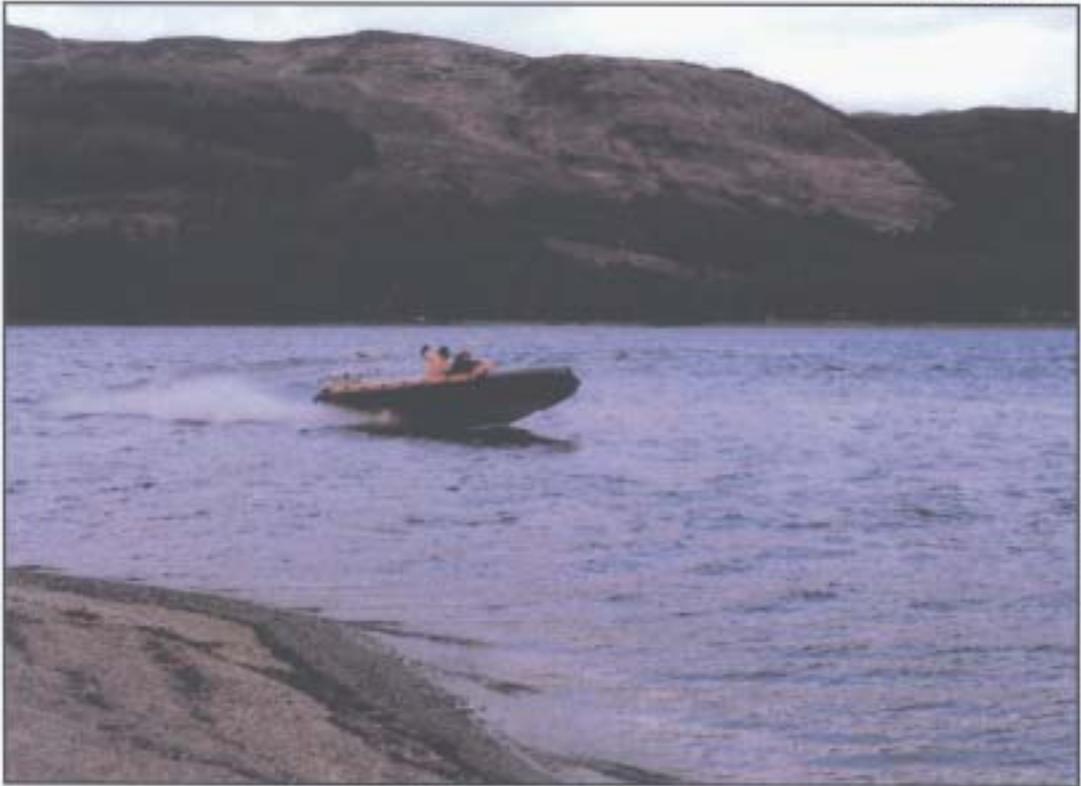
Photograph 3

When the RIB arrived at the island, the elder daughter went ashore and took photographs of the RIB with her father and sister aboard as he manoeuvred the boat at speed clear of the beach (**see Photograph 3**). He then brought the boat onto the beach and they had a picnic lunch. While they were having lunch on the beach it began to snow.

A view of the RIB manoeuvring off Inchlonaig

Shortly after the start of the passage to the island, the elder daughter reported that she had difficulties steering the boat. However, on reaching the island, she went ashore and took photographs of the RIB with her father and sister onboard, manoeuvring at speed, just clear of the beach (**see Photograph 3**). These photographs show that the father was driving the RIB at high speed and making tight turns towards the beach, suggesting that the father did have a certain degree of control of the steering at that time, despite the steering system containing insufficient hydraulic oil. It is therefore possible that any fault or problem with the steering system was intermittent.

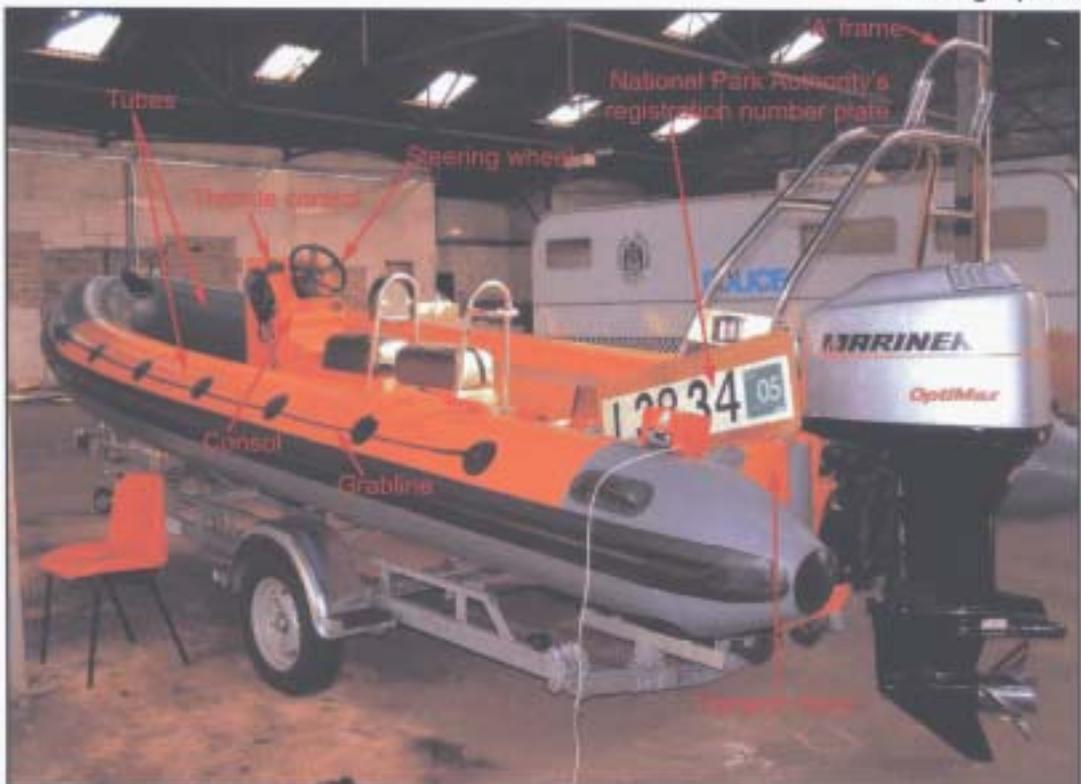
Photograph 4

After lunch, they boarded the RIB to return to Balloch. The father was sitting at the helm, the younger daughter was sitting on the seat behind him, and her elder sister was standing directly behind her and holding onto the backrest (**see Photograph 4**).

The RIB was built by Northcraft of East Yorkshire. It had a glass reinforced plastic (GRP) shallow "V" shaped hull, with buoyancy tubes down the sides of the top of the hull, except for the transom stern. A grab line on each side of the hull was integral to the tubes (see **Photograph 4**).

A stainless steel "A" frame was fitted over the transom stern, to which were fixed the navigation lights along with two of the National Park Authority's registration number plates. These were attached to either side of the frame as shown in **Photograph 4**.

Under the byelaws, all power-driven craft have to be registered with the National Park Authority. Application for registration, or renewal of registration, is made to the National Park Authority. On receipt of the application, the National Park Authority allocates a number to the individual boat. The applicant is required to display the number on both sides of the boat (**see Photograph 4**).

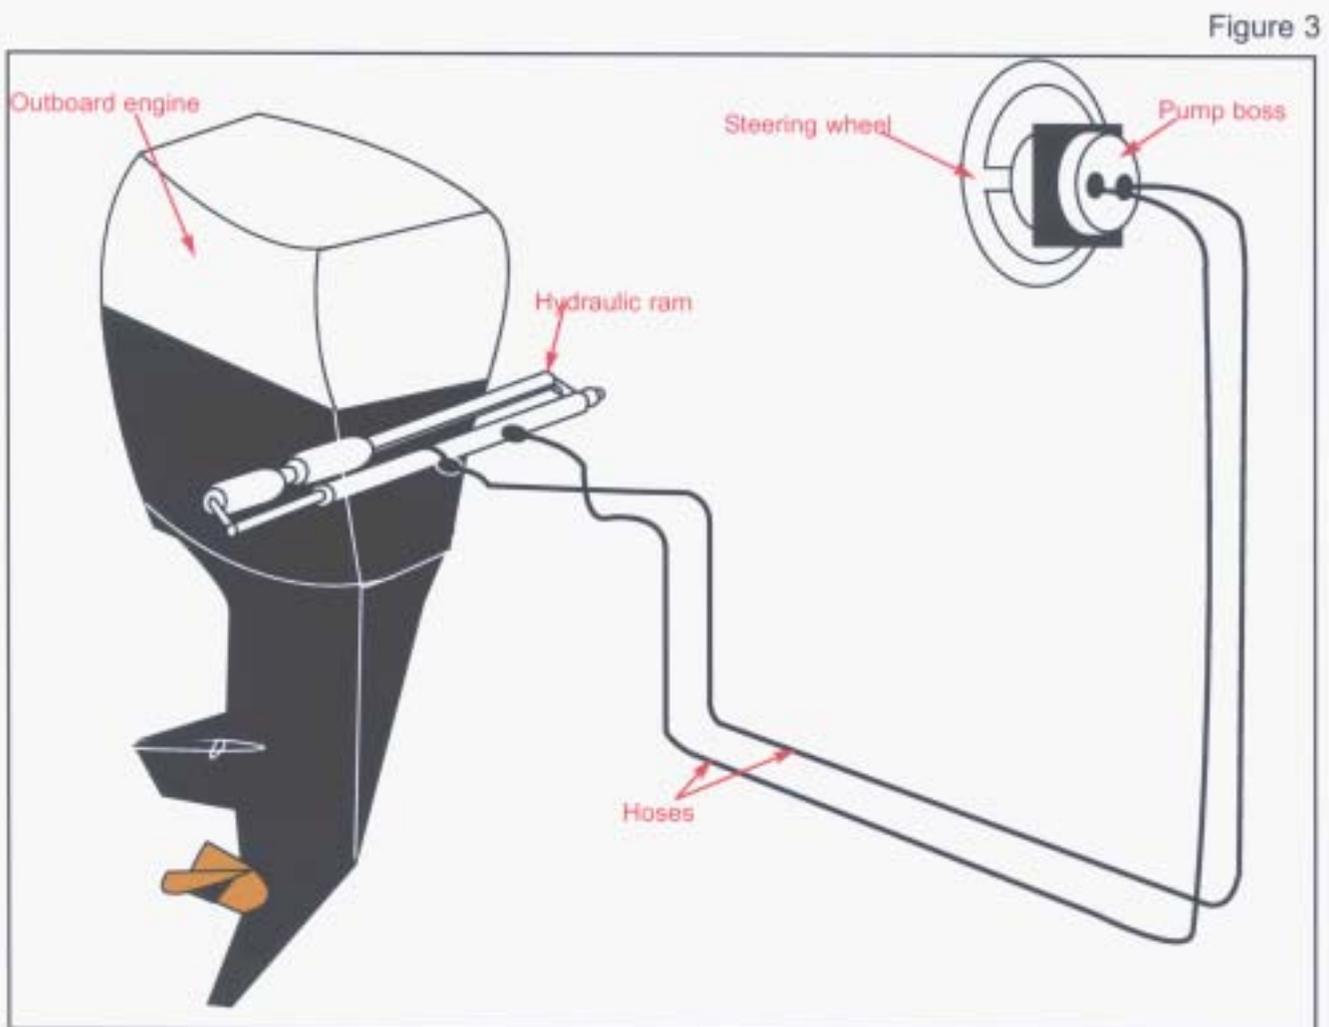
The hydraulic steering system was manufactured by the Italian company Hydrflex. It consisted of the steering wheel which was directly coupled to a hydraulic pump. There were two hydraulic hoses connecting the pump to a hydraulic ram, which controlled the steering by moving the outboard engine. A similar system is shown in Figure 3.

Layout of a hydraulic steering system

This type of hydraulic steering system uses fluid pressure to transfer the movement from the steering wheel to the outboard engine through pipes or hoses containing hydraulic oil. When the wheel is turned to port or starboard, the pump moves a quantity of oil round the system to the appropriate side of a two-way hydraulic ram, causing the ram to move transversely across the transom. The moving part of the ram is connected, by a mechanical linkage arm, to the outboard engine (**see Photograph 6**).
