Report on the investigation of
the collision of the general cargo vessel

Orade

with the Apex Beacon, River Ouse

**Report No 23/2005
December 2005**

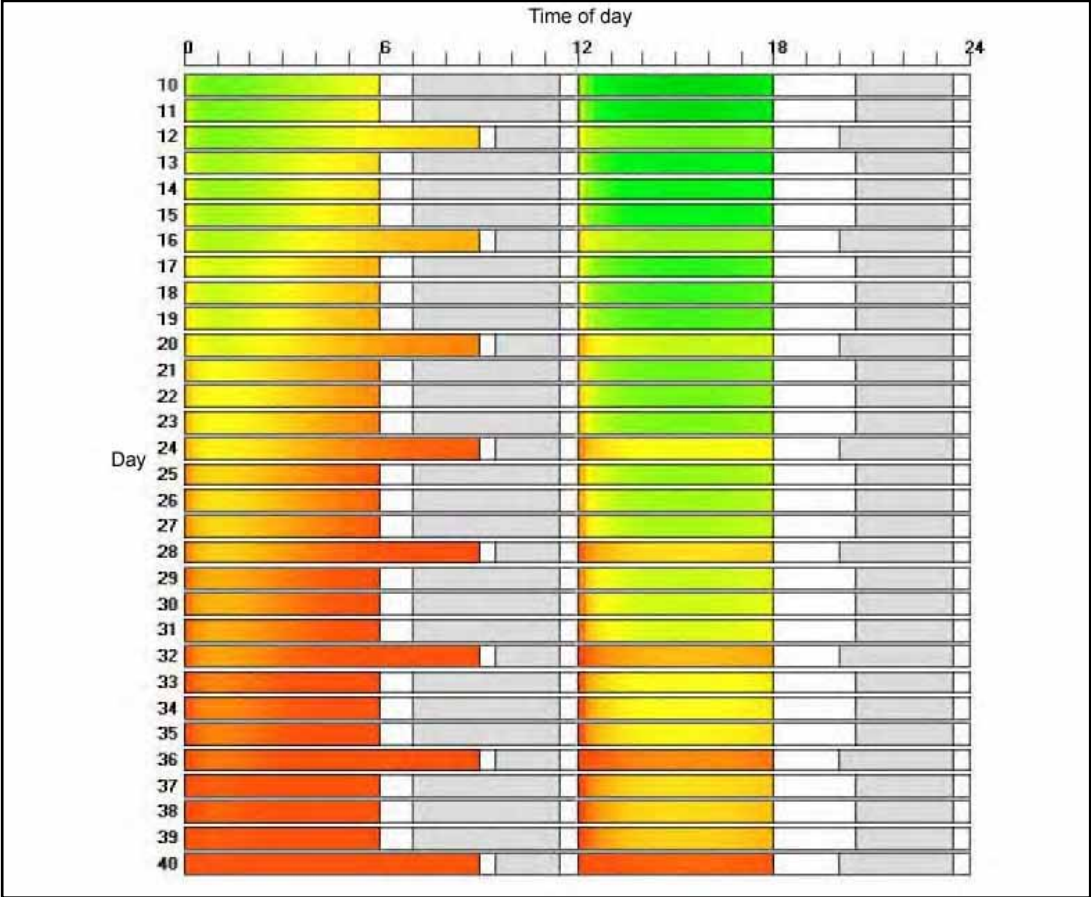
Figure 15a

Further study has taken place with the assistance of QinetiQ Centre for Human Sciences on the effects of 6-on 6-off watchkeeping routines. The results have been highlighted in the MAIB Safety Digest edition 1/2005 (see MAIB website: www.maib.gov.uk). The study used both generic and actual hours of work routines in the short sea trade. These were analysed and compared to research data derived from experiments on air crew. The results, which were adjusted for known differences in the criteria used for analysis, indicated that the watchkeepers in question had reached dangerous levels of fatigue after just 2 or 3 weeks in the routine (**Figure 15a and 15b**).

Chief Officer based on generic data (before day ten he was well rested)

Duty periods are coded red for high risk, yellow for moderate risk, and green for low risk. Sleep periods are in grey.

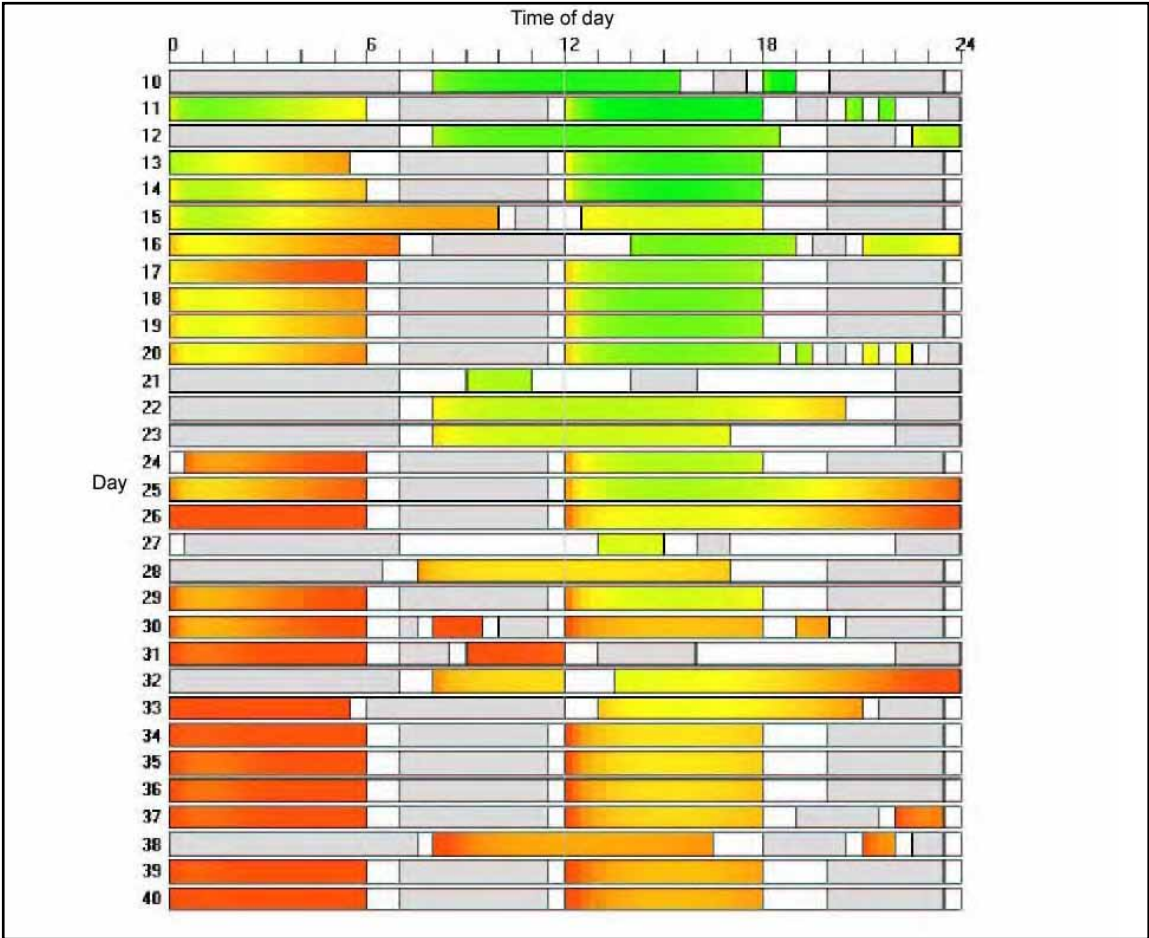
Figure 15b

Chief Officer based on actual data (before day ten he was well rested)
