Report on the investigation of the
grounding of the passenger ro-ro ferry

Sardinia Vera

off Newhaven on

**Report No 19/2005
September 2005**

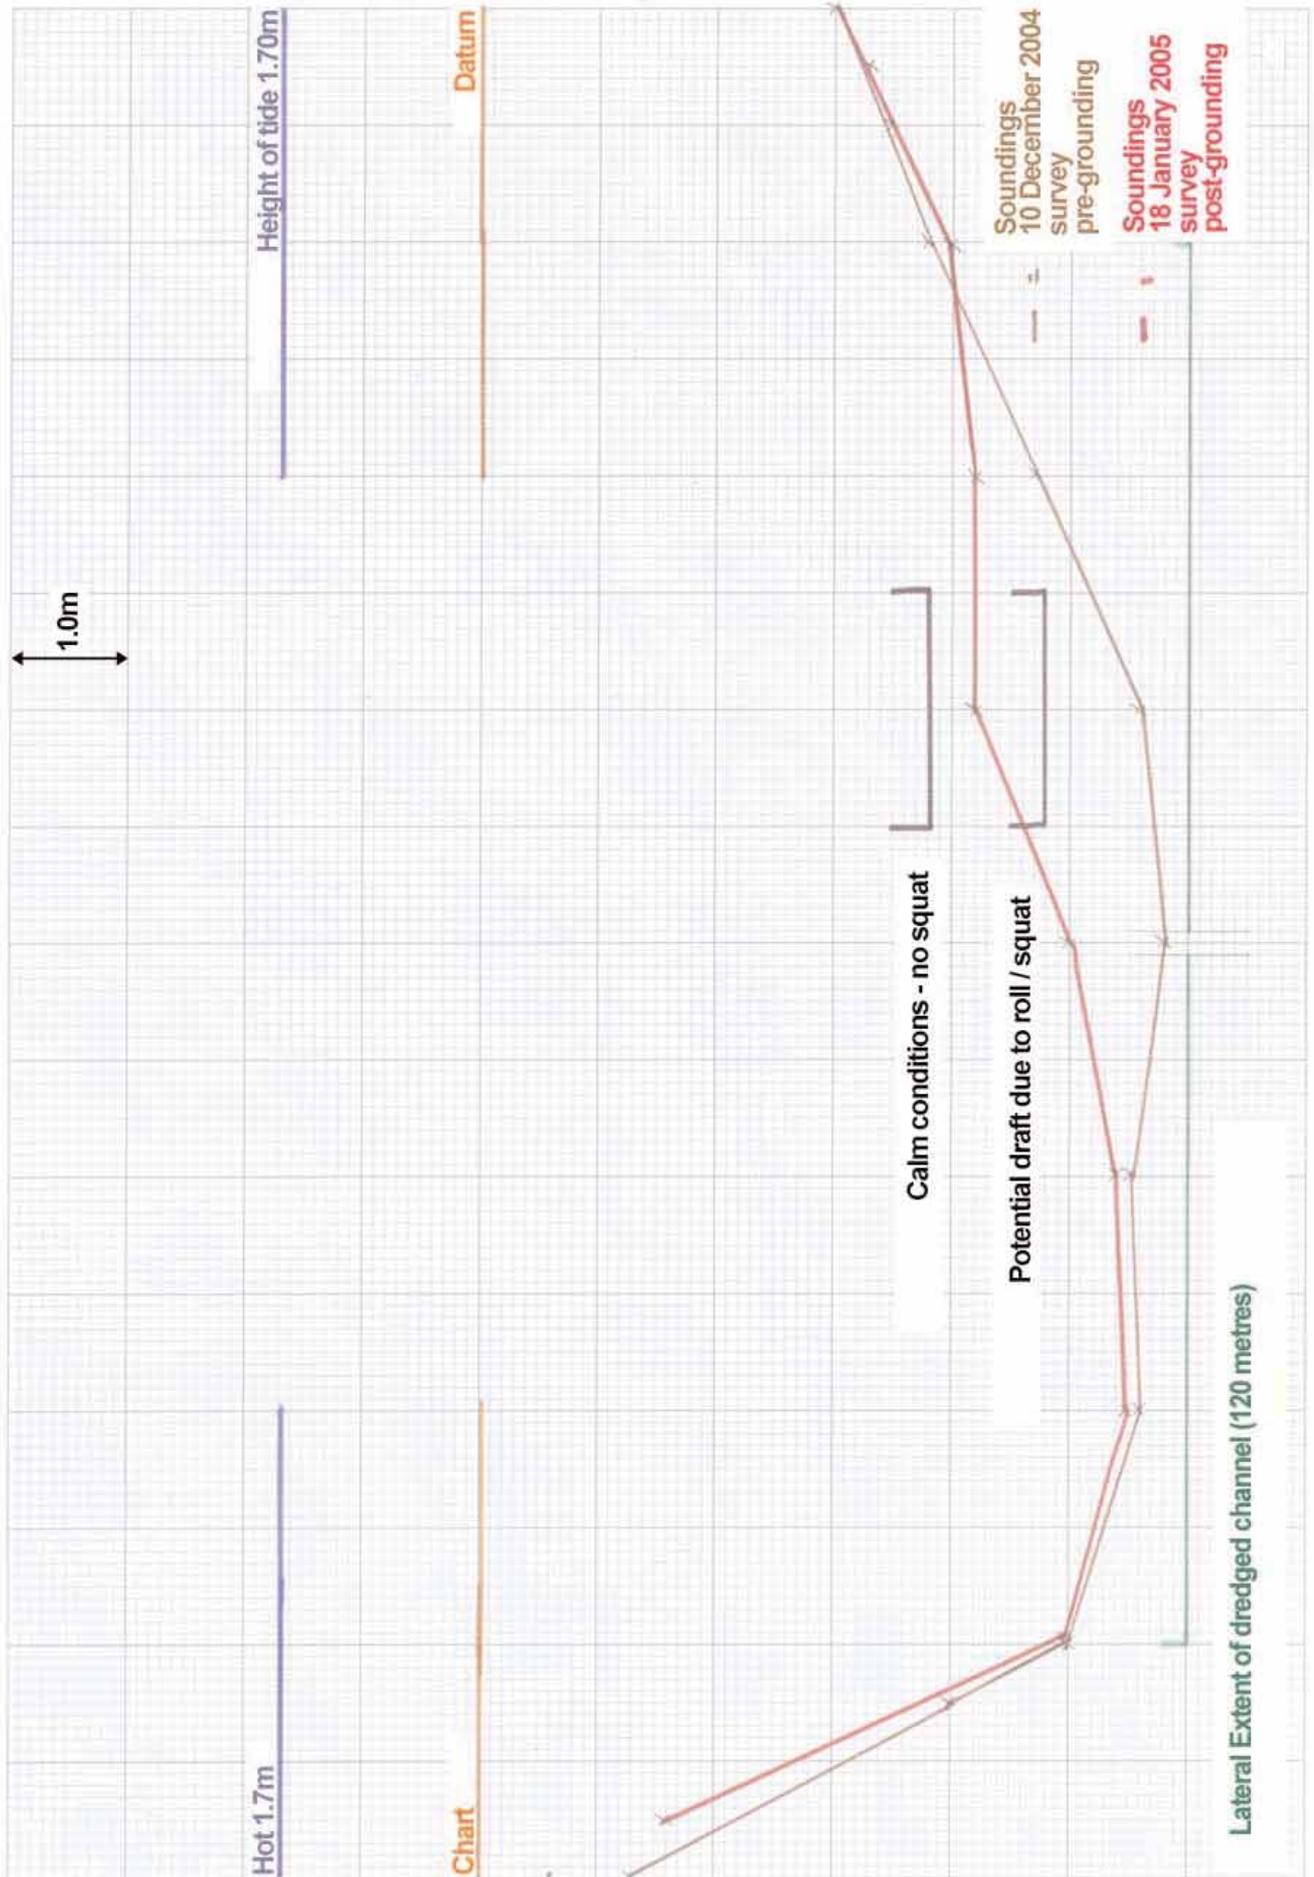
Figure 4

The position of grounding (20 metres to the right of the centreline), had 1.6 metres less water than charted and was 2.0 metres less than the declared dredged depth. With a beam of 19.5 metres and a draught of 5.5 metres, the width of channel available to *Sardinia Vera* at low states of tide had been reduced to three beam widths (**see Figure 4**).
