Report on the investigation of
the collision between

Brenda Prior and Beatrice

Lambeth Pier, River Thames

**Report No 16/2005
August 2005**

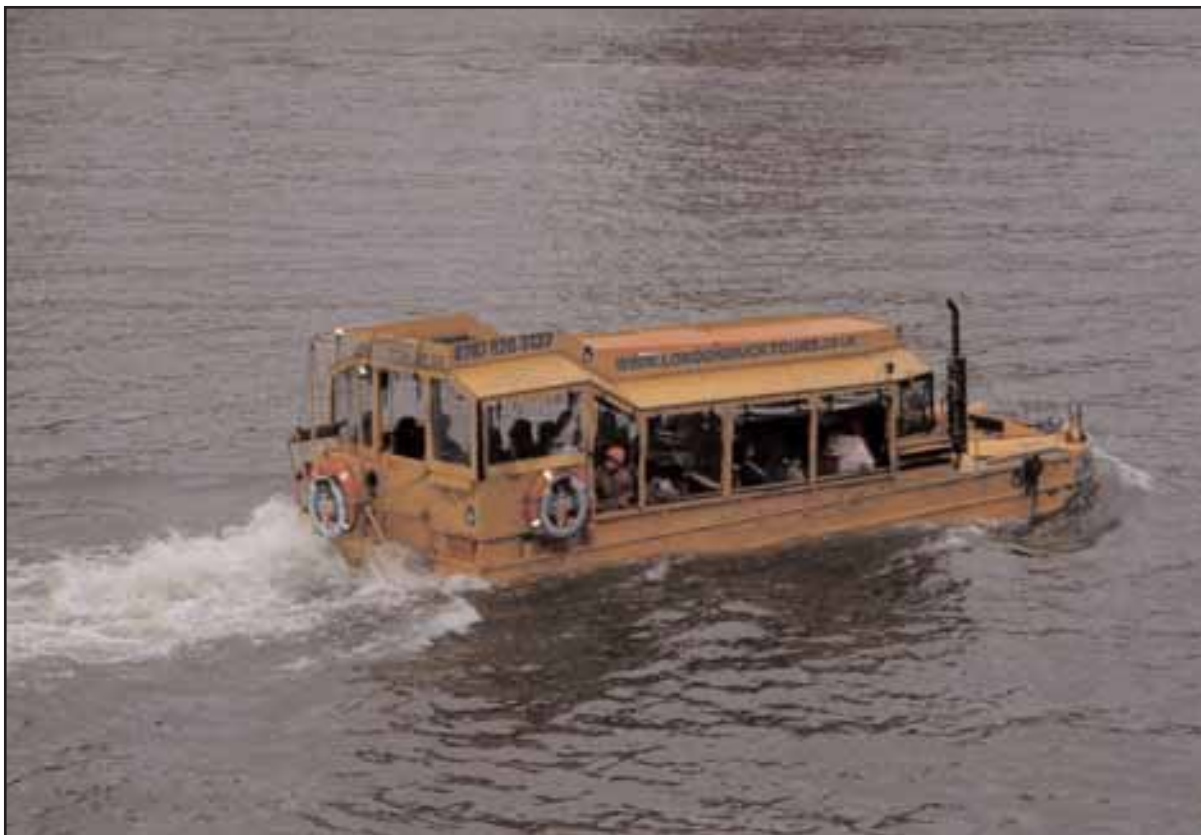
Figure 2

The DUKW *Beatrice*

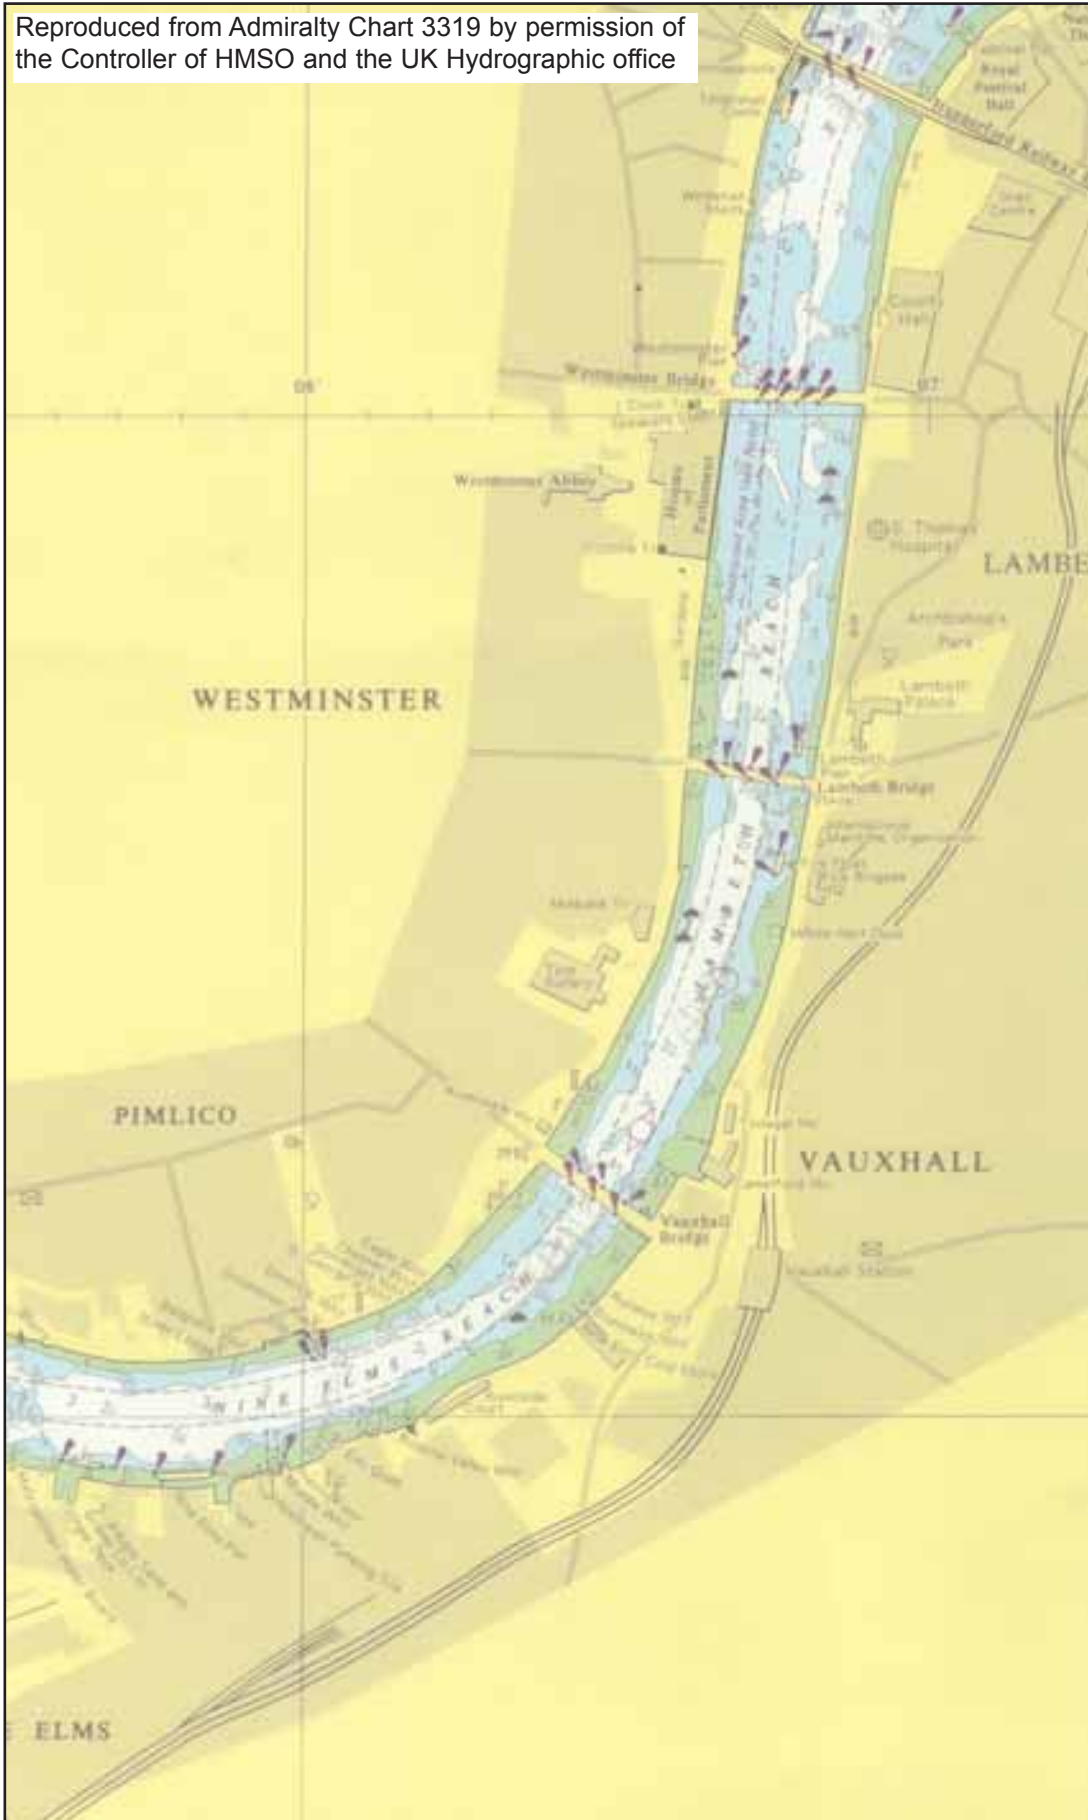
Figure 3

The mate reported that while transiting Nine Elms Reach (**Figure 3**) on approach to Vauxhall Bridge, *Brenda Prior* passed two inbound tugs. The record of warning light activation maintained by the PLA confirmed this (**Annex B**). The master called London VTS just before the charted reporting point at Vauxhall Bridge: *Brenda Prior* was now at three quarters speed, which equated to a speed over the ground of 4.0 knots. Before entering under the centre arch at Vauxhall Bridge, the master asked the mate to keep a good lookout for the DUKW that he knew had entered the water. The mate went to the port wing outside of the wheelhouse and stood on the raised section slightly aft of the wing. He sighted a DUKW approximately half way between Vauxhall Bridge and Lambeth Bridge, close to the starboard extremity of the channel proceeding downstream toward Lambeth Bridge. The mate reported the sighting to the master. With his transponder box switched on, in the downstream mode, the master took the centre arch at Vauxhall Bridge.

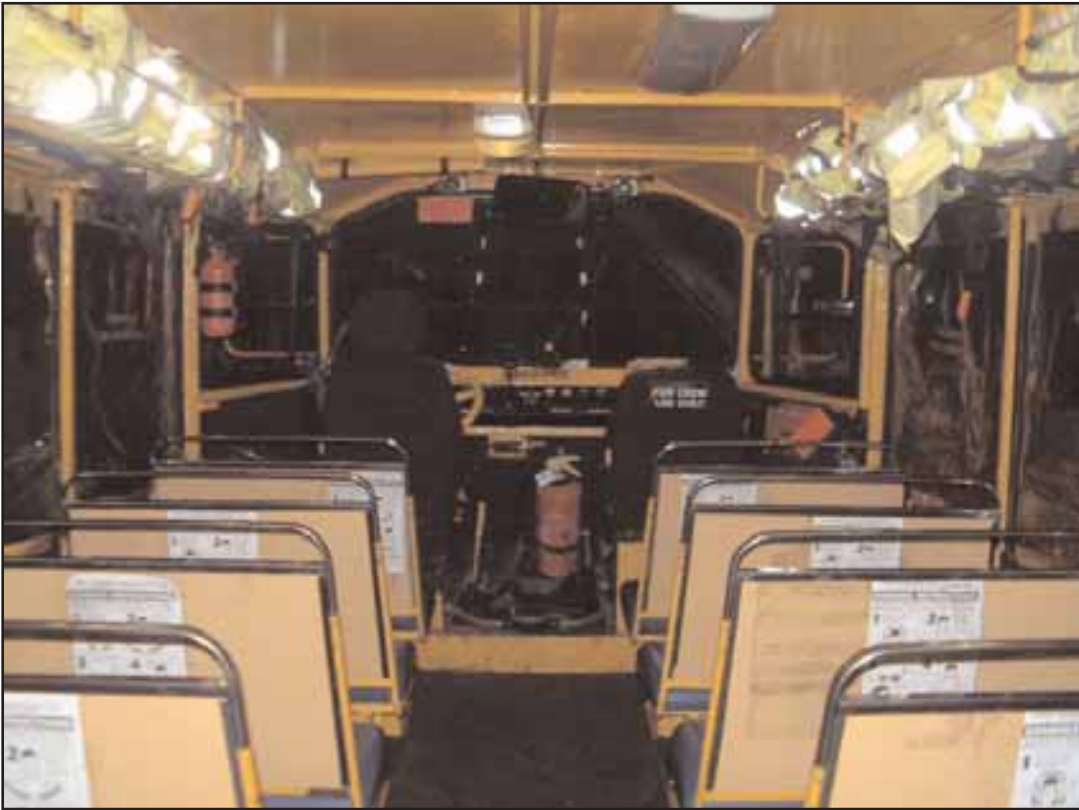
Figure 7

The single interior compartment accommodates the skipper, attendant, and 30 fare paying passengers on standard road transport seating (**see Figure 7**). Protection from the elements is achieved using a solid roof and vinyl side canopies supported by a steel framework. Access is gained by two retractable ladders positioned at the stern (**see Figure 8**).

Interior of DUKW *Beatrice*
