Report on the investigation of

the grounding of

British Enterprise

> Report No 25/2005 December 2005

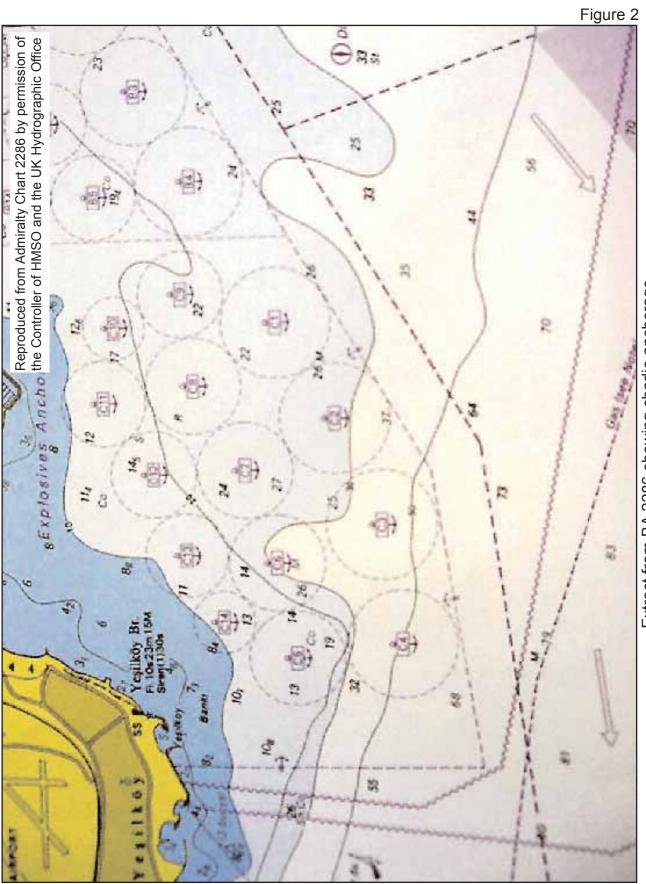
Extract from BA 2286 showing charlie anchorage

The master and third officer checked the vessel's position and assured themselves she should still have sufficient water according to charted depths as indicated on the British Admiralty chart in use, BA2286, *The Southern Approaches to Istanbul Bogazi (The Bosporus)*. The master began implementing the company emergency contingency plans, which included sounding and checking all tanks and voids, and inspecting the vessel for cargo leakage. The master then attempted to manoeuvre her clear of the uncharted shoal or obstruction.

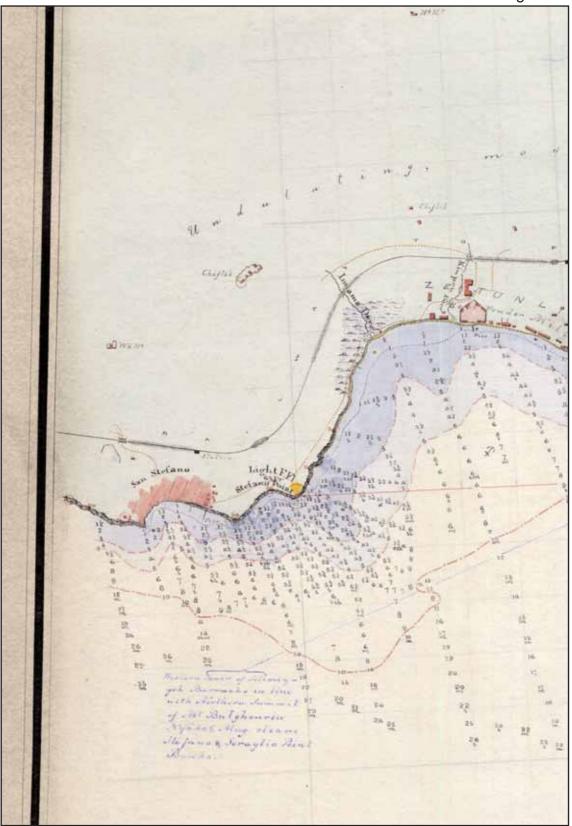
Figure 15

A larger scale Admiralty chart of the area (chart 2286) was published in 1882, based on the survey of 1879 **(see Figure 15)**.

Extract from the survey sheet (A6805) 1879 by HMS Fawn

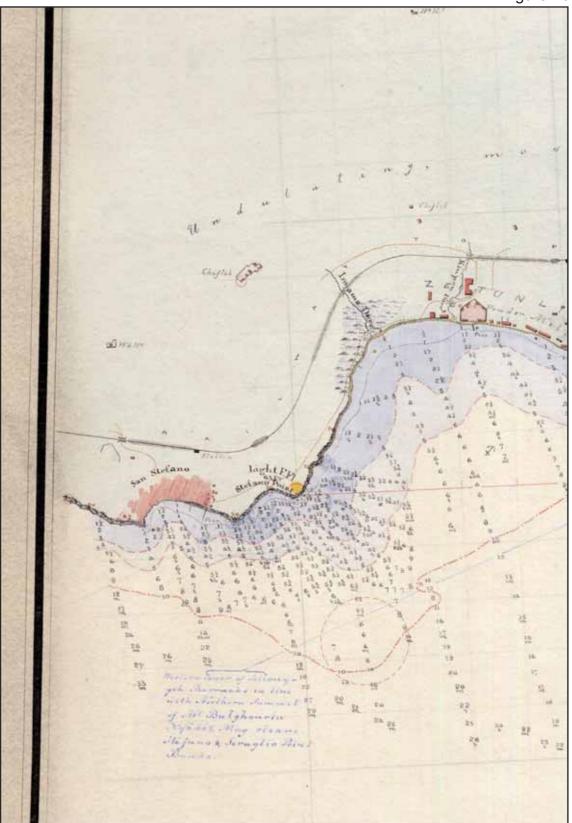
Figure 16

The MAIB has superimposed C5 anchorage on the 1879 survey details (**see Figure 16**), and, after converting the imperial soundings to metric, the results were put on a plan of C5 anchorage (**see Figure 17**).

C5 sector superimposed upon 1879 survey report (soundings in fathoms)

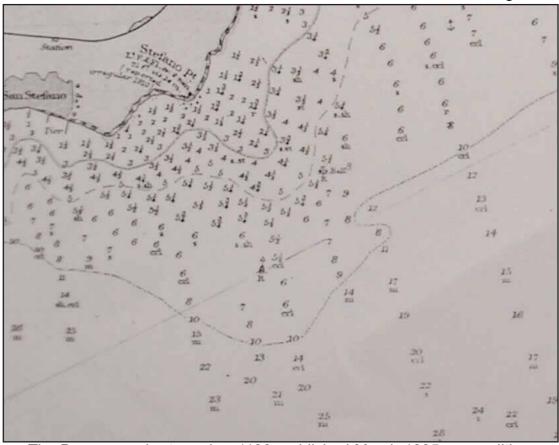
The Bosporus, chart number 1198, published March 1905, new edition November 1915 (soundings in fathoms)

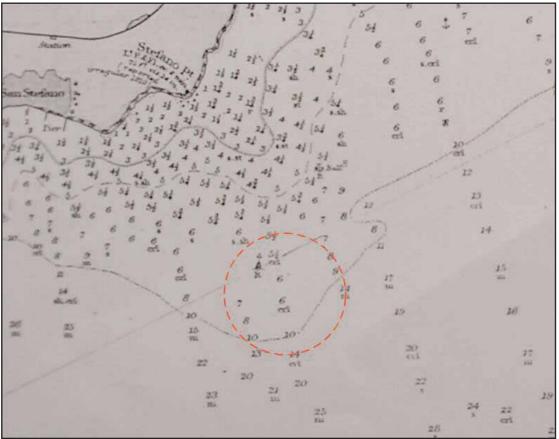
Figure 20

C5 anchorage superimposed upon the 19th November 1915 edition of chart 1198 published 4th March 1905 (soundings in fathoms)

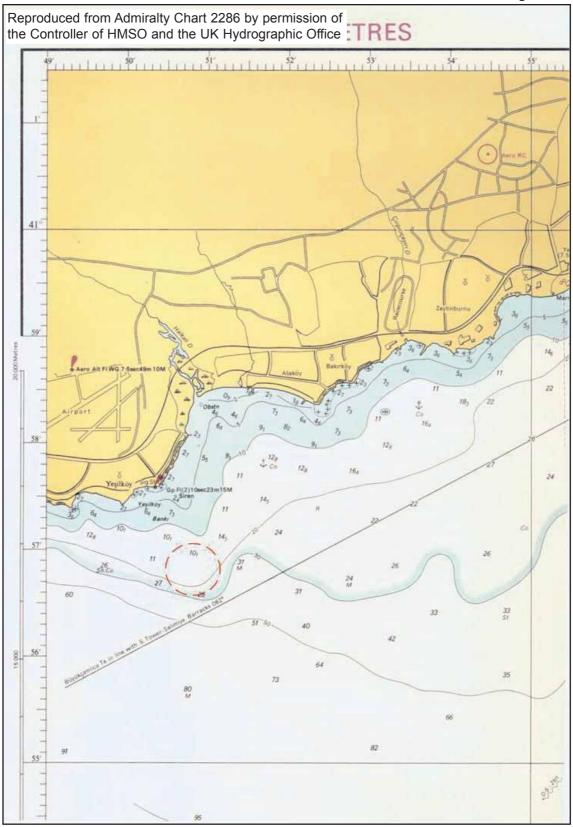
The UKHO published a new metric version of BA2286 in 1975. **Figure 20** shows an extract from the first edition of the 1975 chart, with C5 anchorage superimposed. No new British survey had been undertaken and, in accordance with International Hydrographic Organisation (IHO) guidelines, the UKHO used Turkish chart TR2923, which had been published between 1965 and 1971, as the source of the latest hydrographic information.

1975 BA chart of area Edition 1 (soundings in metres)

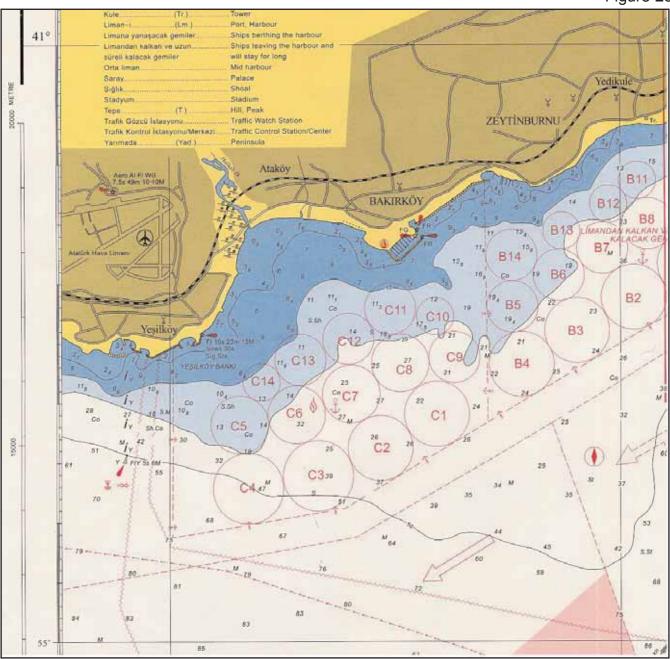
Figure 24

After the accident, Turkish notice to mariners 19/2005 was issued on 29 January 2005, following a survey of the area by THO. The survey revealed the minimum sounding within C5 anchorage to be 6.1 metres. The notice to mariners was accompanied by a chart block correction for chart TR2923. **Figure 24** shows the block inserted onto the chart.

2000 Turkish chart of area showing Charlie anchorage area
