Report on the investigation of
the grounding of
Stolt Tern
Holyhead, Wales
1 December 2004

Marine Accident Investigation Branch
Carlton House
Carlton Place
Southampton
United Kingdom
SO15 2DZ

Report No 18/2005
September 2005

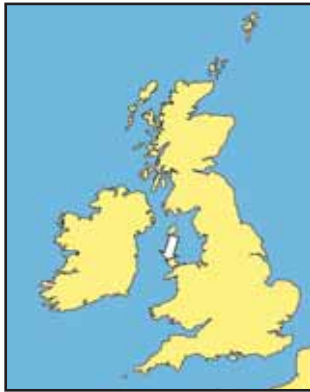
At 0940(UTC) on 1 December 2004, the Cayman Islands registered product tanker *Stolt Tern* ran aground off the south eastern end of the breakwater in Holyhead, following passage from Immingham. The vessel was re-floated the same morning and proceeded to an alongside berth. The ship was carrying 4000 tonnes of gas oil. However, despite damage to the vessel, including a split to her hull, there was no pollution.
