Report on the investigation of
the collision between
Cepheus J and Ileksa
in the Kattegat
22 November 2004

**Report No 12/2005
July 2005**

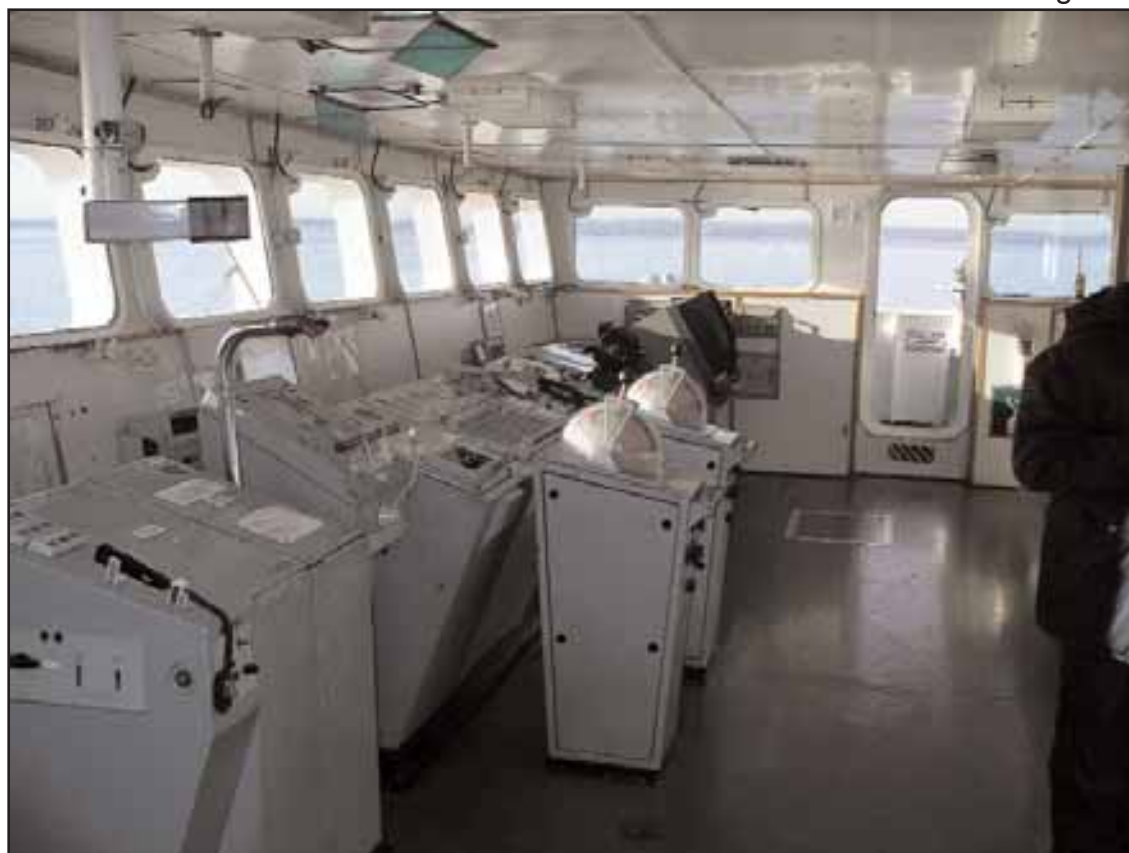
Figure 7

The bridge equipment on board *Ileksa* complied with the requirements of SOLAS for a vessel of her size, but included an additional radar. The radar displays were placed on either side of the engine and steering control console, which was arranged such that the helm controls were at the centreline (see **Figure 7**). Both radars were manufactured by Furuno, and had 50.8cm high resolution colour displays. Each radar was fitted with a basic plotting aid (E plot), and had the facility to display target trails. The radar scanners were mounted above the bridge, on a gantry. This gantry created shadow sectors on both radars, which extended abeam, and were a maximum of 5° wide. This did not affect the radar picture in the fore and aft direction.

Ileksa's bridge

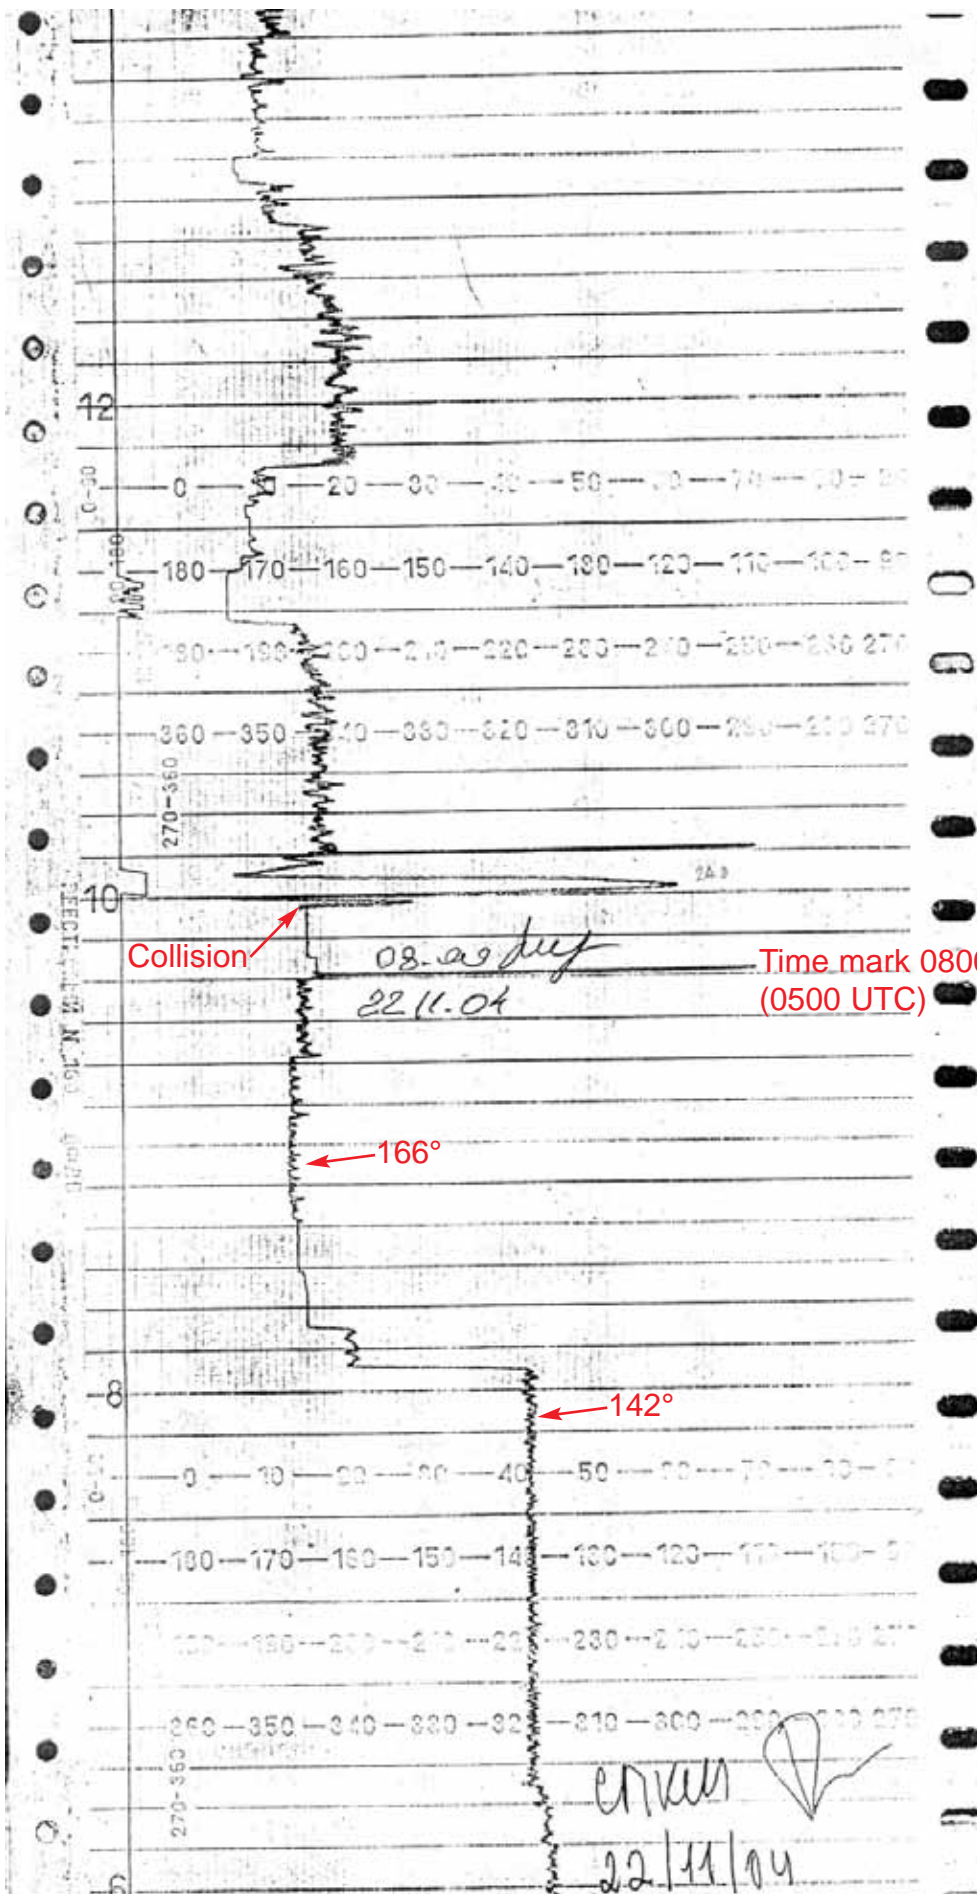
Course recorder trace - mv Ileksa
