Report on the investigation of  
explosion and fire  
on  
***Border Heather***  
in Grangemouth  
Firth of Forth, Scotland  
31 October 2004

**Report No 5/2006  
February 2006**

At about 1823 UTC on 31 October 2004, the 2159gt Isle of Man registered tanker *Border Heather* suffered an explosion and fire in her forecastle while in Grangemouth. Significant damage was caused to the vessel's structure and systems but no-one was injured and there was no pollution.

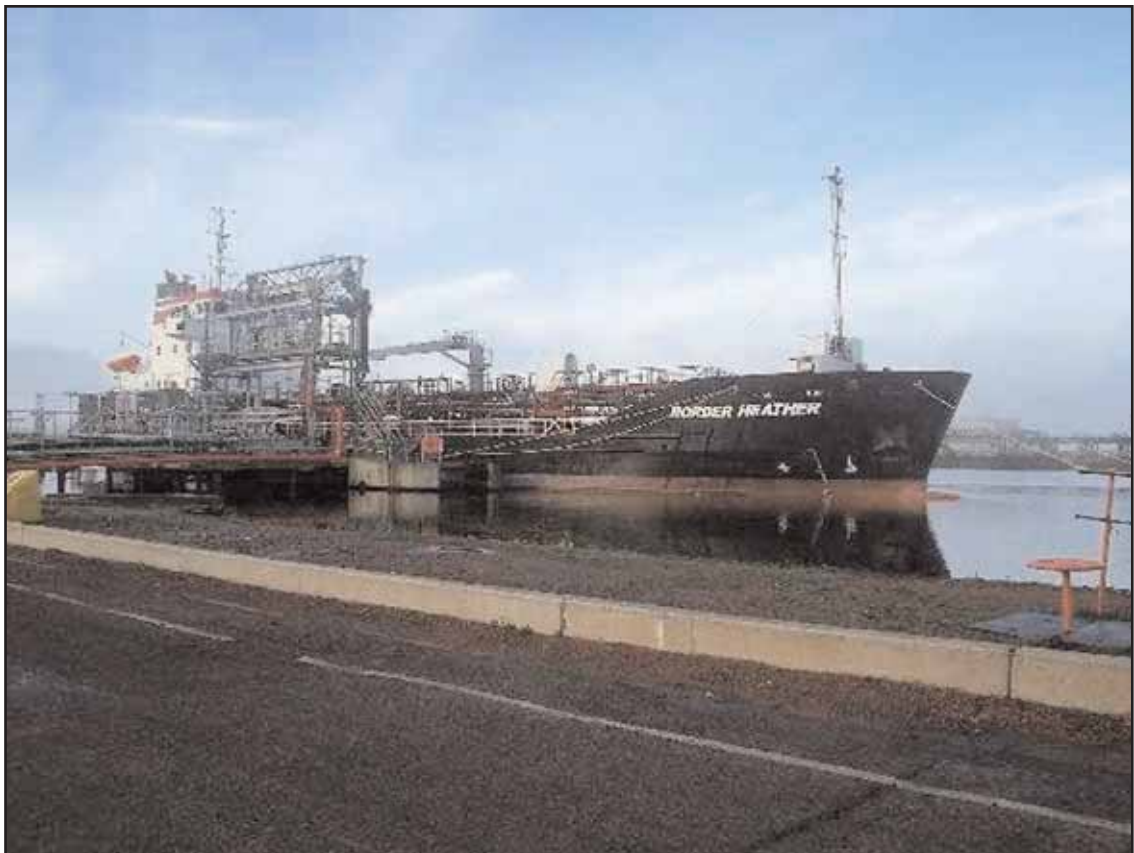
Figure 3

*Border Heather alongside*

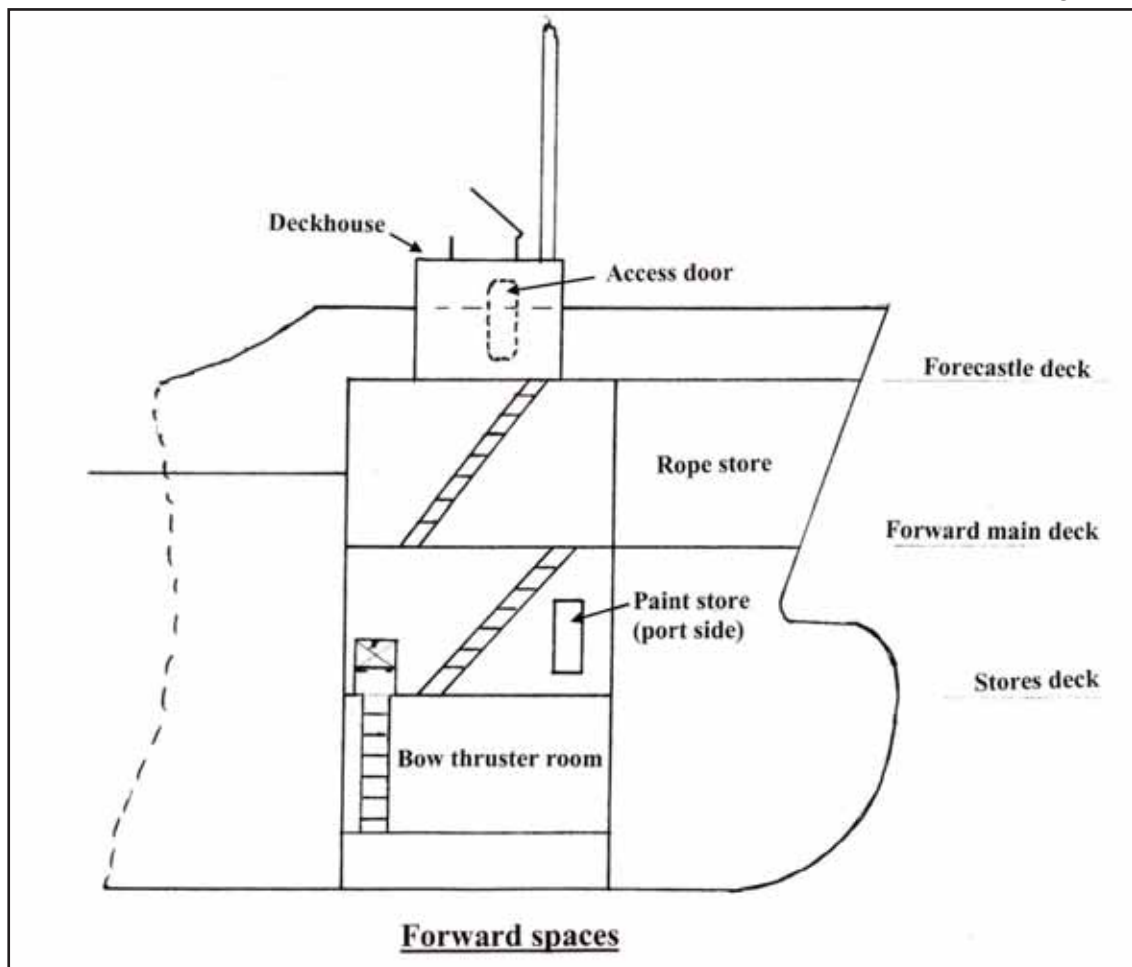
Figure 6

The forecastle deck is one deck above the main or working deck level. On it is mounted a deckhouse containing an access door, and ventilation ducts serving the spaces below. On the roof of this deckhouse are the foremast and a stores access hatch down to the stairwell (**Figure 6**).

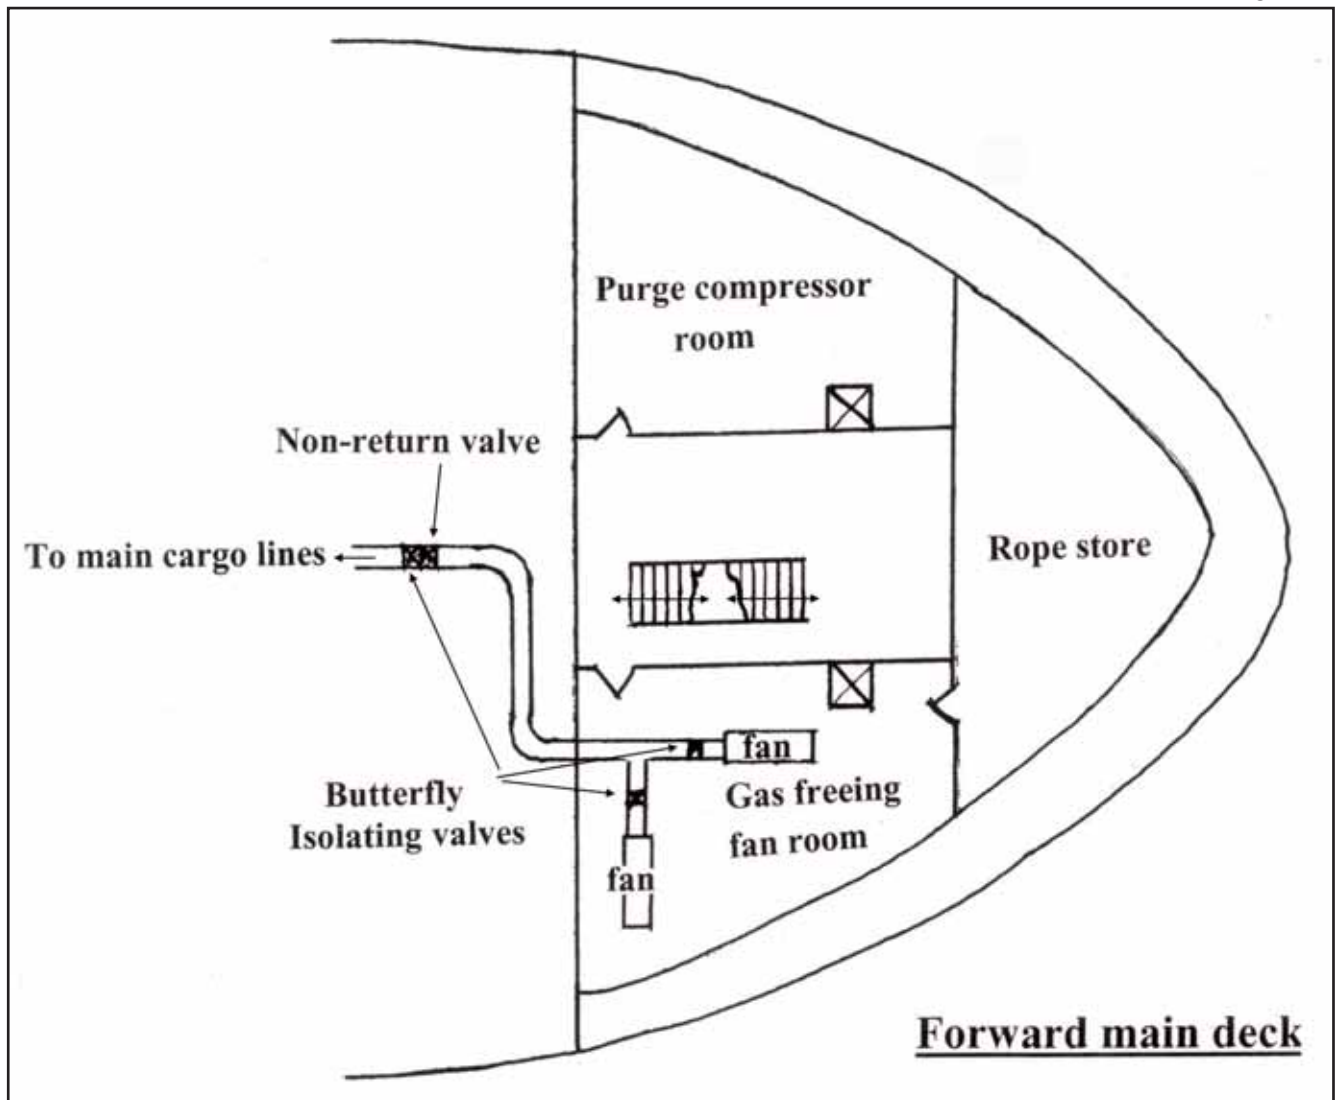
Figure 18

Aft of the bulkhead, this line is connected to the cargo filling and discharge piping system. Two further valves separate the fans from the cargo system, one non-return and one butterfly. These valves are outside the gas freeing room. The butterfly valve is locally operated (**Figure 18**).

Drawings approved by the vessel's classification society, Lloyd's Register of Shipping (LRS), show the butterfly valve and the non-return valve, but no spectacle plate is shown.
