Report on the investigation of

a fatal accident on board

mv Nordstrand

> Report No 8/2005 April 2005

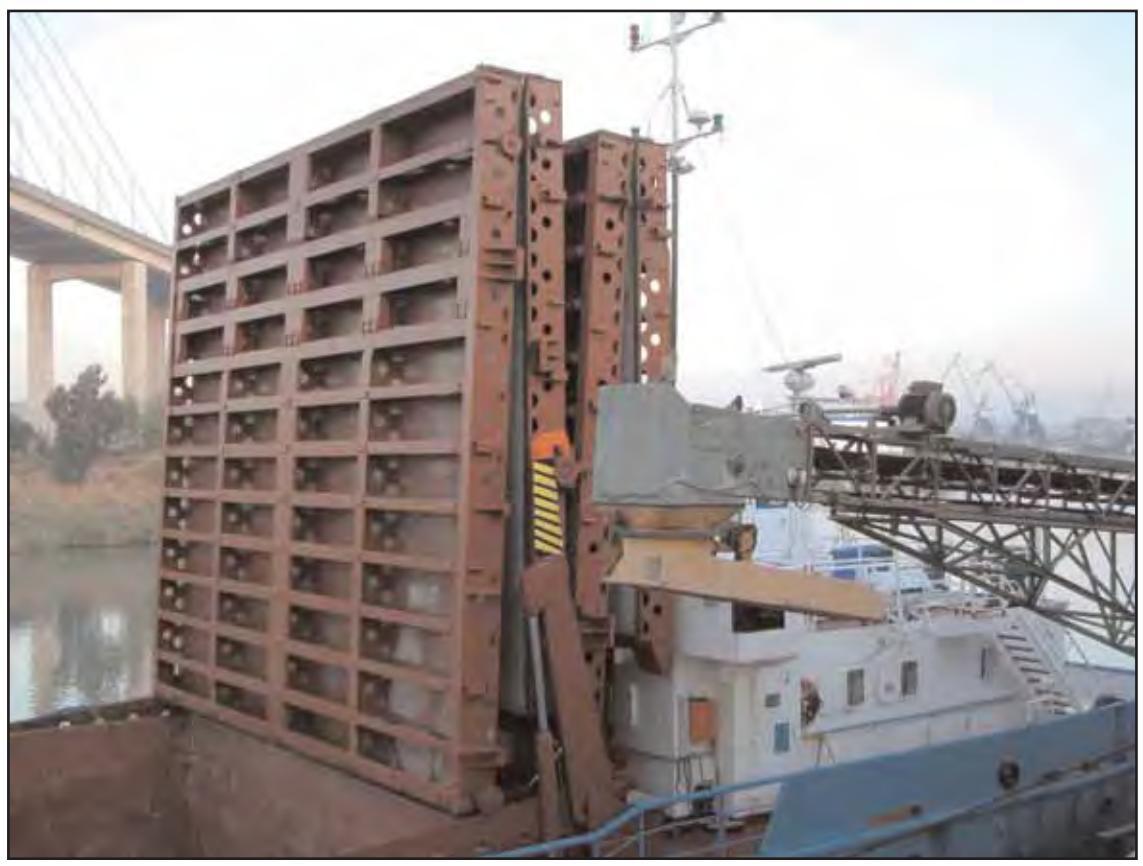
Figure 2

After hatch cover in the open position

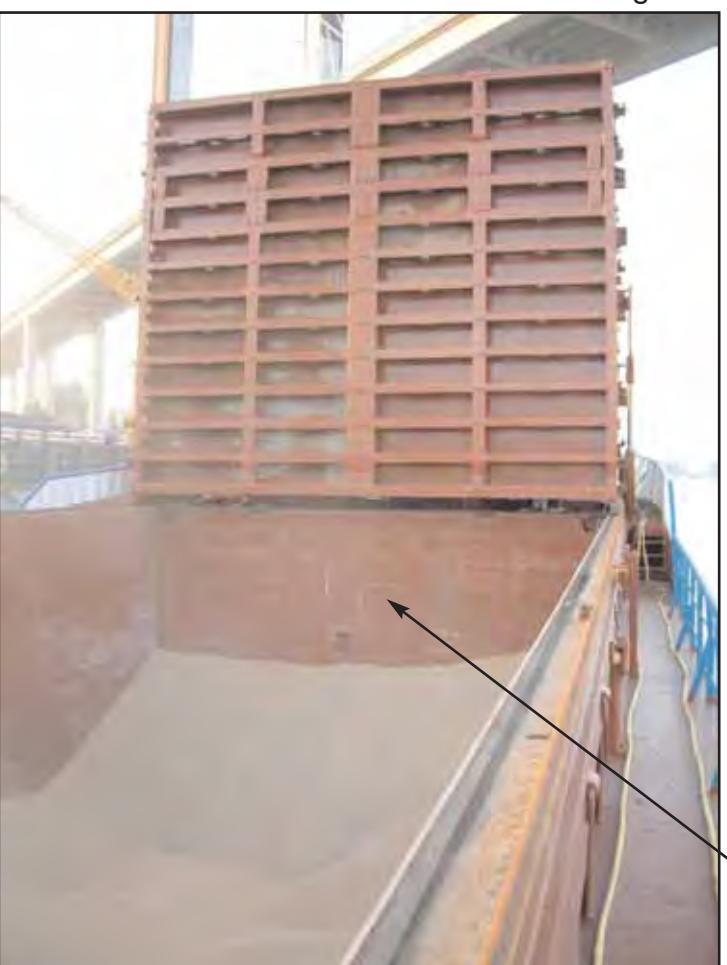
Figure 5

When in the forward or after stowage position, there remains a gap of about 5 -10cm between the dividing bulkhead and the end of the hold, behind which cargo can accumulate. This needs to be cleared before embarking new cargo. The forward bulkhead in its stowed position is shown at Figure 5.

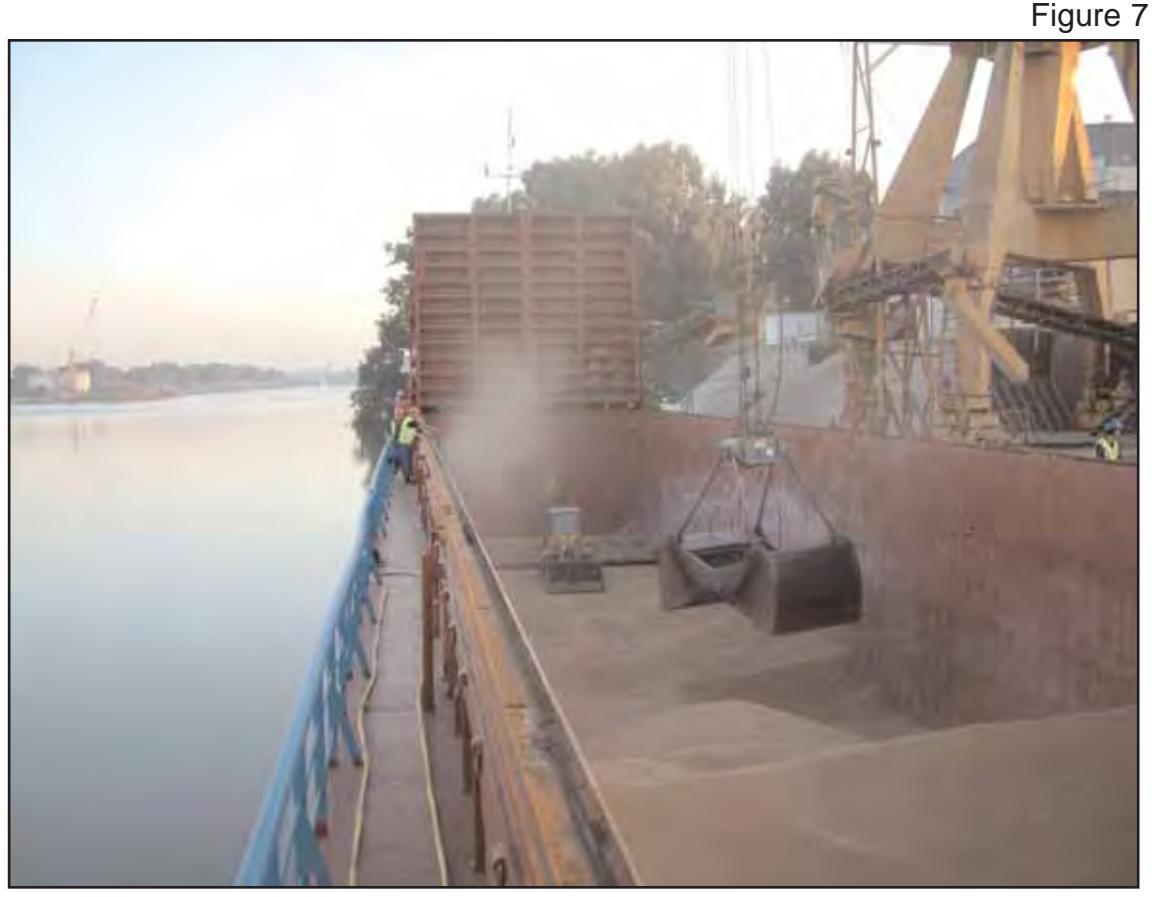
On 17 September, the cargo was progressively moved from the after end of the hold using a "Bobcat" bulldozer, and discharged ashore using a shore grab **(Figure 7)**. When work completed on 17 September, there were approximately 500 tonnes of wheat remaining to be discharged.

Cargo discharge arrangments using a "Bobcat" bulldozer and shore grab

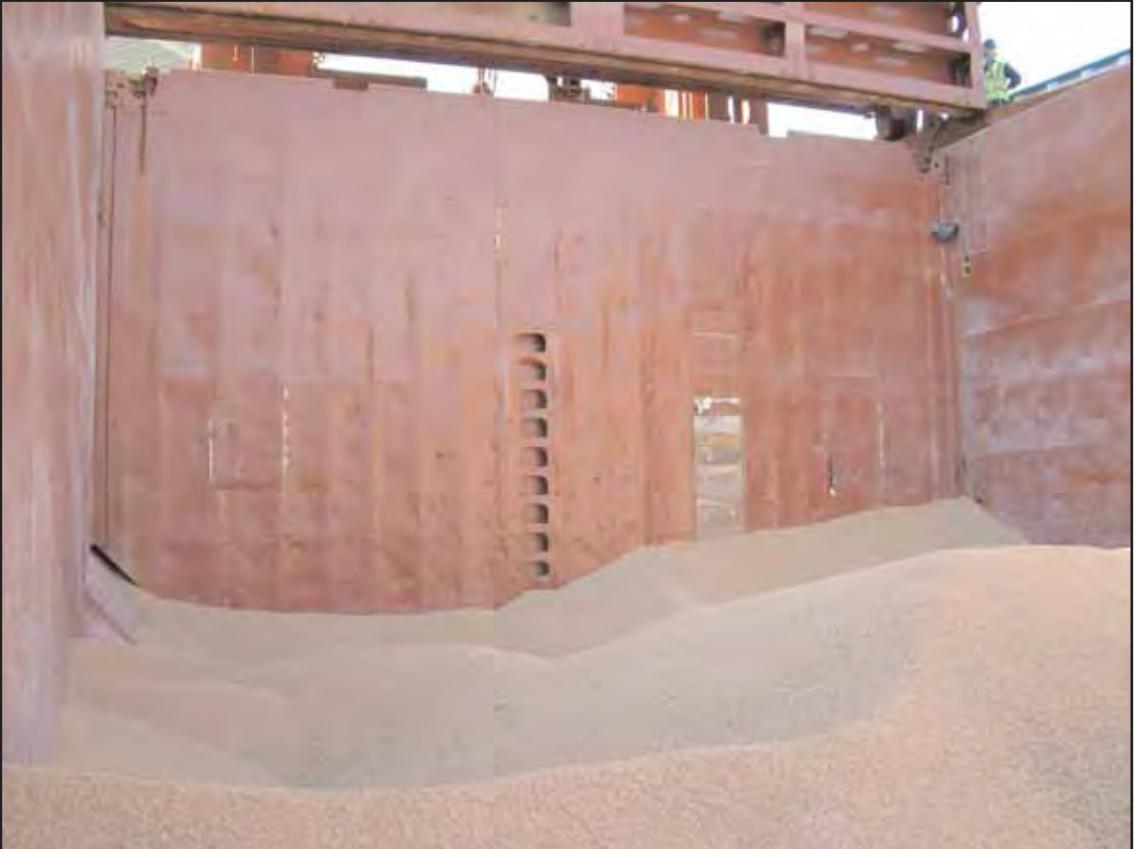
Figure 8

The cargo discharge proceeded smoothly, with most of the wheat having been moved from the after end of the hold to a position just forward of midships **(Figure 8)**. At about 0820, AB Soares entered the hold and took with him one of the jacks required to lift the bulkhead. Using a rope, the chief officer lowered a second jack into the hold, from the deck. At about 0825, the chief officer and AB Morais entered the hold and started to sweep up the remaining wheat at the after end in preparation for moving the after portable bulkhead.

Wheat cargo in forward hold position

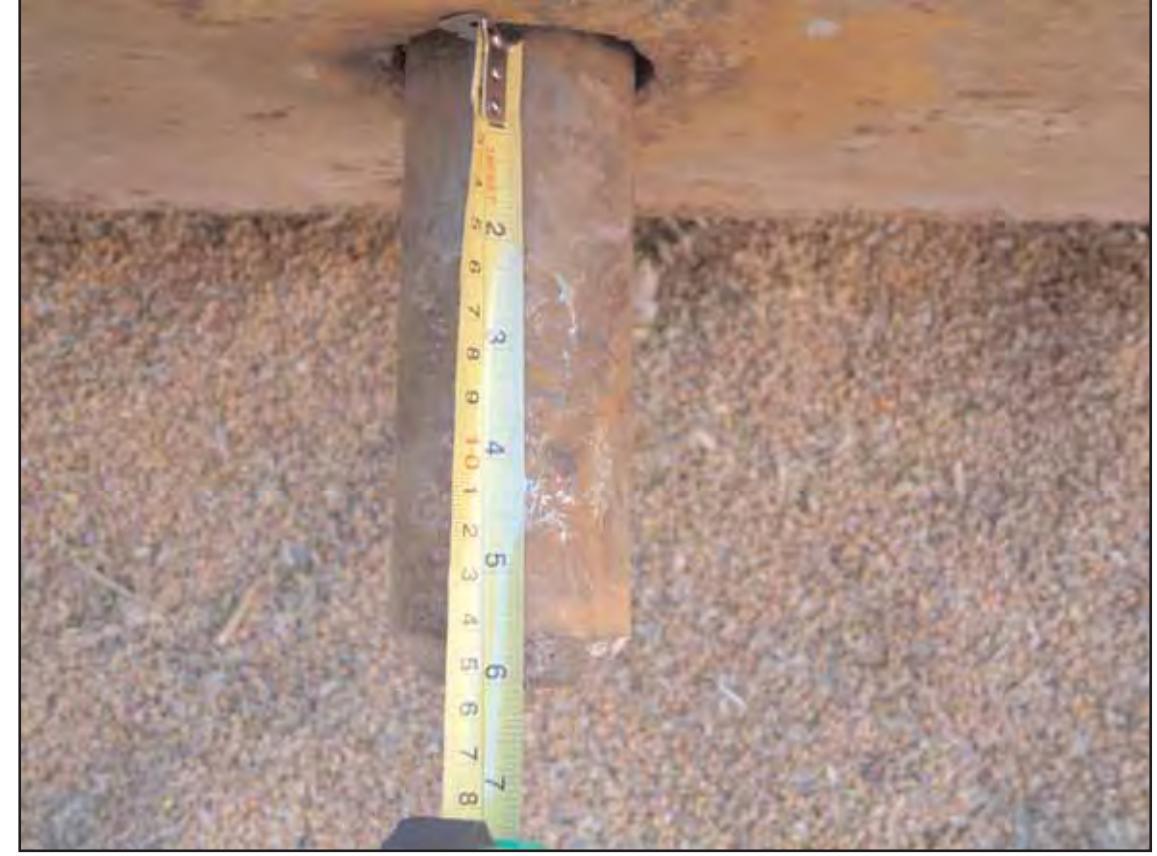
Figure 16

The elongated slots in the longitudinal bulkheads for the upper port and starboard securing bolts were found to be in good, corrosion free condition and obstruction free. The two main lower securing bolts, and the two bulkhead jacking pins (Figure 16) were also free to operate.

Blukhead jacking pin
