Report of the investigation of
the lifeboat release gear test on
RFA *Fort Victoria*
which caused injuries to two people
at Falmouth ship repair yard
10 September 2004

Marine Accident Investigation Branch
Carlton House
Carlton Place
Southampton
United Kingdom
SO15 2DZ

Report No 9/2005
May 2005

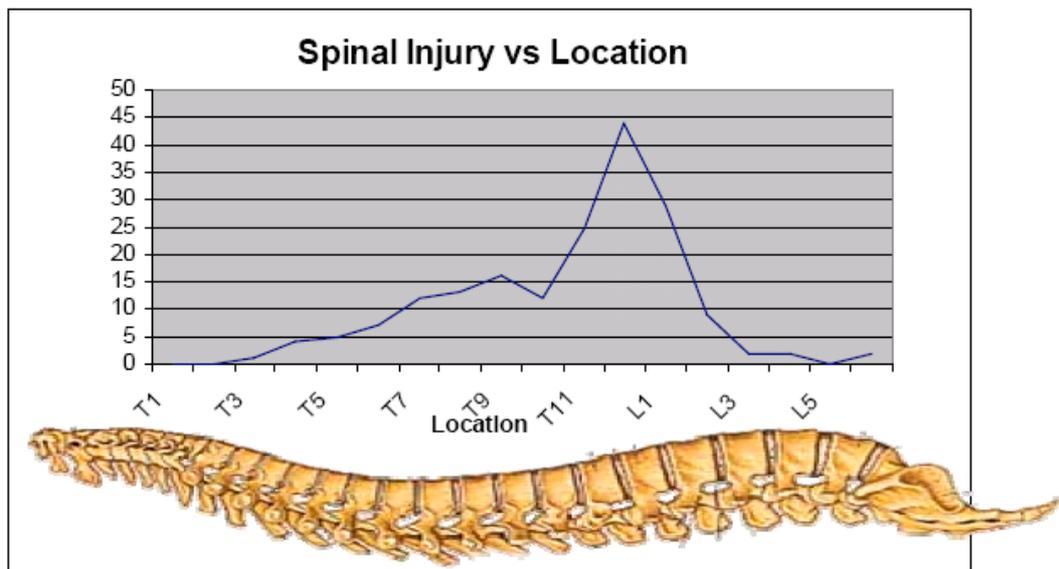
Figure 8

The expert provided information on spinal injuries sustained by RAF crews during the operation of aircraft ejection systems. This shows a high incidence of injuries in the region of the L1 (lumbar) vertebra (**Figure 8**). The spinal injury sustained by the crew member on board the lifeboat, occurred in the same position as the majority of the injuries sustained by RAF crew who eject from an aircraft.

The lack of seat padding in the lifeboat probably exacerbated the transmission of the impact force to the spines of those on board. Although padding is provided to protect the head against the side of the lifeboat, the inclusion of seat padding

Figure 1: Spinal injury distribution (from ref 2)
