Report on the investigation of  
an accident on board  
the commercial sailing vessel

***Albatros***

22 August 2004

**Report No 7/2005**  
**April 2005**

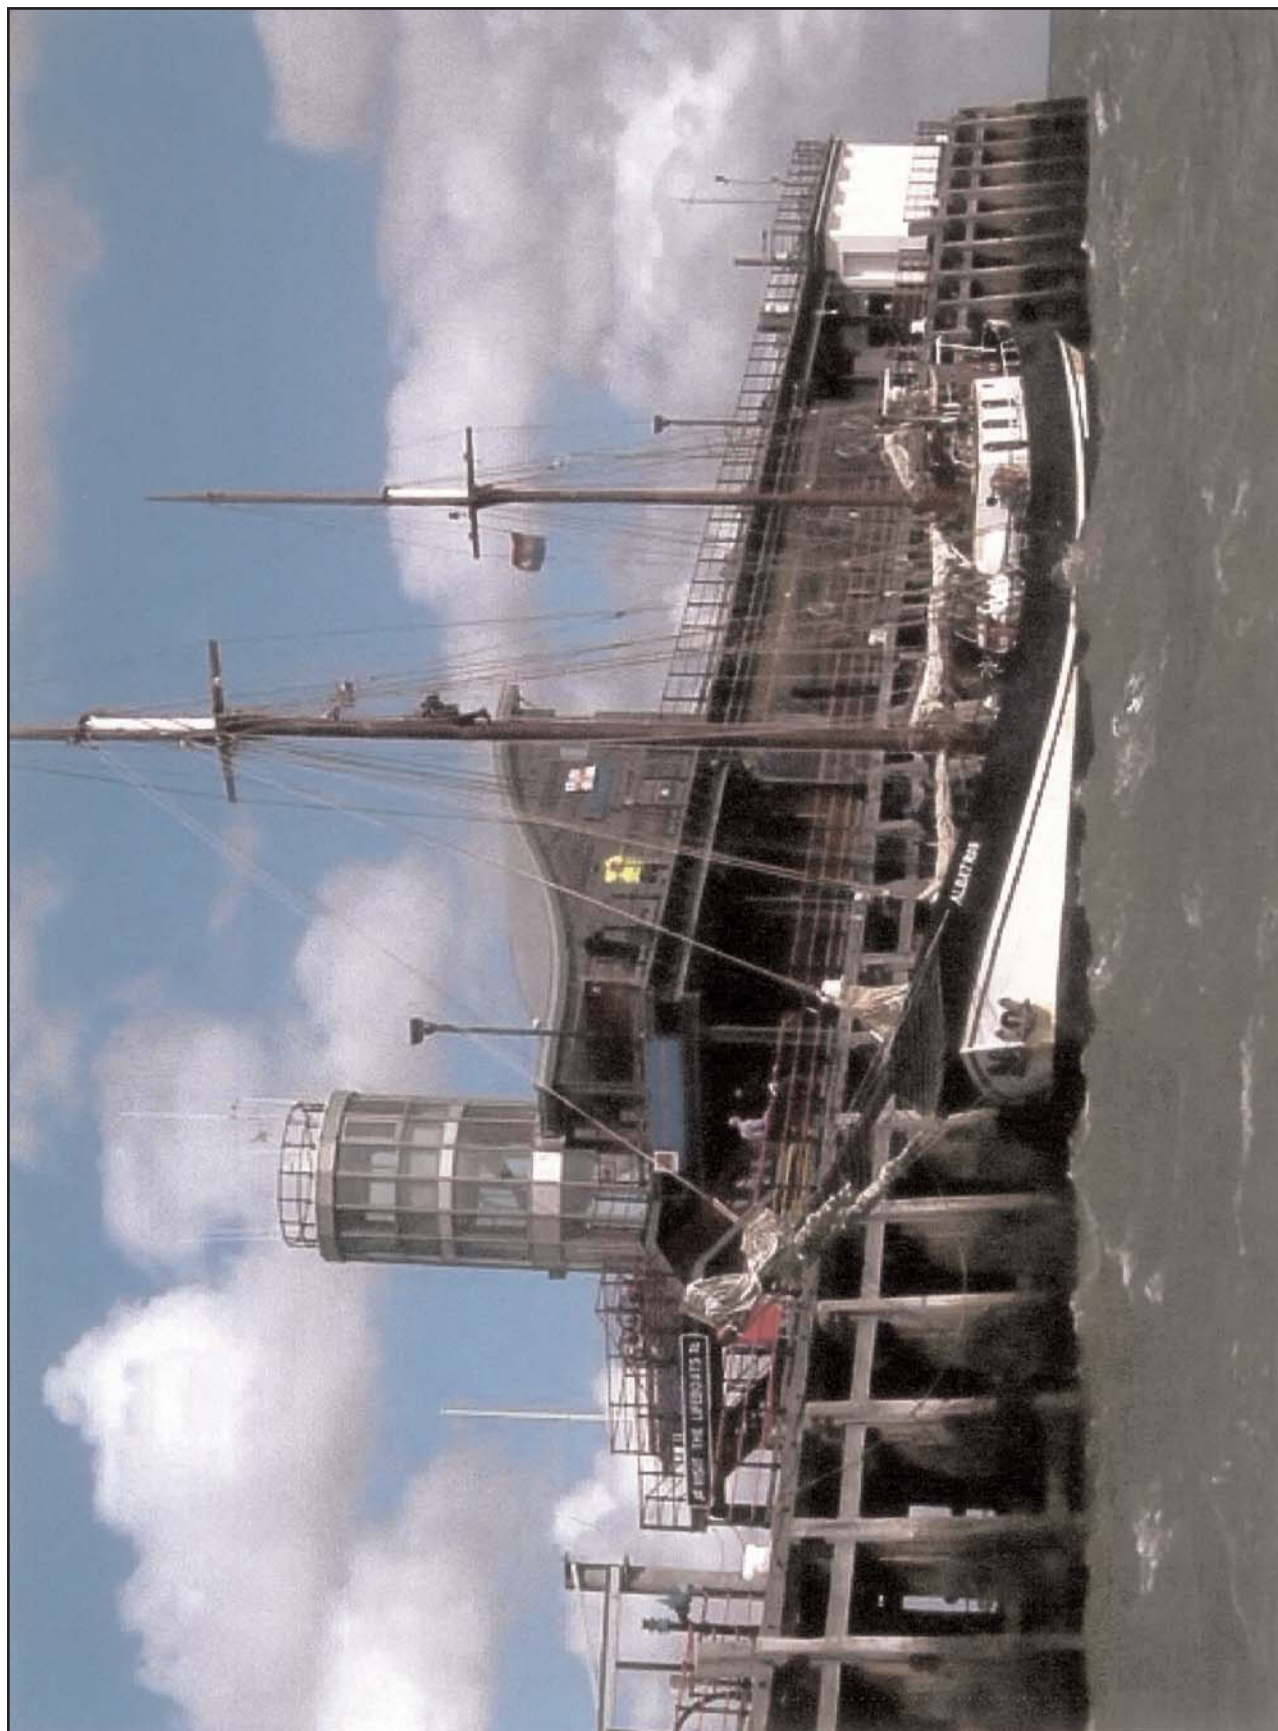
Figure 1

*Albatros alongside at Southend Pier Head*

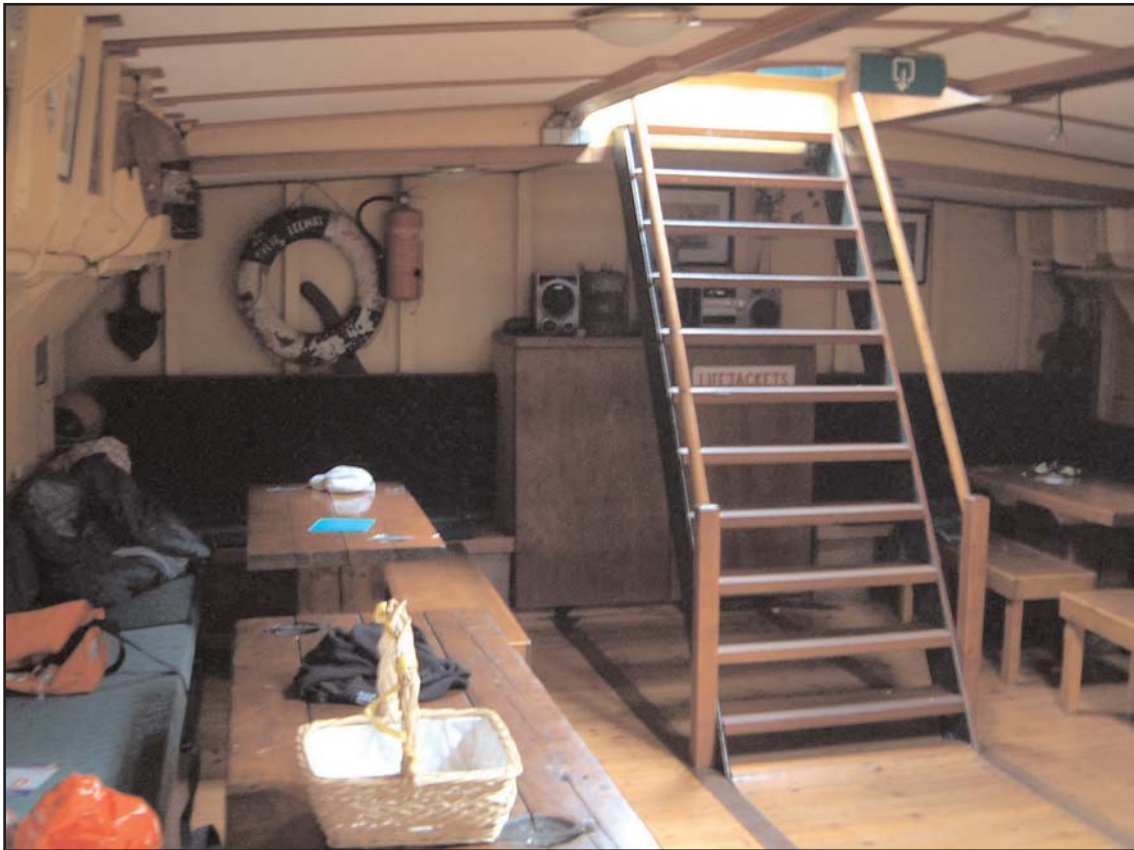
Figure 2a

Before *Albatros* left Southend, all passengers and crew were mustered in the former cargo hold (now a mess deck) where the master provided a safety briefing and introduced the crew to the passengers (**Figures 2a and 2b**). This included an introduction covering the history of the vessel, and was followed by a briefing on the following six basic safety rules:

Mess deck - venue used for passenger safety briefing

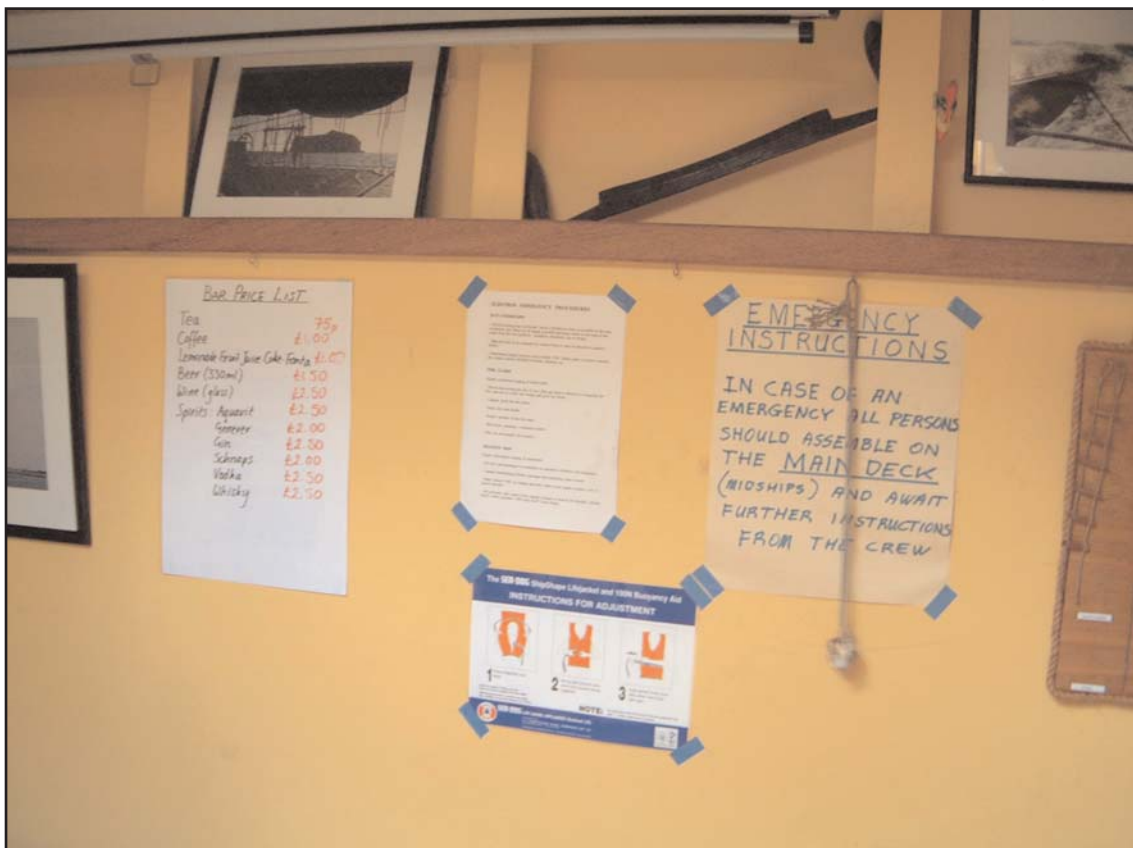
Figure 2b

Safety notices posted on mess deck bulkhead

Procedures and instructions on board *Albatros* were displayed on the forward bulkhead of the mess deck area (**Figure 2b**). These comprised:

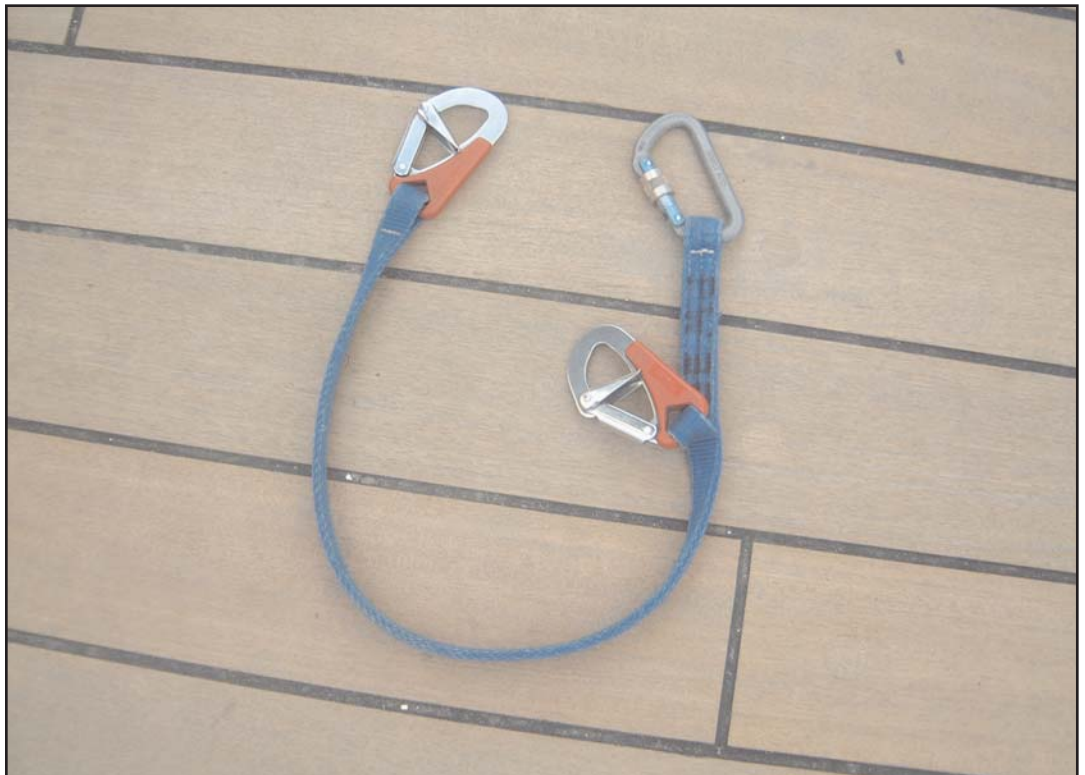
Figure 12

Lifeline with karibiner clip used for securing the lifeline to the safety harness, complete with two double action clips for different working conditions
