Report on the investigations of

the foundering of
fv Kathryn Jane
4.6nm west of Skye
on or about 28 July 2004
with the loss of the skipper and
one possible crew member

the capsize and foundering of
fv Emerald Dawn
off Kilkeel
on 10 November 2004
with the loss of one life

the foundering of
fv Jann Denise II
5 miles SSE of the River Tyne
on 17 November 2004
with the loss of her two crew

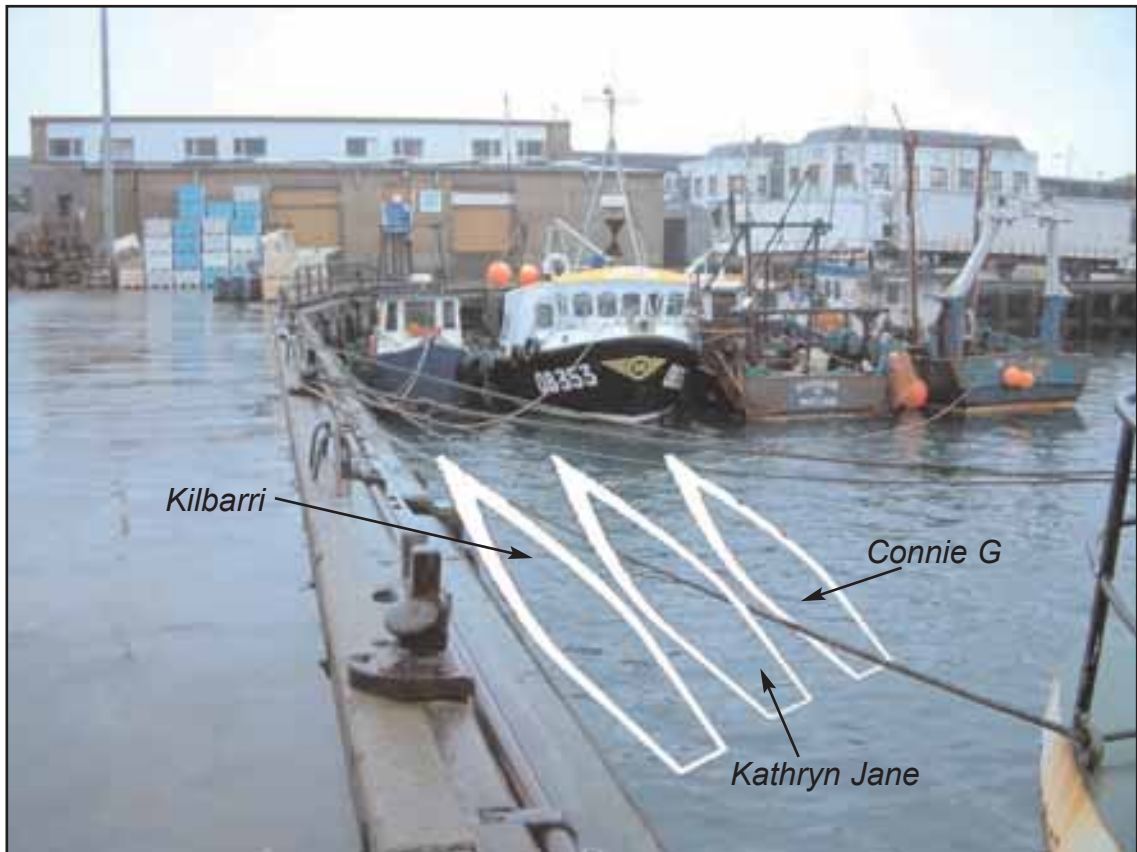
Figure 2

Kathryn Jane entered Mallaig Harbour before midday on 27 July to land her catch and make arrangements to take ice on board for the next period of fishing. At 1940 UTC the skipper took 550.65 litres of fuel on board, which was sufficient for about 4 days' fishing. After taking on the fuel, *Kathryn Jane* tied up alongside the Oban registered fv *Kilbarri*, which was alongside the pier. Soon after, the fv *Connie G* berthed outboard of *Kathryn Jane* (**Figure 2**). As the skipper of *Connie G* walked across *Kathryn Jane* towards the pier ladder, he noticed a number of holes in the steel upper deck of the vessel. The largest hole was about 100mm in diameter, located just aft of the fish hold hatch.

Location of *Kathryn Jane* in Mallaig Harbour

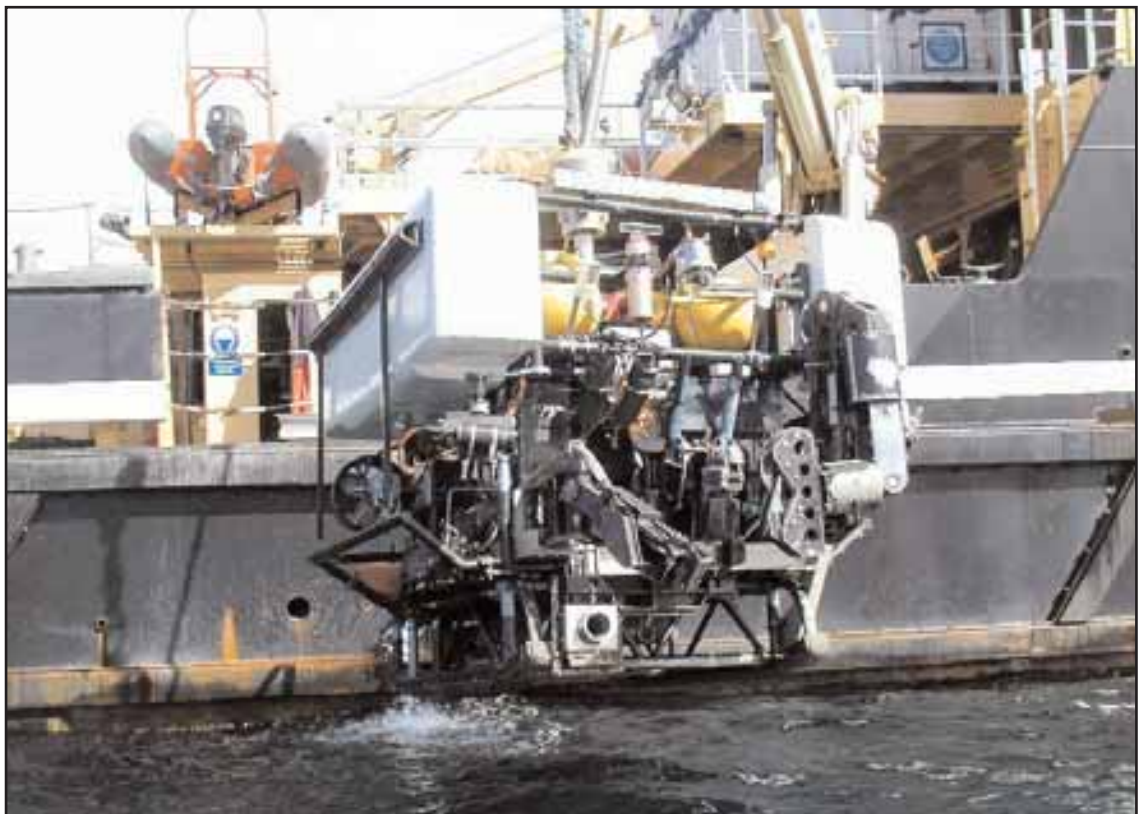
Figure 5

RMAS Warden and work class Super Scorpio ROV

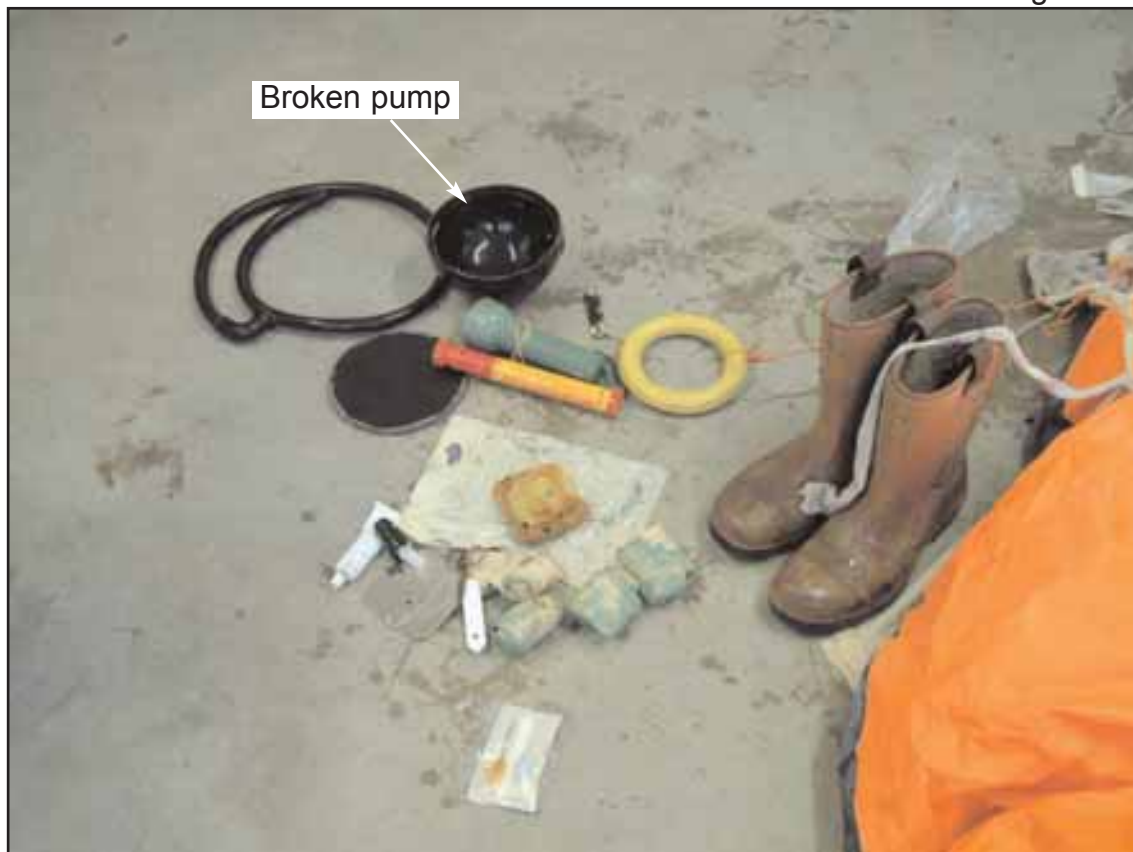
Figure 15

The liferaft's rubber buoyancy tubes were perished and leaking air. The raft's pump had broken into two pieces, so the owner kept the raft inflated by blowing into the tubes. The liferaft was also not watertight and he frequently had to use the bowl part of the broken pump to bail the water out (**Figure 15**). Surviving through the night was an ordeal, and the owner was cold and tired by the next day.

Photograph showing condition of liferaft

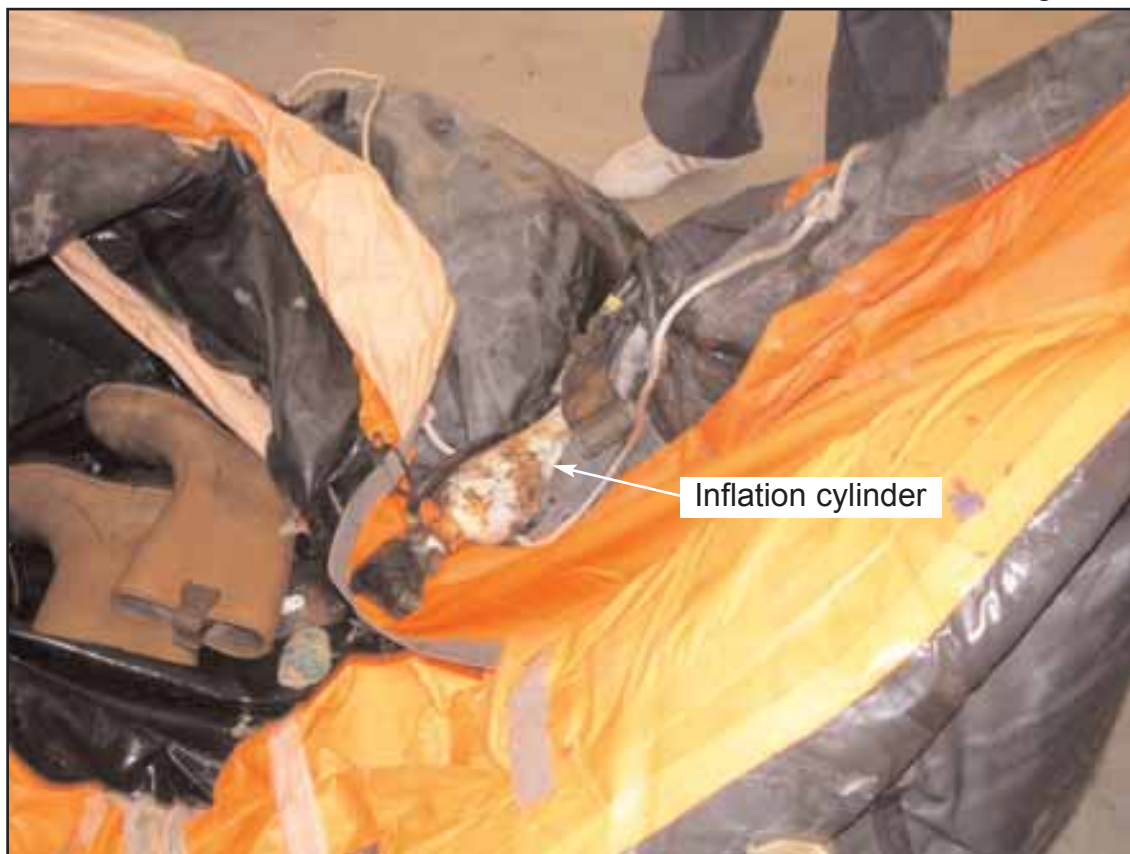
Figure 18

It was not known when this liferaft was last serviced. A flare in the raft with an expiry date of 2/92 indicates the likelihood that it was at least 12 years ago (**Figure 17**). All the equipment in the liferaft was in very poor condition and most was inoperable. The gas cylinder was badly corroded (**Figure 18**).

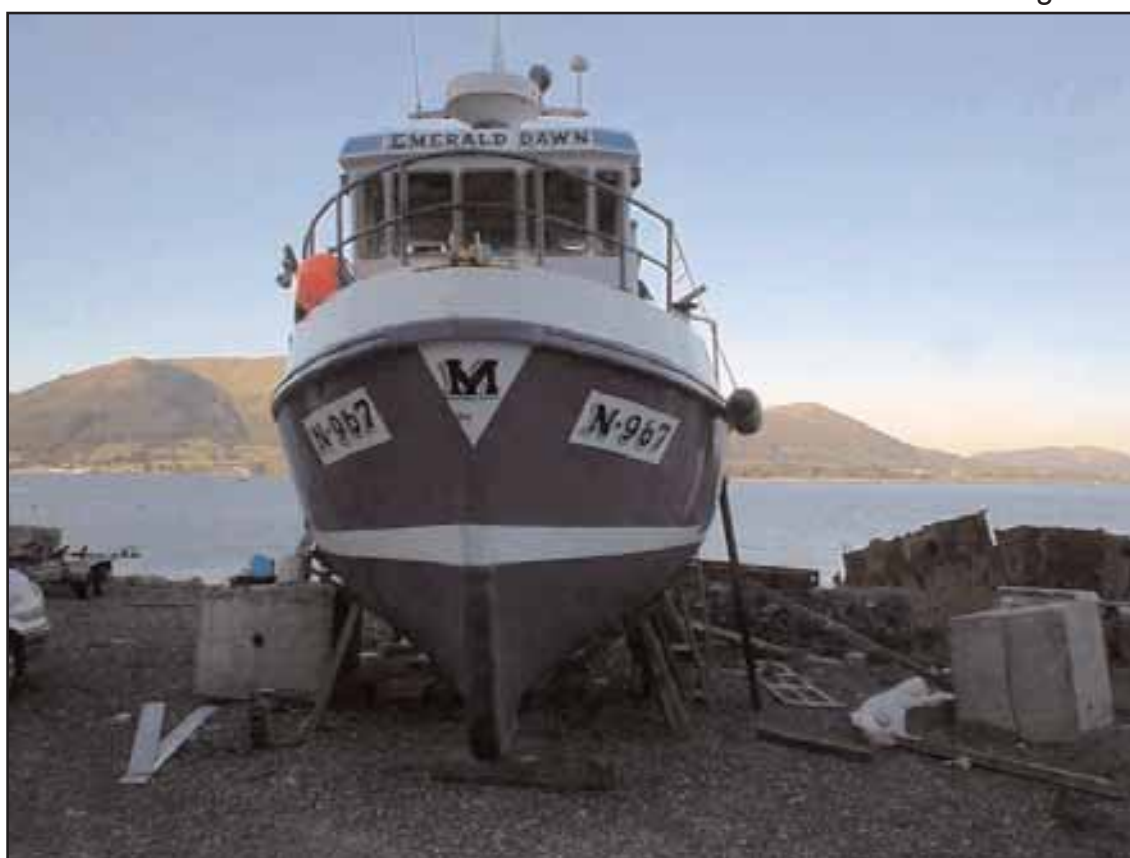
Figure 19

Emerald Dawn under refit

In August 2004, *Emerald Dawn* was lifted out of the water for a refit at a marina on the south side of Carlingford Loch (**Figure 19**). The owner was an experienced marine mechanic and he carried out the refit work himself.

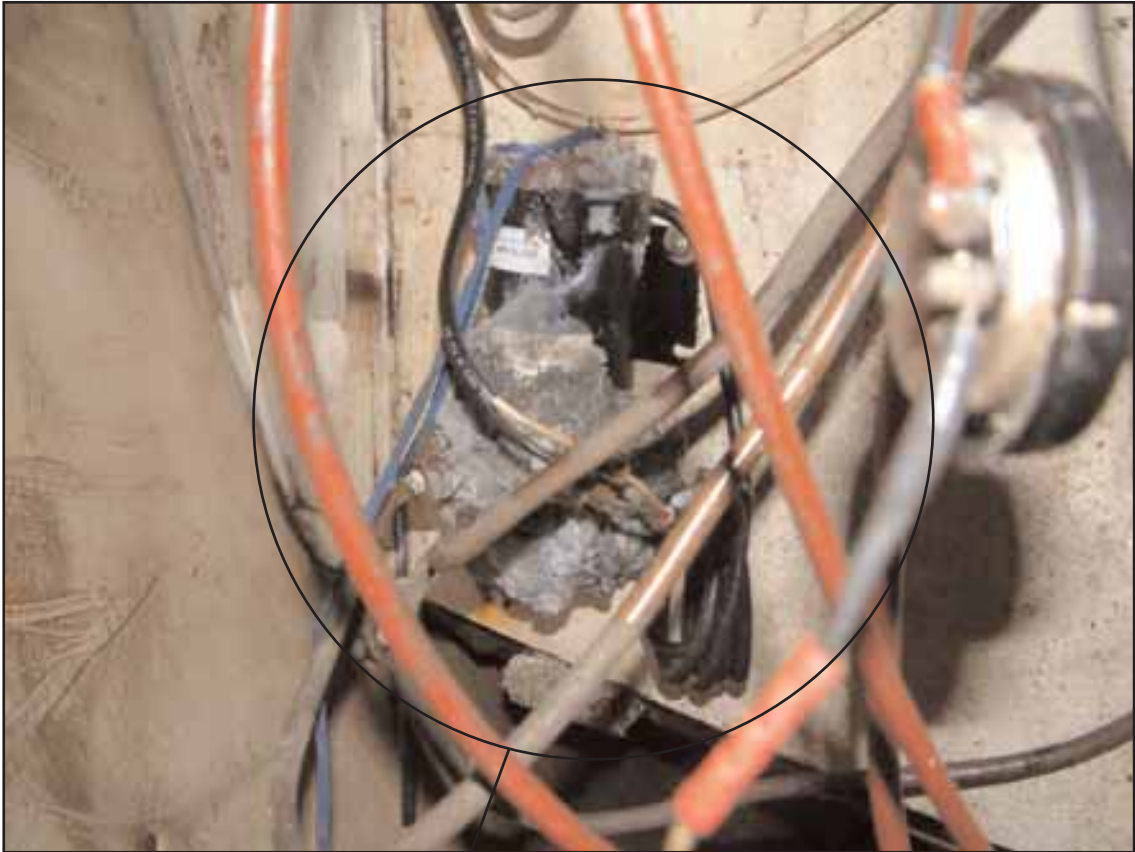
Figure 23

The rudder was controlled by an independent closed circuit hydraulic system, with its electrically driven, hydraulic pump situated on the after bulkhead of the forepeak compartment (**Figure 23**). Directional control was achieved either by the autopilot or by a hand tiller situated at the starboard side of the wheelhouse (**Figure 24**). In the event of failure of the pump, steering could be maintained using the ship’s wheel, which provided hydraulic power directly to the hydraulic rams situated on the rudder stock.

Steering gear hydraulic pump arrangement
