Report on the investigation of the
swamping and foundering of a
4.6m grp open sports boat
with the loss of three lives
on Loch Ryan
south-west Scotland
12 July 2003

Marine Accident Investigation Branch
First Floor
Carlton House
Carlton Place
Southampton
United Kingdom
SO15 2DZ

Report No 5/2004
April 2004

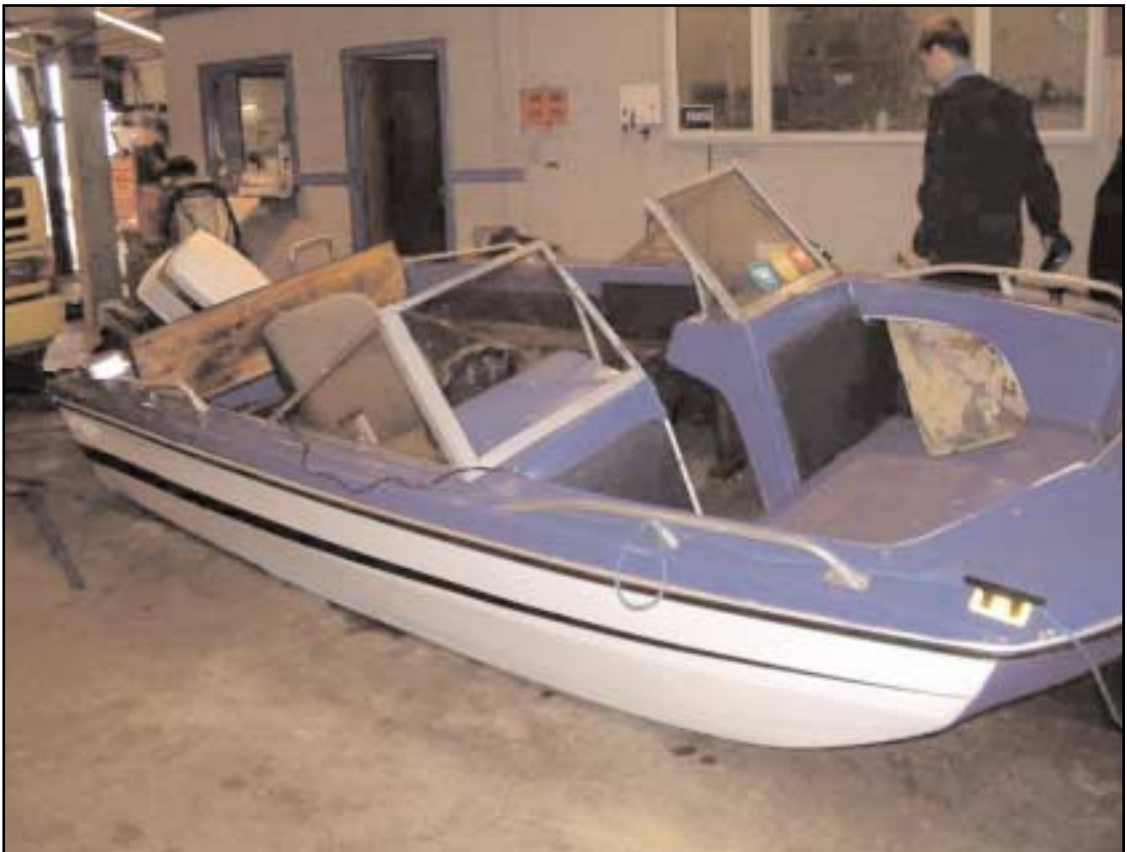
On Friday 11 July 2003, Shaun Ridley, his two sons Steven and Michael, and his father, brought their recently purchased, second-hand, 4.6m long moulded GRP boat to Loch Ryan for a weekend of fishing (**Photograph 2**). Accompanying them from Manchester was a family friend.

View of the GRP boat

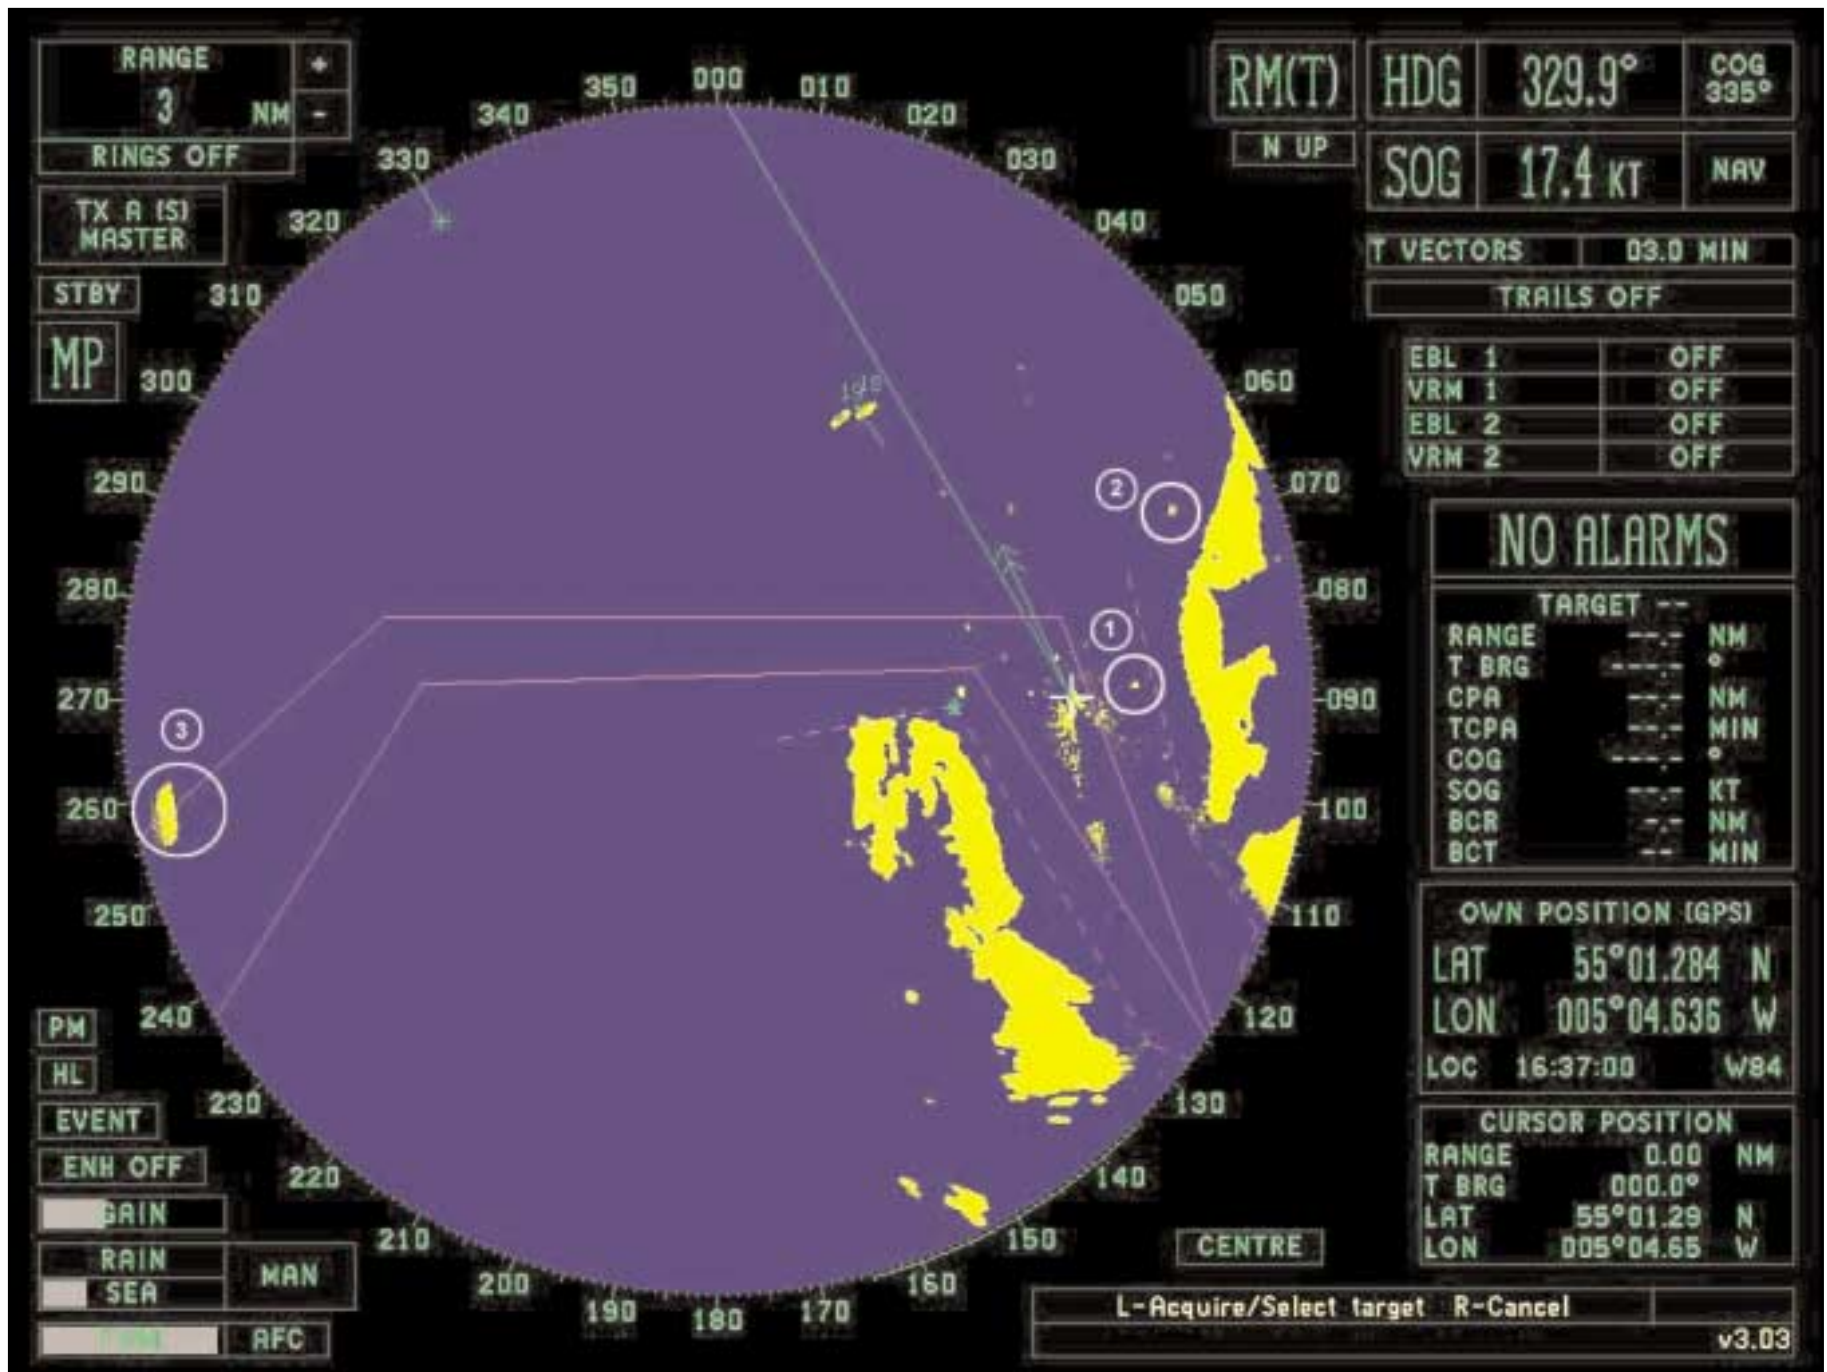
Radar display from the conventional ferry *Stena Caledonia* departing Loch Ryan at 1637 with a contact believed to be the boat (1), a contact believed to be the fishing boat that passed at 1641 (2), and contact (3) SSE inbound

At 1637, the ferry passed the small boat at a speed of about 17 knots, at a distance of 2 to 3 cables, altered course to port around Milleur buoy and proceeded out of the loch. At about 1638, the radar targets of the small boat and the fishing boat were lost in the radar shadow sector behind the vessel (**see Figure 2, Section 1.6**).

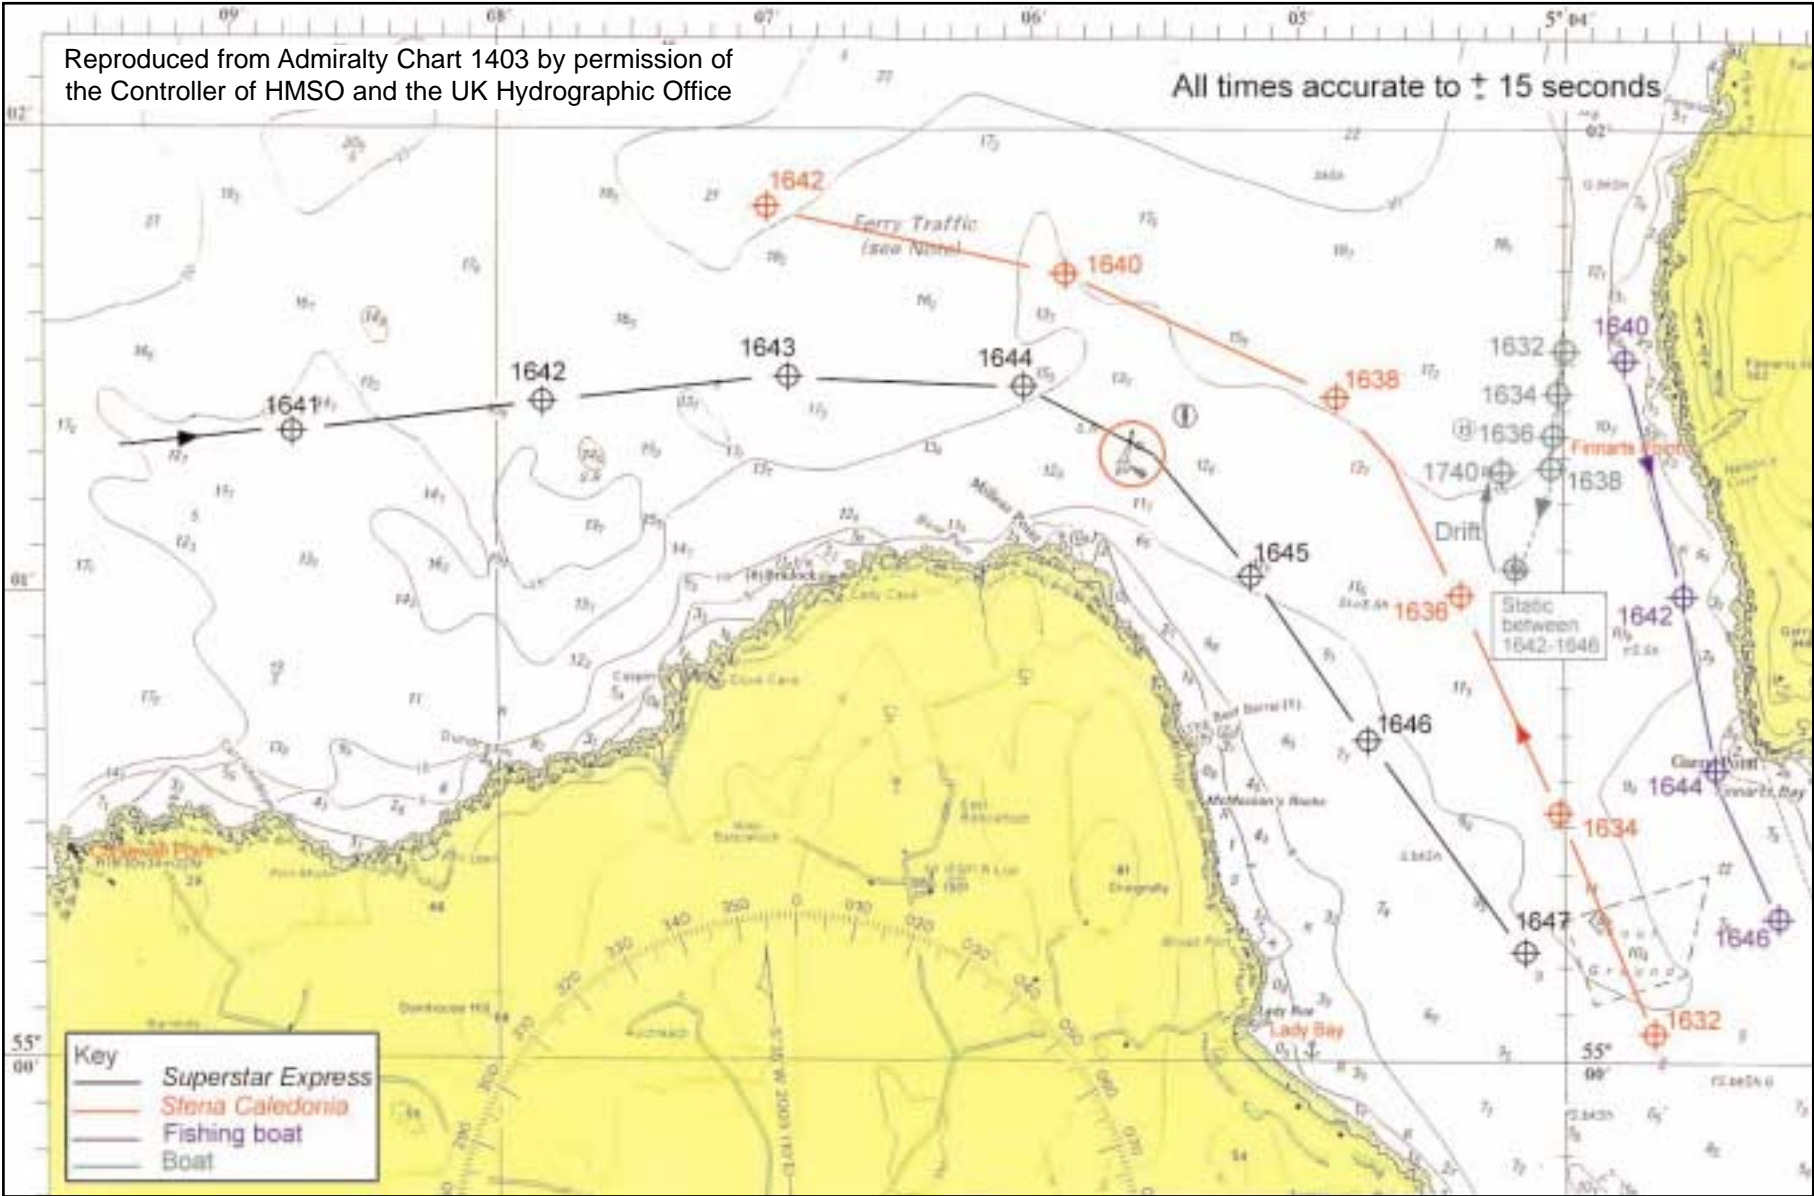
Figure 3

Chartlet of entrance to Loch Ryan showing probable track of the boat between 1632 and 1646, and tracks of *Stena Caledonia*, *Superstar Express* and a fishing vessel

The boat was detected on *Superstar Express's* radar at 1642, by which time it was stopped in the water further out into the loch to the south-south-west of her 1638 position (**see Figure 3**). The target remained stationary, or nearly stationary, until it was lost to *Superstar Express's* radar just before 1647. Within this time, the radar echo was lost briefly at about 1644 as *Superstar Express* turned around Milleur Buoy into the loch.

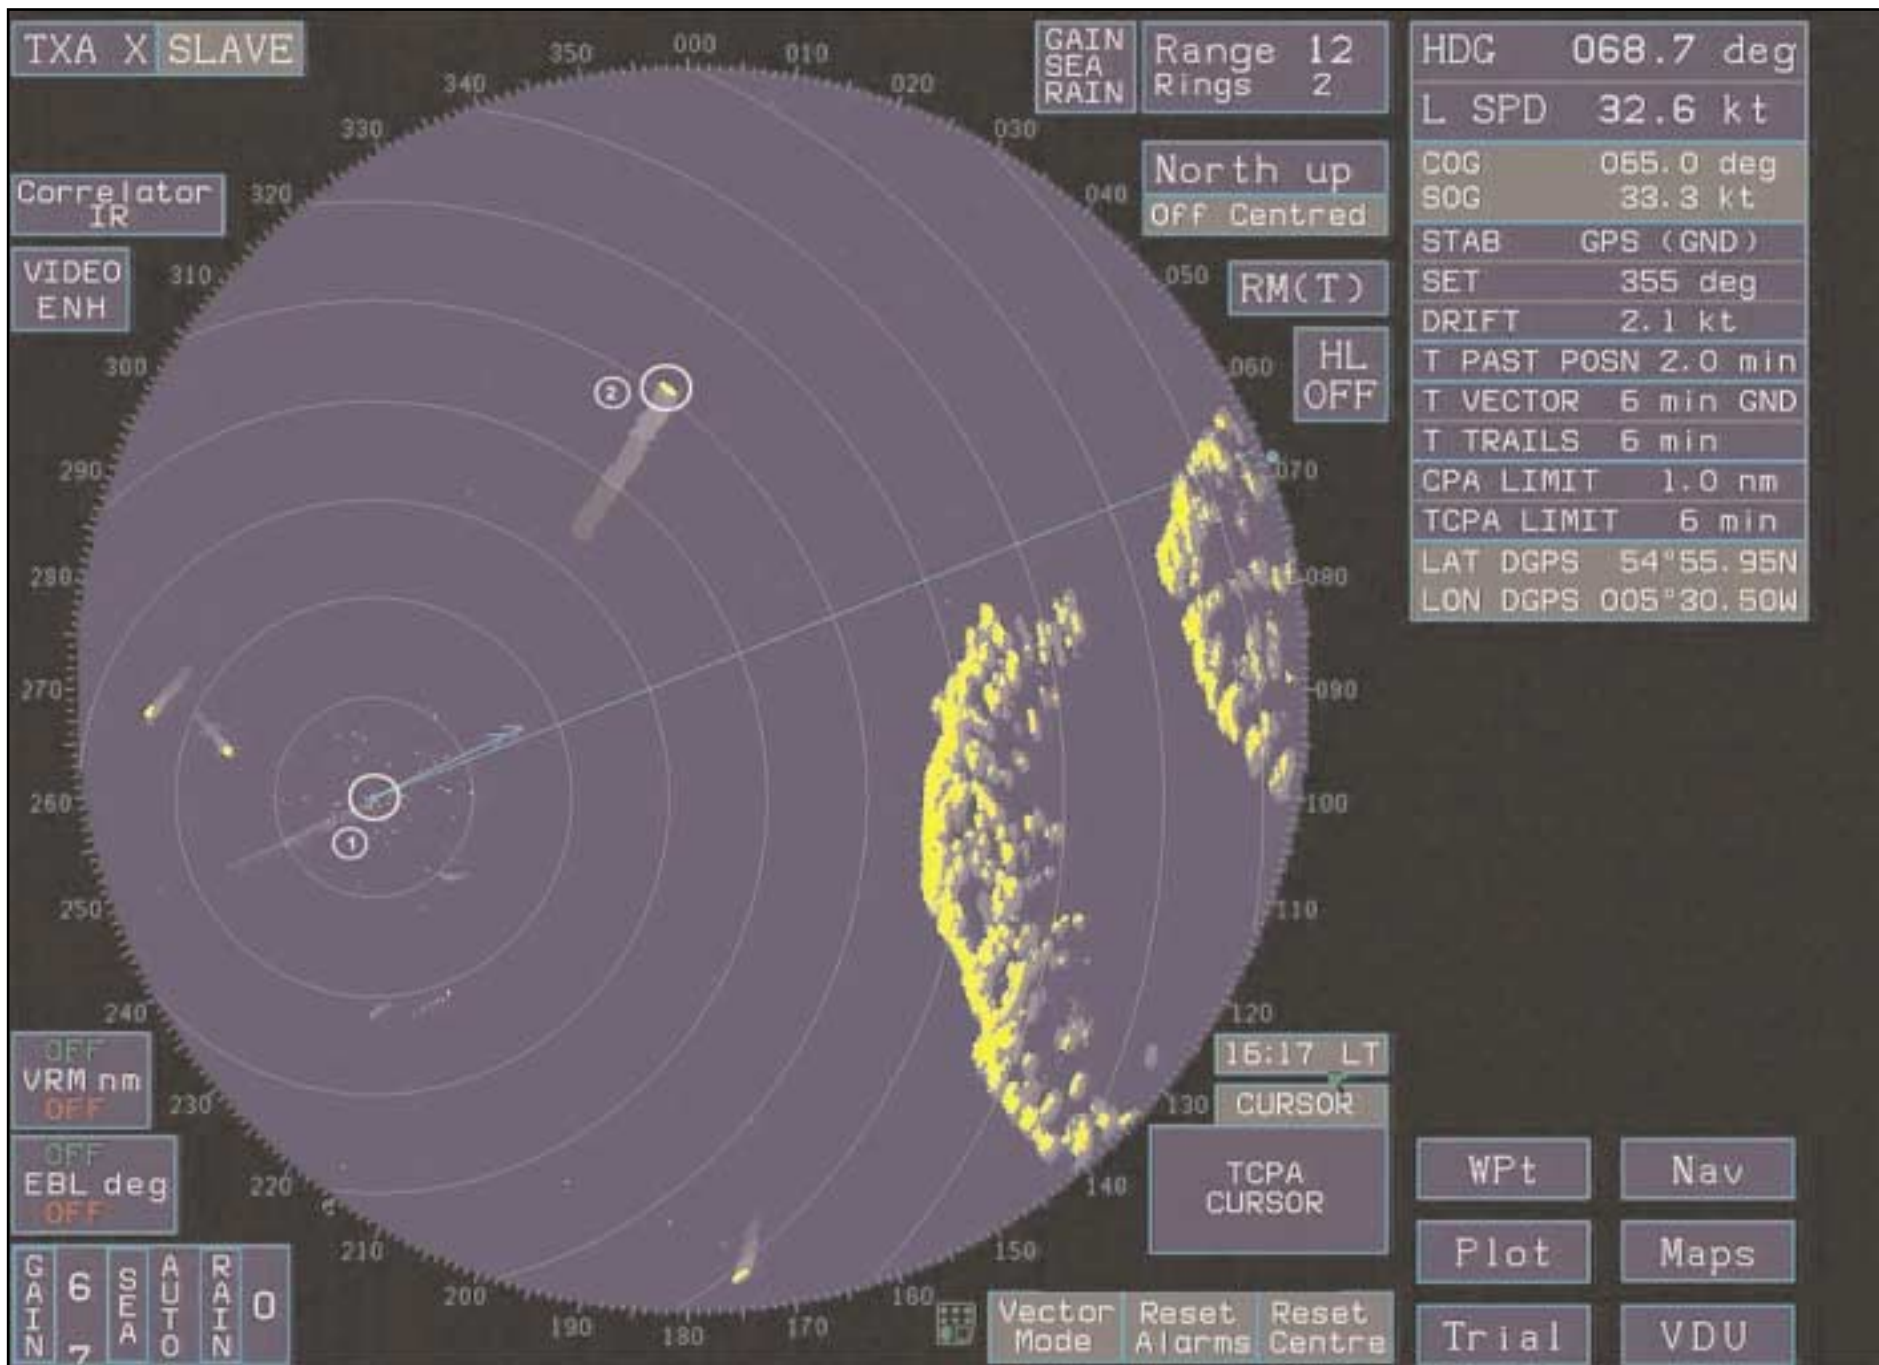
A further contact detected by analysis of the radar recordings was of an HSC operating between Belfast and Troon, which was heading in a north-easterly direction at about 35 knots. She was about 7 miles north-west of Corsewall Point at 1618 (**see Figure 5**).

Radar display from the HSC *Superstar Express* (1) en route to Loch Ryan at 1617 and track of *Seacat Rapide* (2)

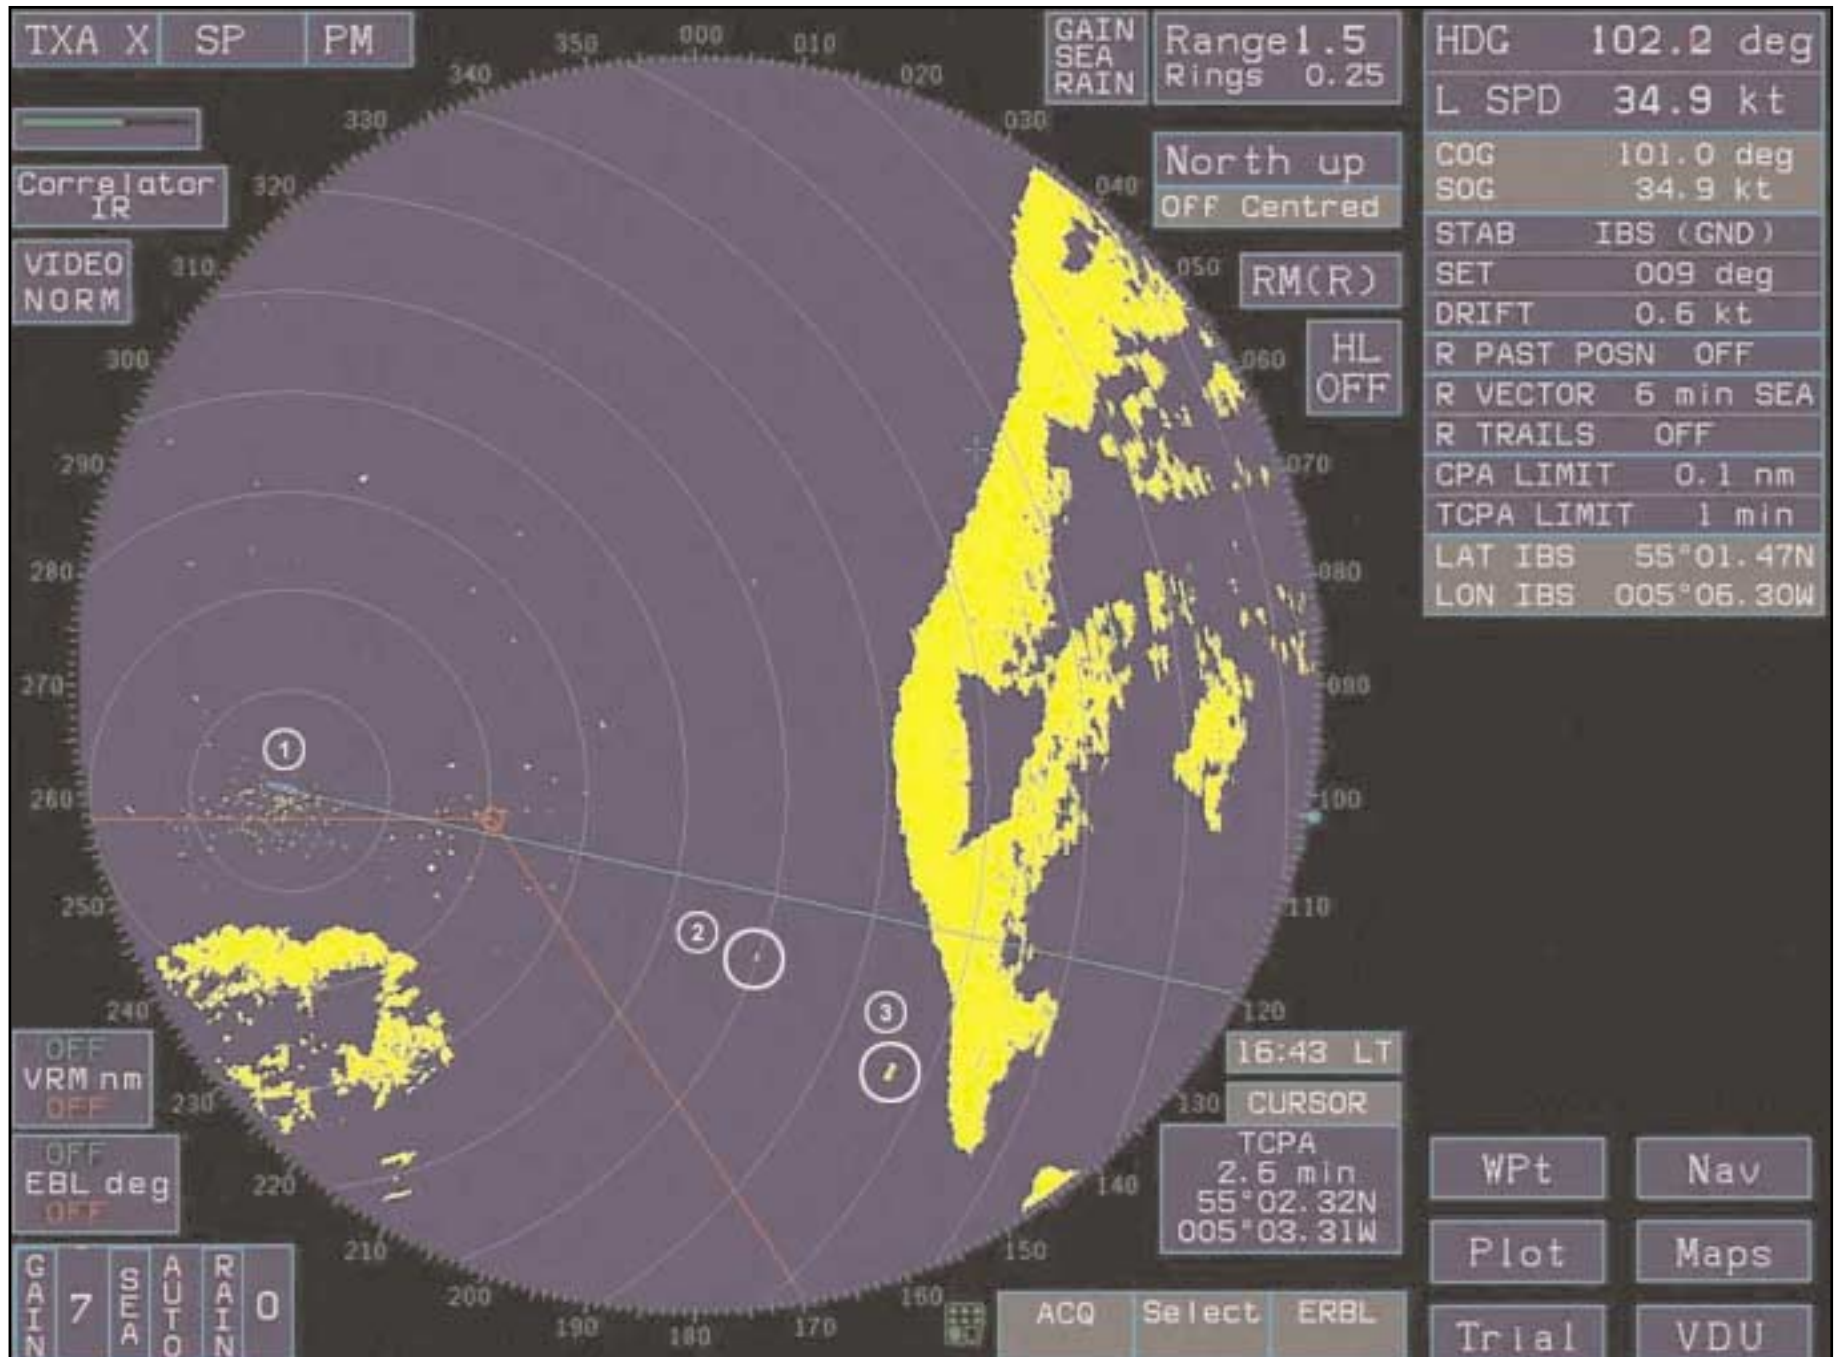
Superstar Express inbound at 1643 (1), contact (2) believed to be the boat, and contact (3) believed to be the fishing boat

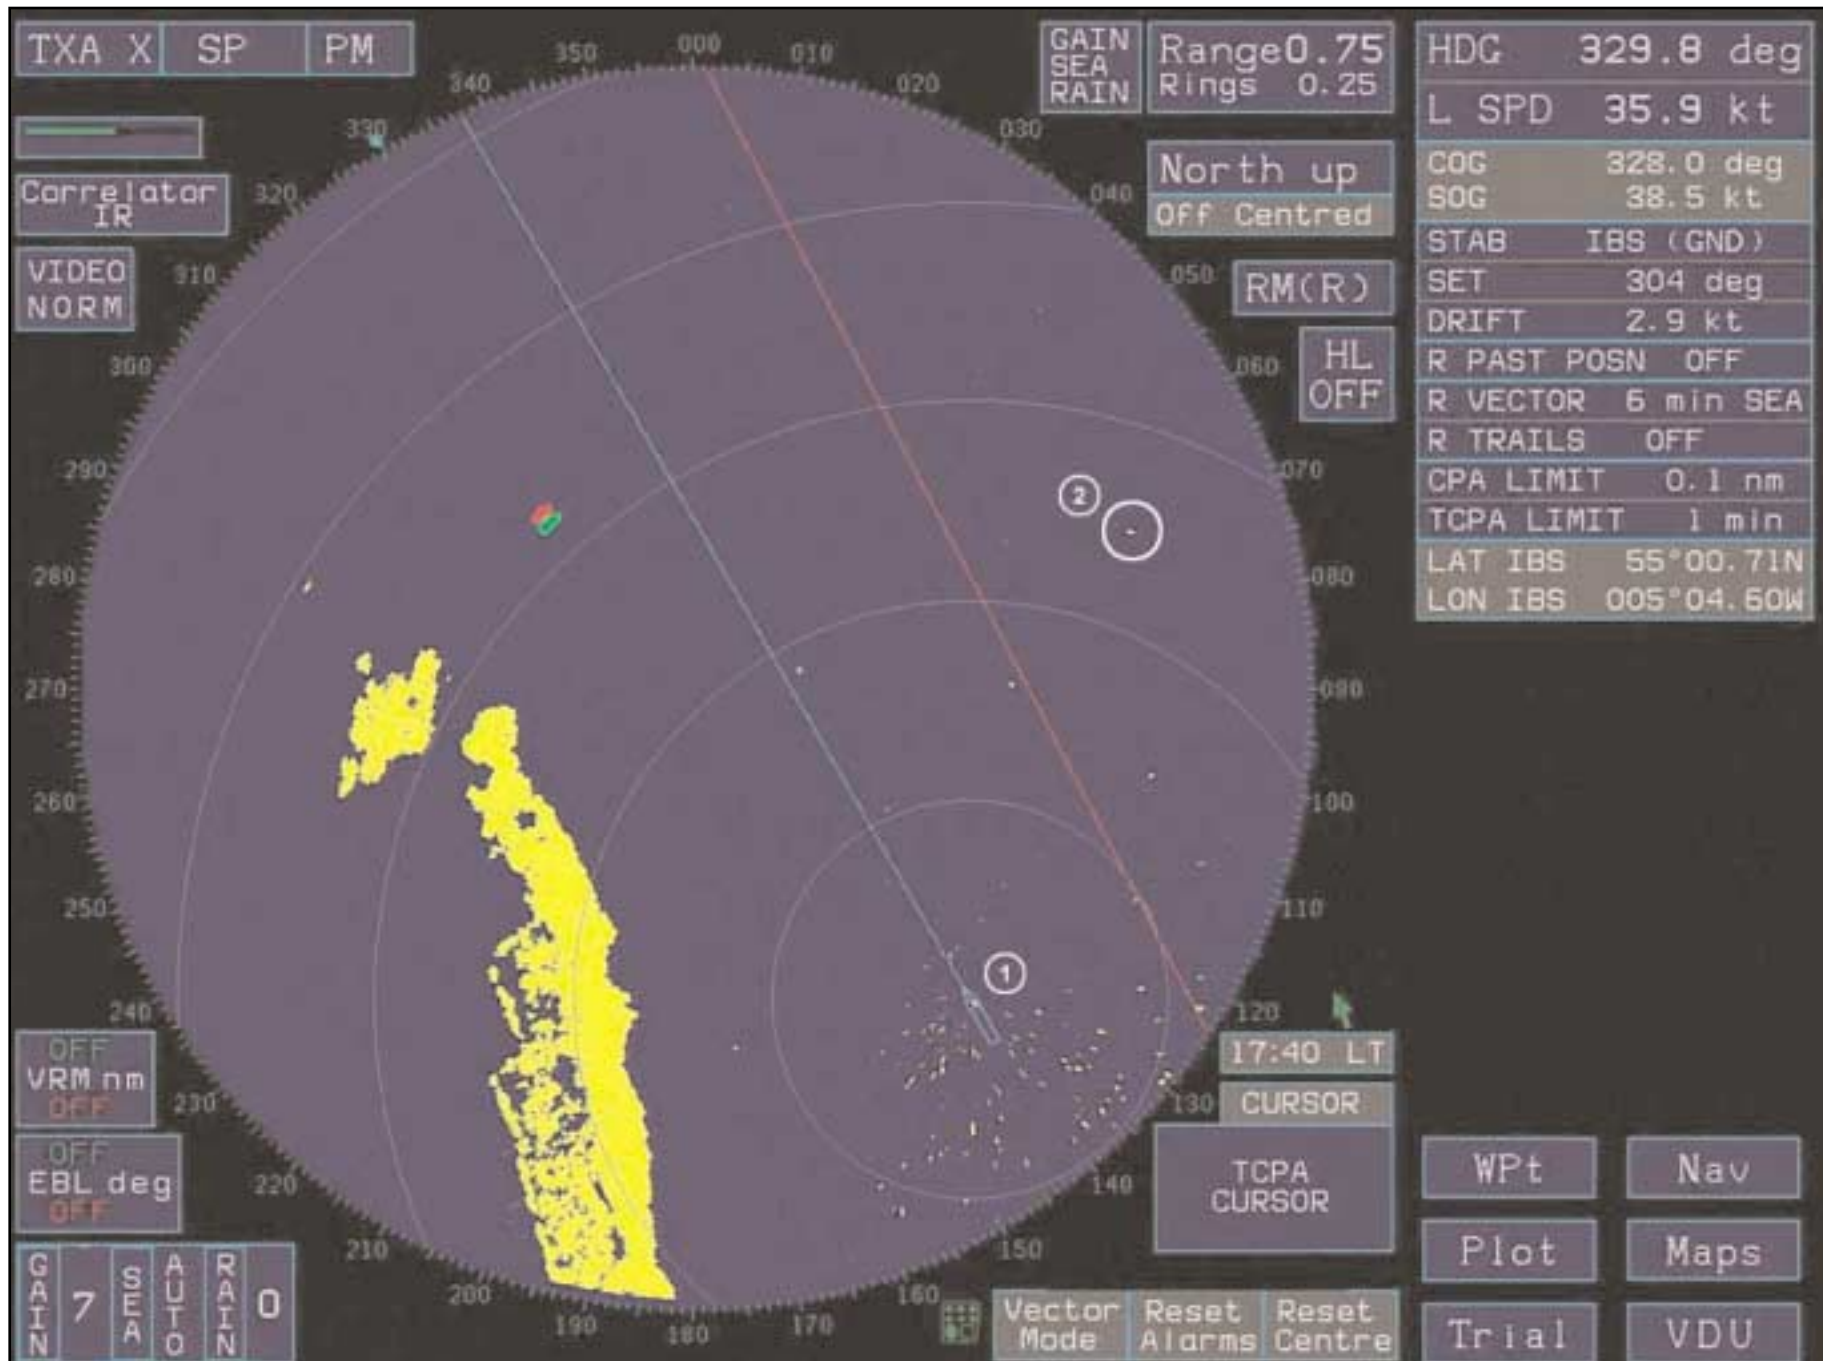
Superstar Express outbound at 1740 (1), and contact (2) believed to be the boat

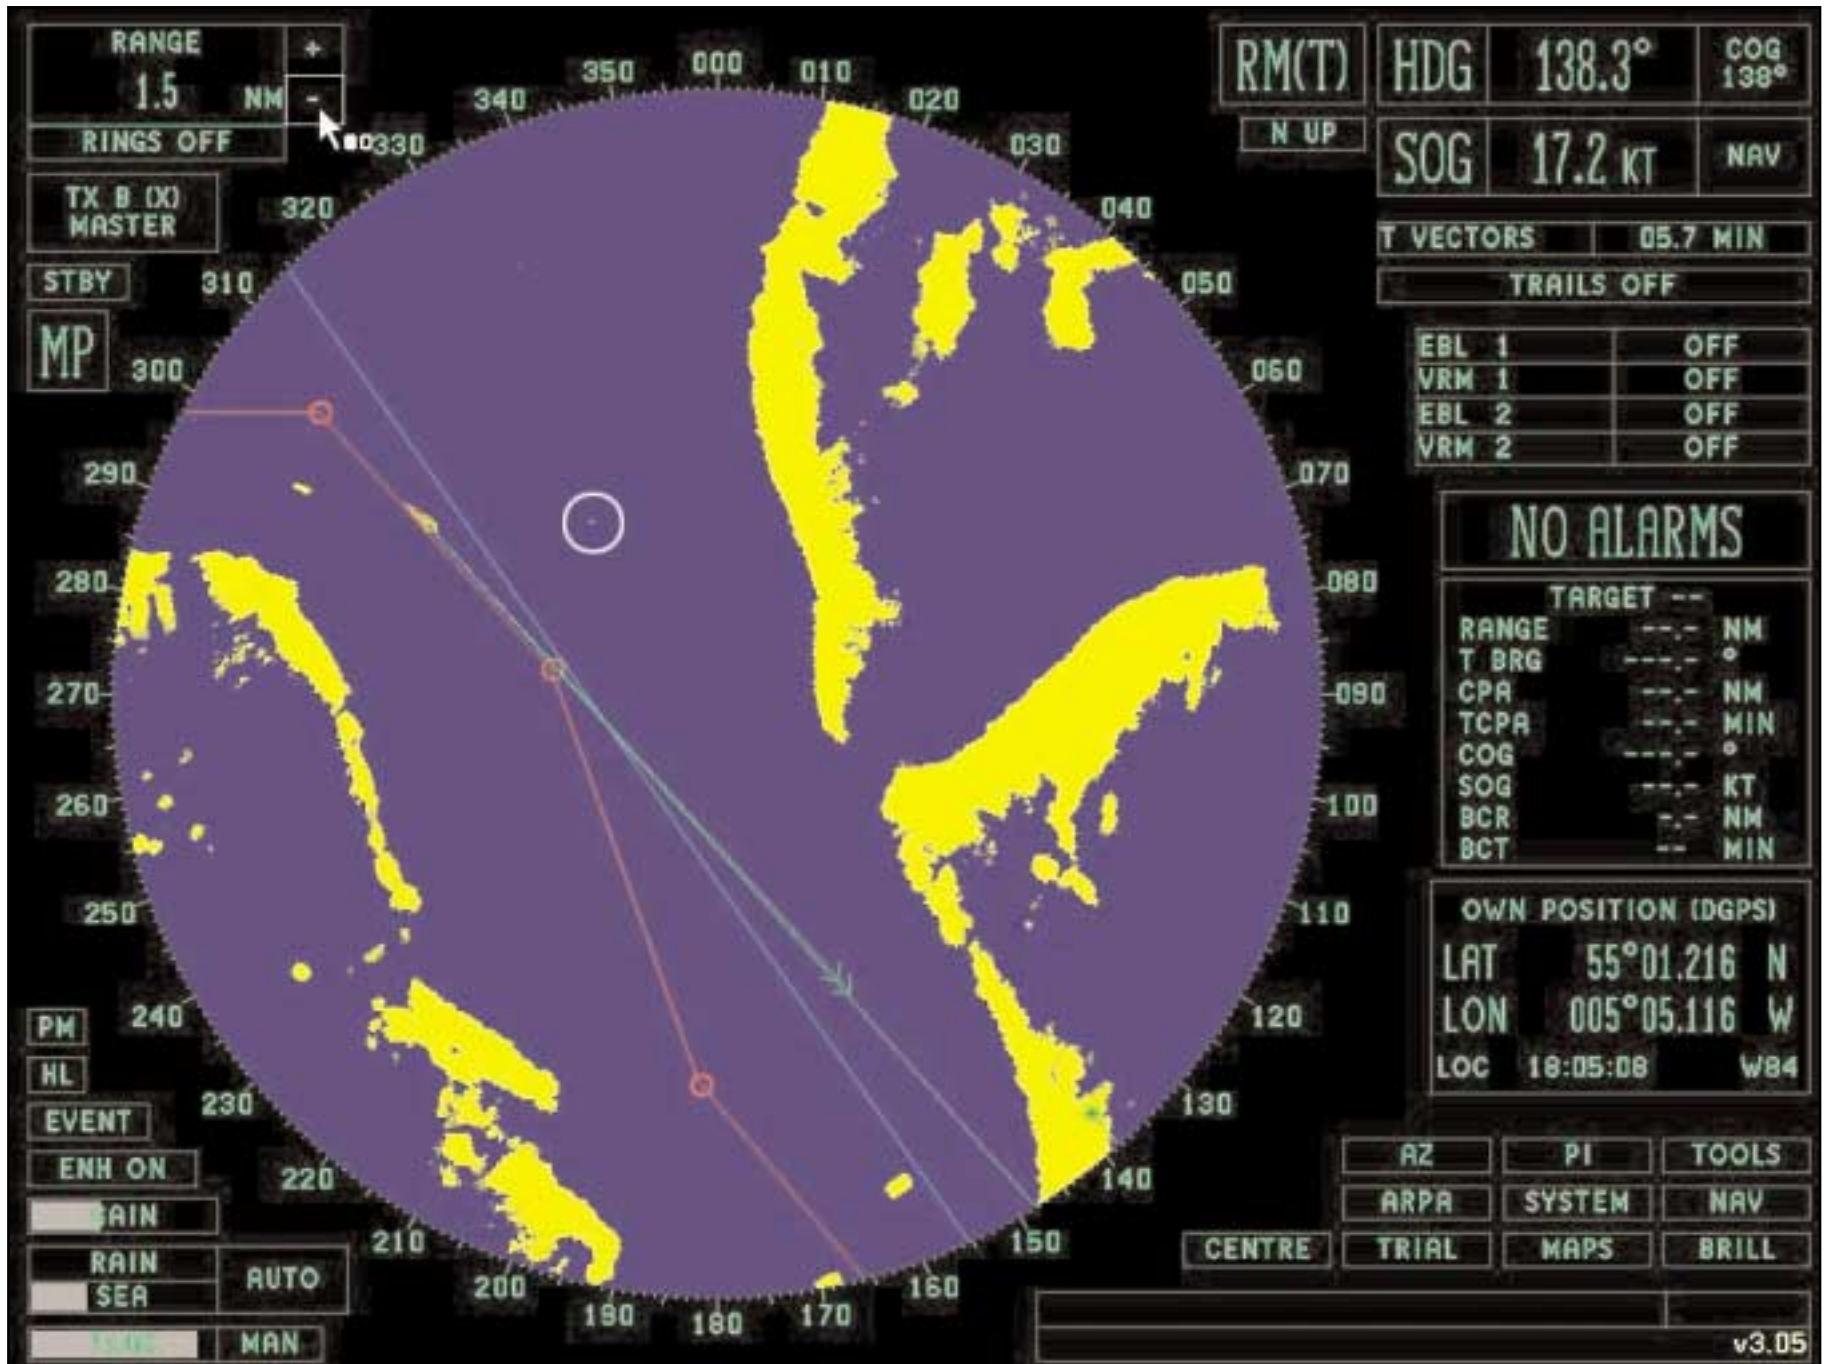
European Highlander inbound at 1805 - contact circled

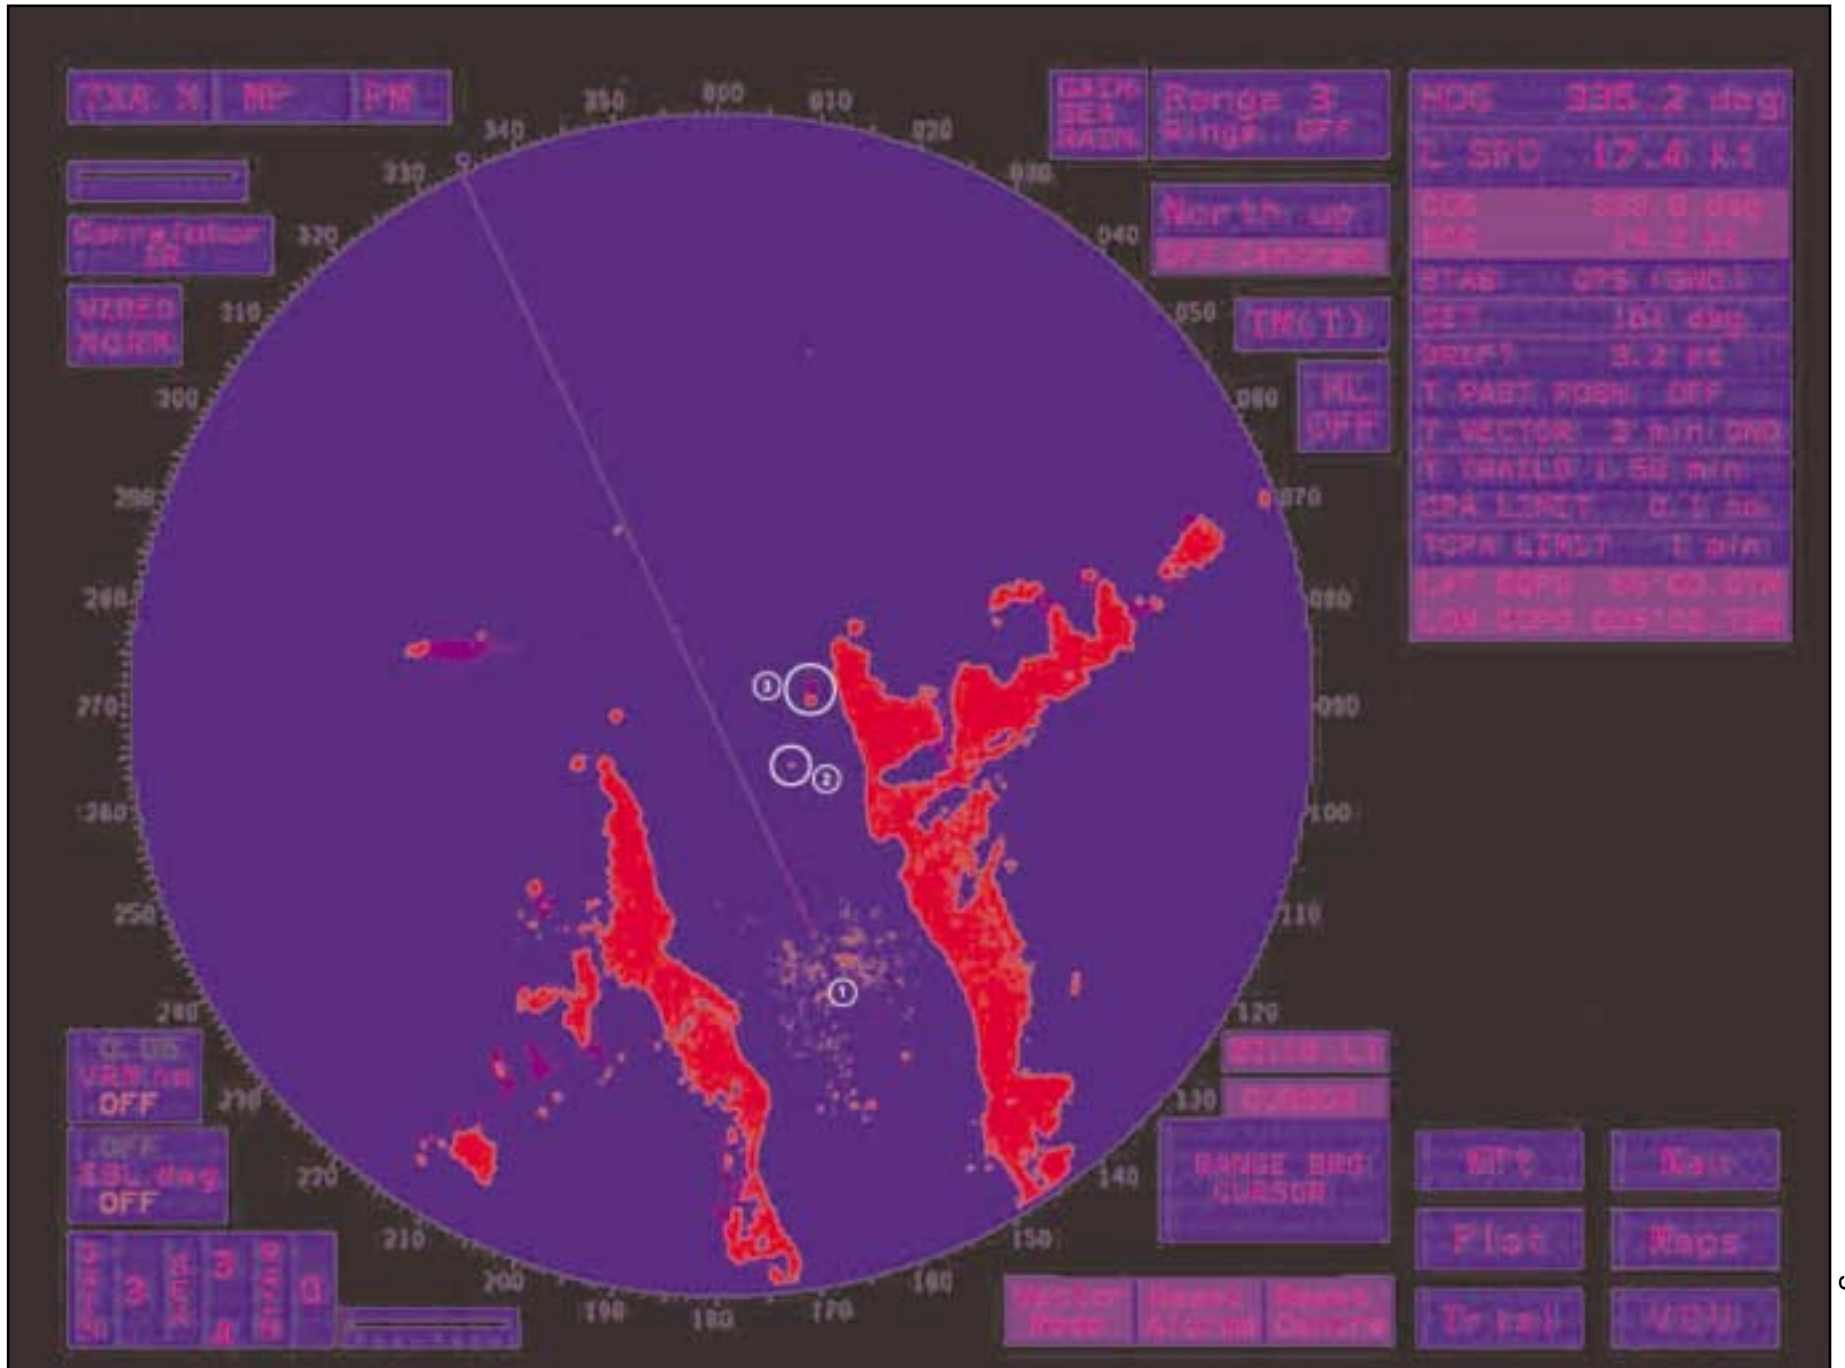
Stena Voyager outbound at 2018 (1), contact (2) believed to be the boat, and contact (3) believed to be the yacht Catalina

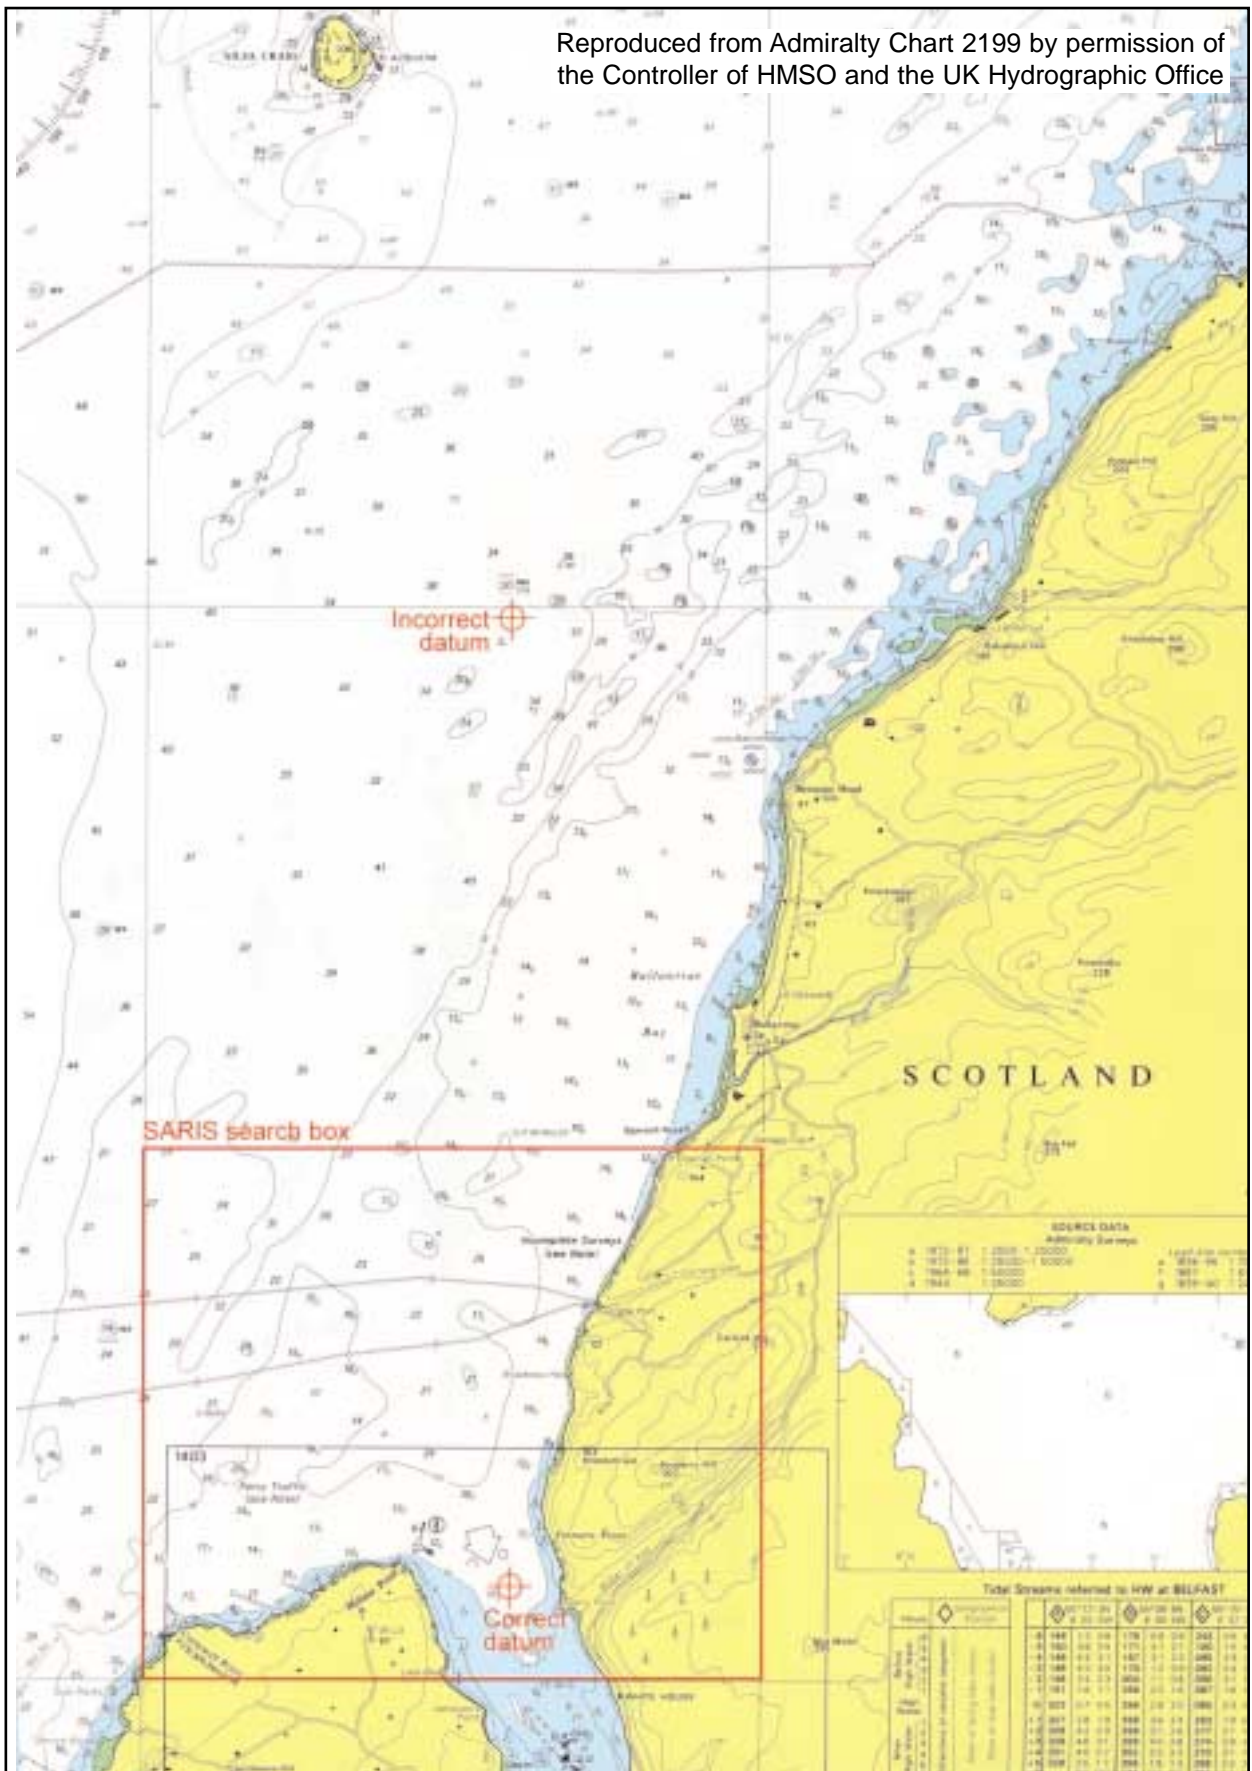
Charlet of mouth of Loch Ryan and Ailsa Craig showing SARIS search box and datum positions
