Report on the investigation of
the collision between
Hyundai Dominion and Sky Hope
in the East China Sea
21 June 2004

Marine Accident Investigation Branch
Carlton House
Carlton Place
Southampton
United Kingdom
SO15 2DZ

**Report No 17/2005
August 2005**

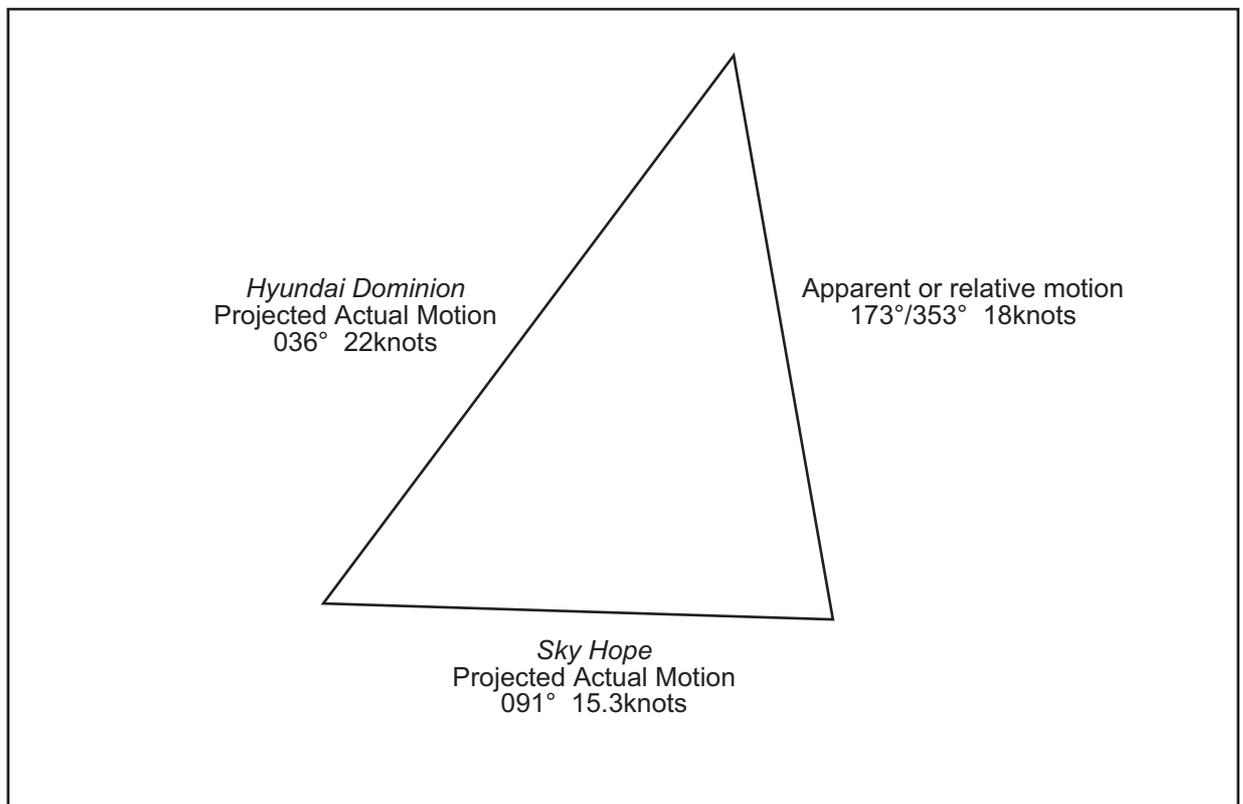
Figure 10 shows that *Sky Hope* closed *Hyundai Dominion* from a bearing of 353°, and that *Hyundai Dominion* closed *Sky Hope* from a bearing of 173°. The closing speed of the two vessels was about 18 knots.

However, as **Figure 10** shows, *Hyundai Dominion* closed on a bearing of 173°, not 210°.

As 173° was forward of the starboard beam of *Sky Hope*, this was a crossing, not an overtaking situation as assessed by *Sky Hope*'s OOW.

Plot to find relative motion
